Operational Inspection

Thurston Parish Council

New Green Centre
New Green Ave, Thurston, IP31 3TG

Operational Inspection - 2-September-2024 - 11:53 Inspector Dan Carr

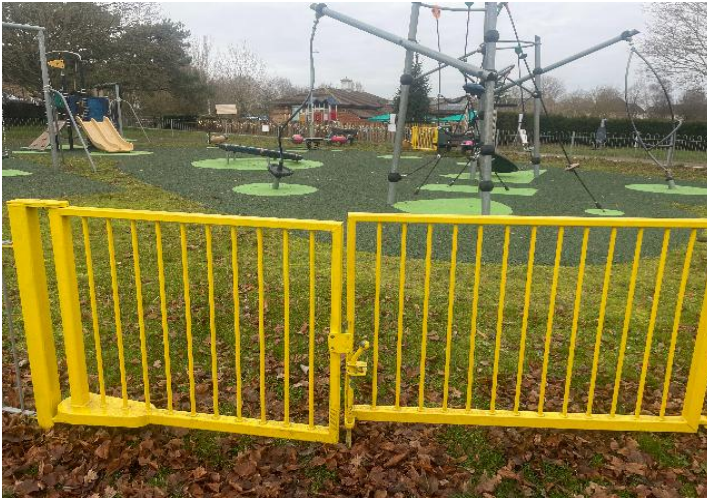
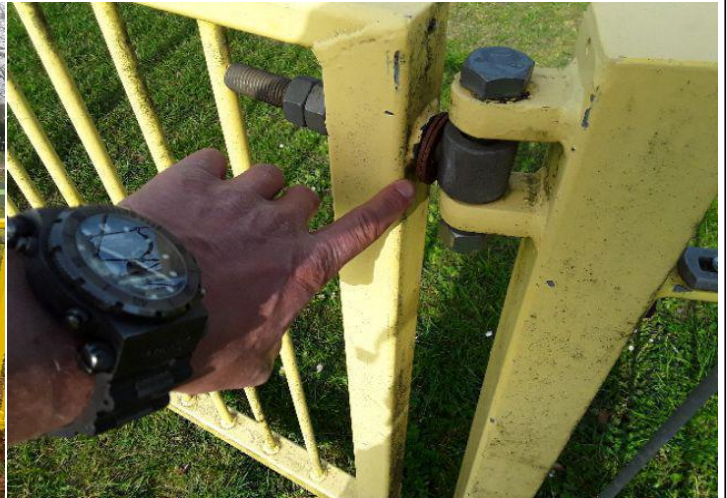
Finding: The paintwork on this item has been damaged or worn exposing the metal underneath which is rusting

Action: Treat any rusting components and repaint

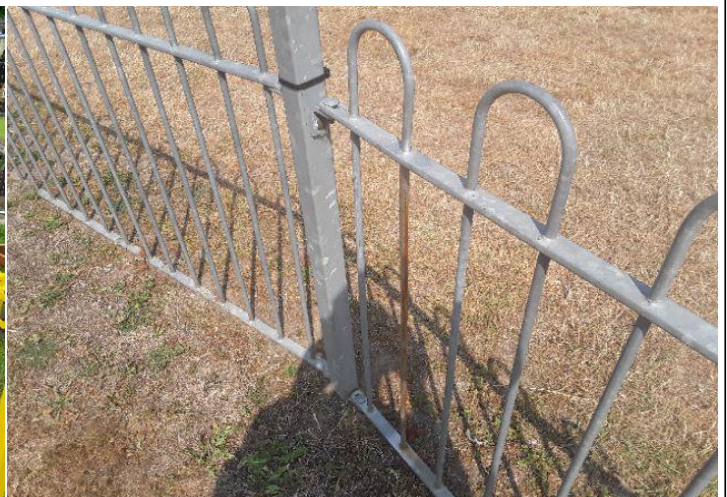
Finding: The paintwork on this item has been damaged or worn exposing the metal underneath which is rusting

Action: Treat any rusting components and repaint

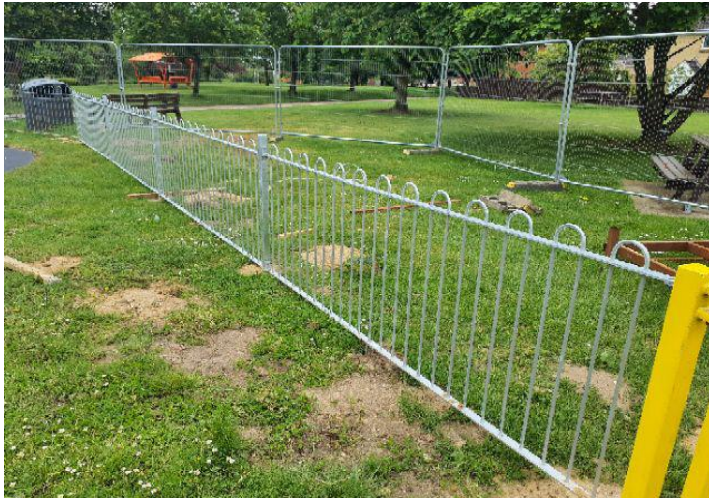
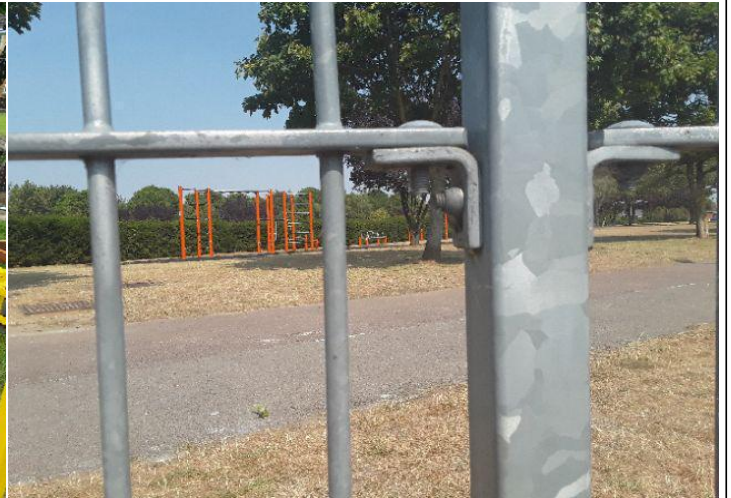
Finding: There is or are fixings missing on the item

Action: Replace 2 missing fixings

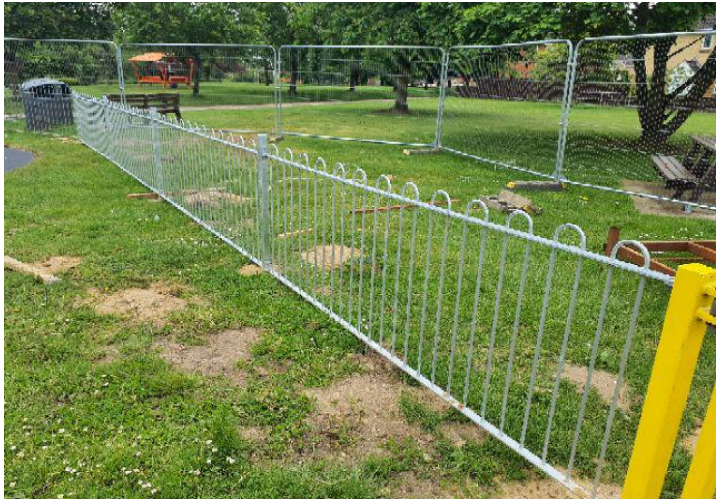
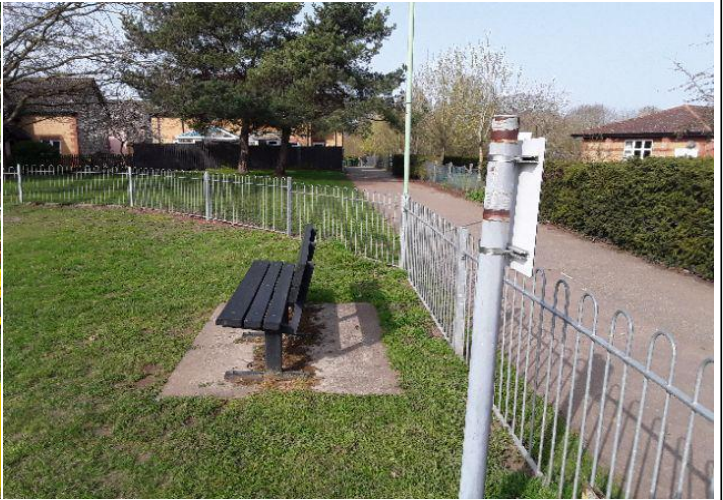
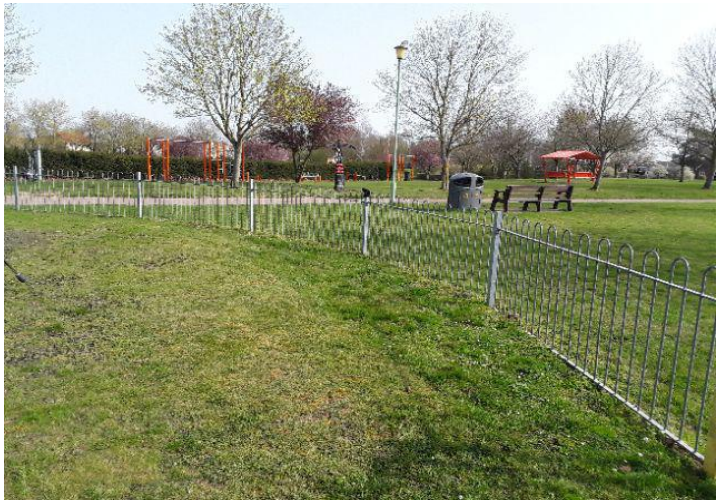
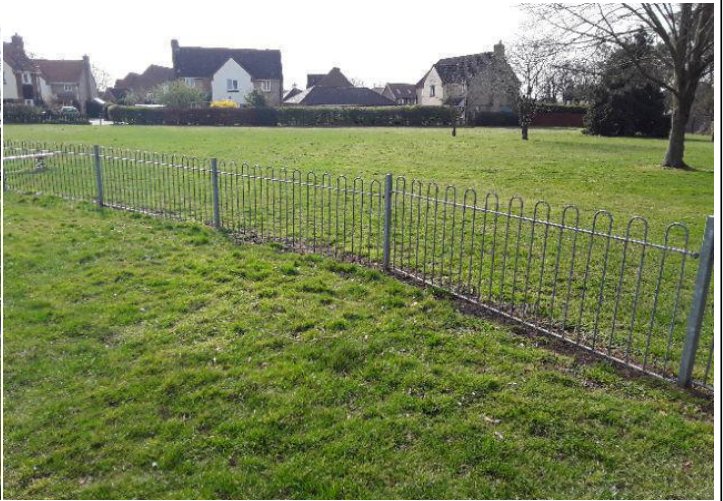
Finding: There are 2 loose posts around the fence

Action: Monitor for any further deterioration and reset as required

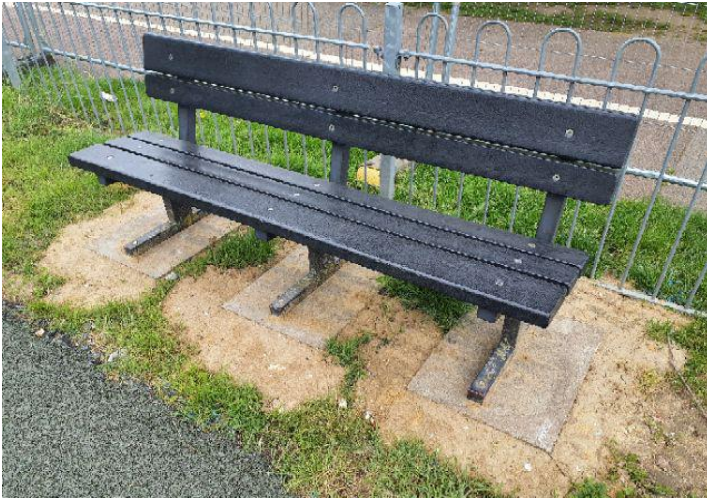
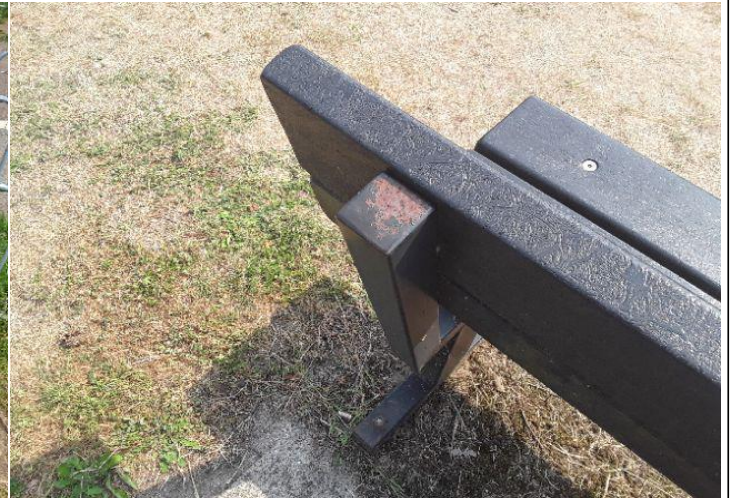
Finding: The paintwork on this item has been damaged or worn exposing the metal underneath which is rusting

Action: Treat any rusting components and repaint

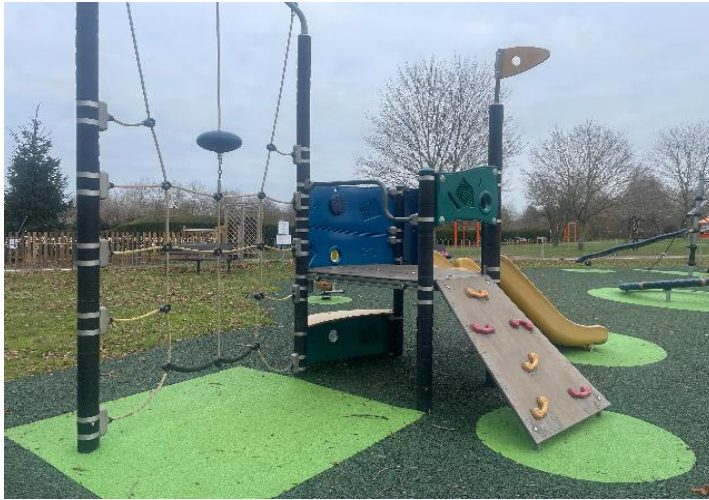
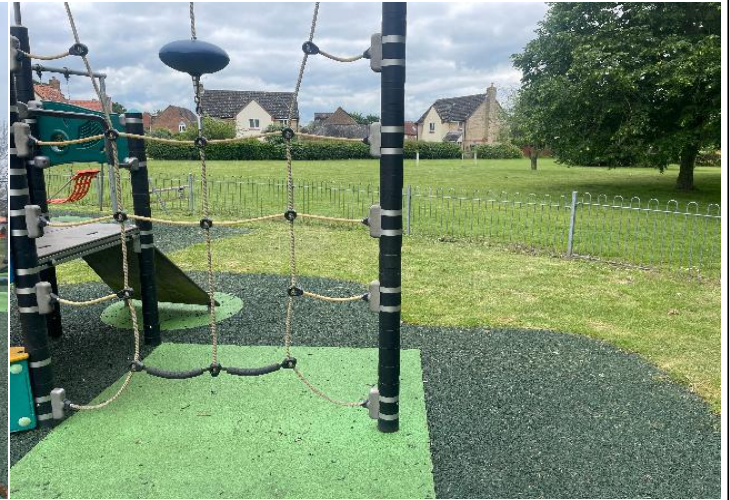
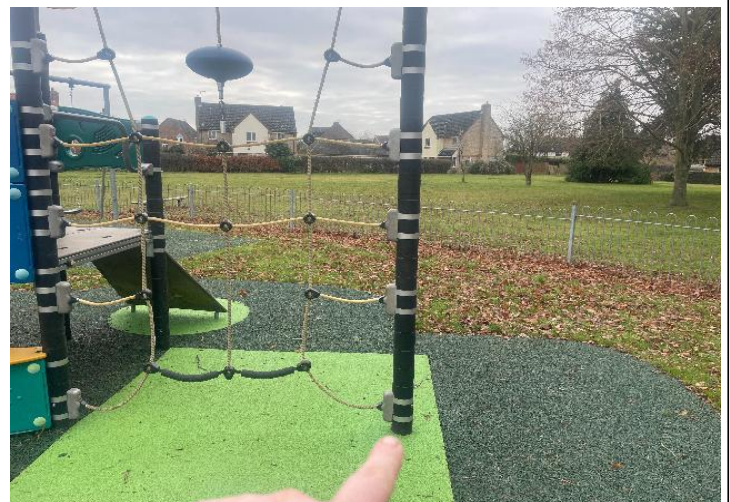
Finding: The item is slightly loose in its foundations

Action: Monitor for any further deterioration and repair as required

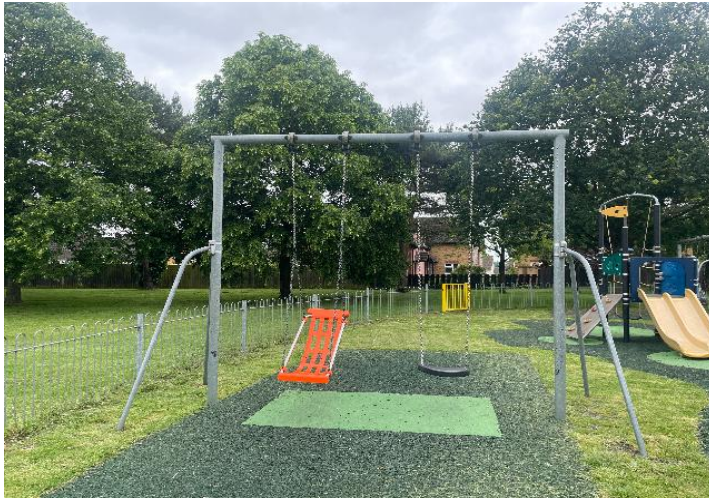
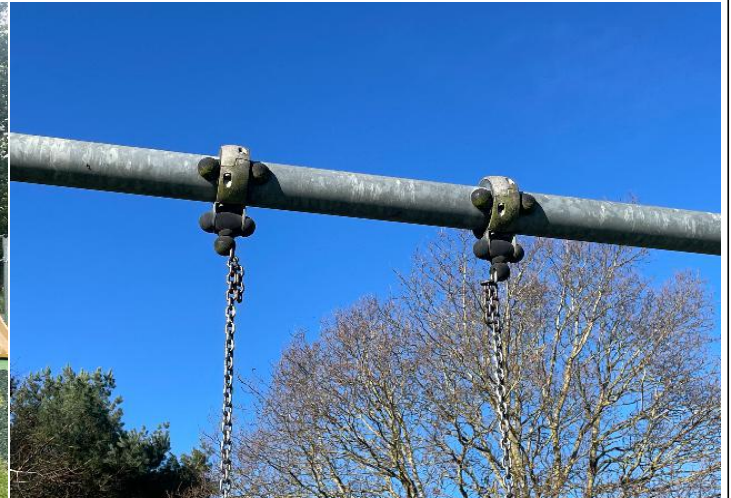
Finding: There is some notable evidence of chain wear

Action: Monitor for any further deterioration and replace when 40% worn

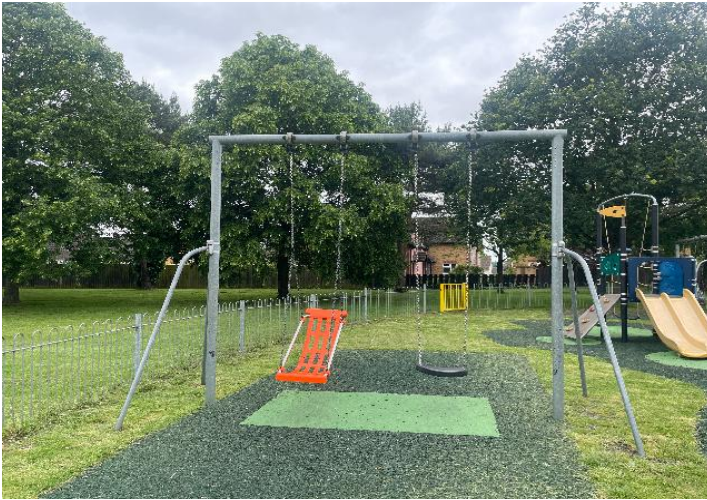
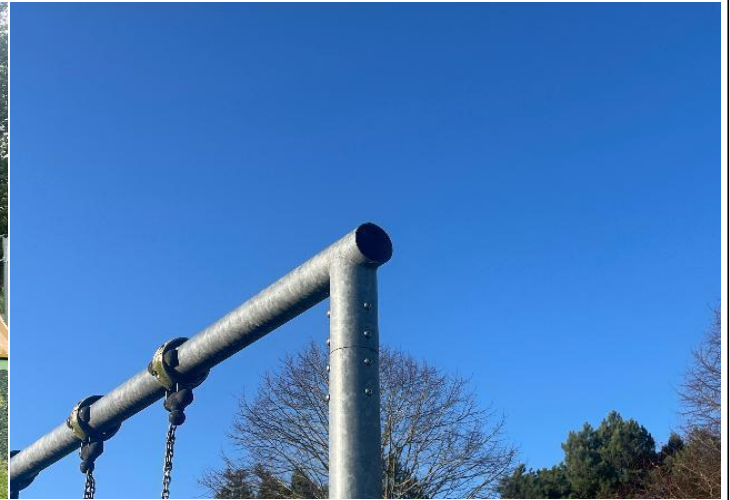
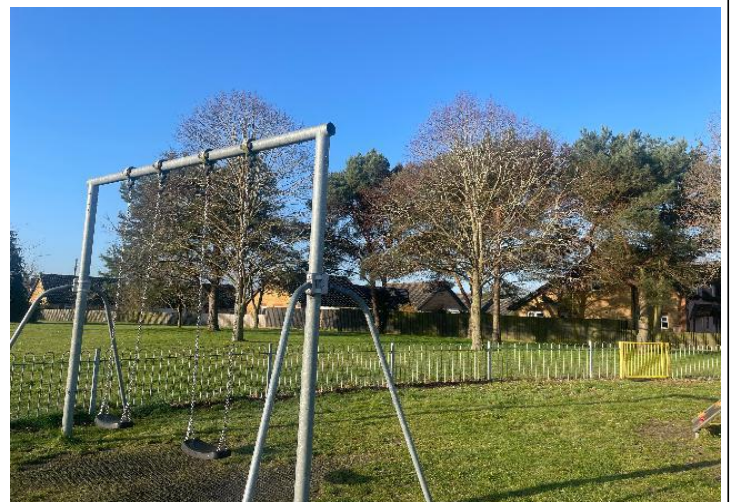
Finding: There is/are bolt cap covers missing or damaged on the item

Action: Replace missing or damaged bolt cap covers

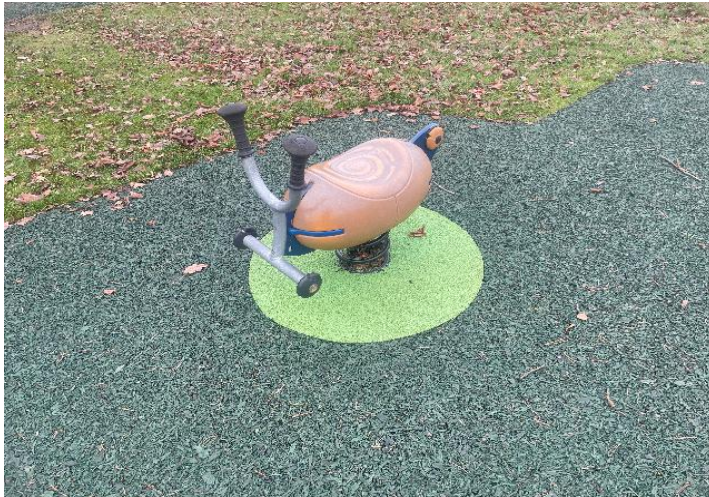
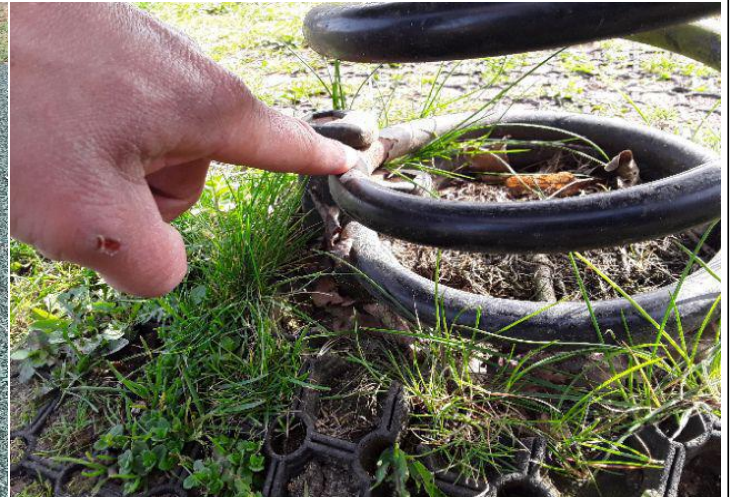
Finding: The paintwork on the spring has been damaged or worn exposing the metal underneath which is rusting

Action: Treat any rusting components and repaint

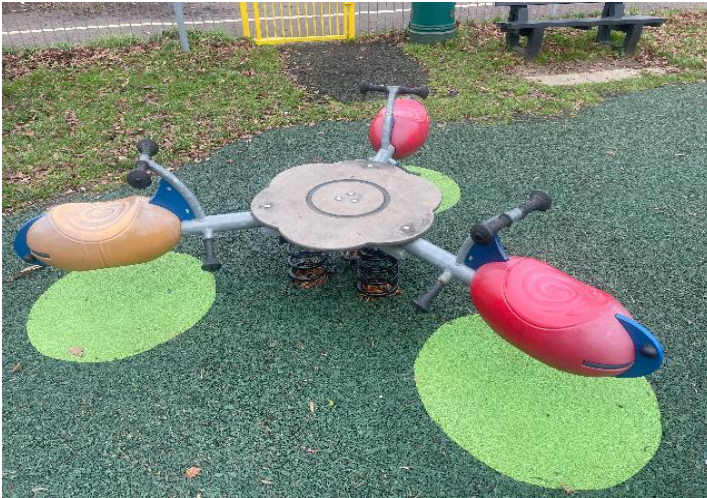
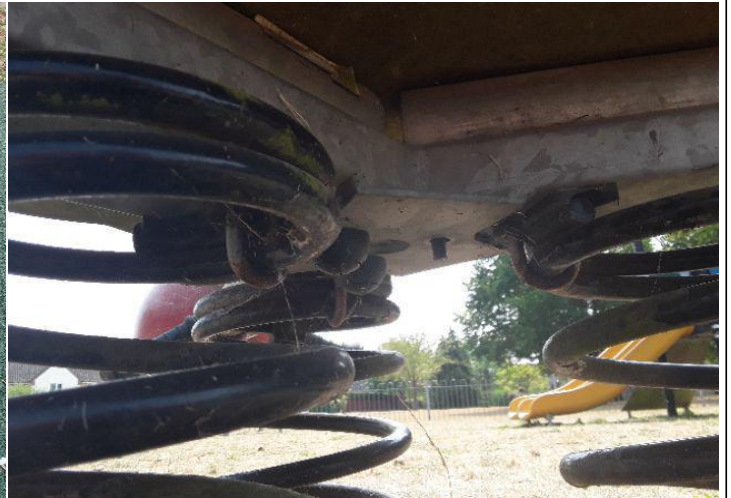
Finding: There is or are fixings missing on the item

Action: Replace all missing fixings

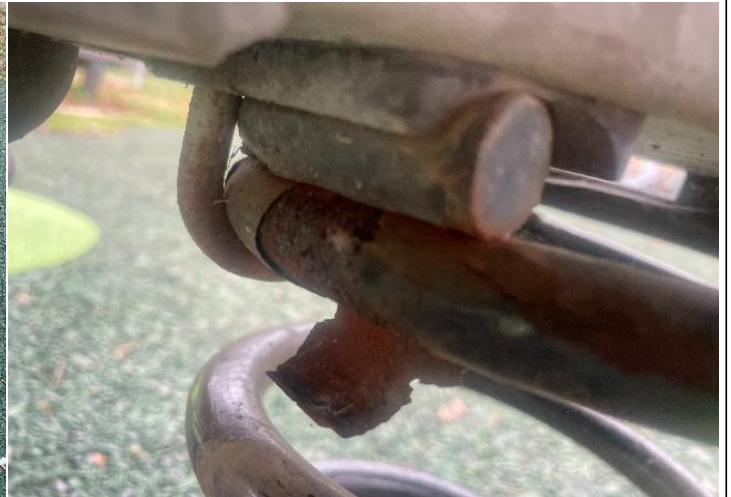
Finding: The paintwork on the spring has been damaged or worn exposing the metal underneath which is rusting

Action: Treat any rusting components and repaint

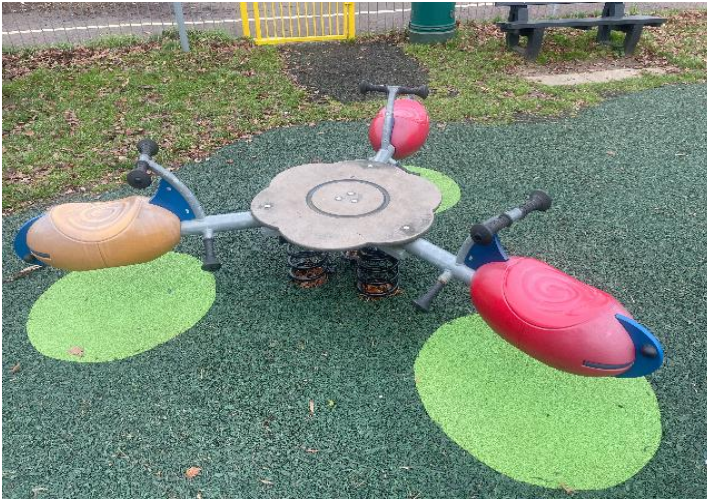
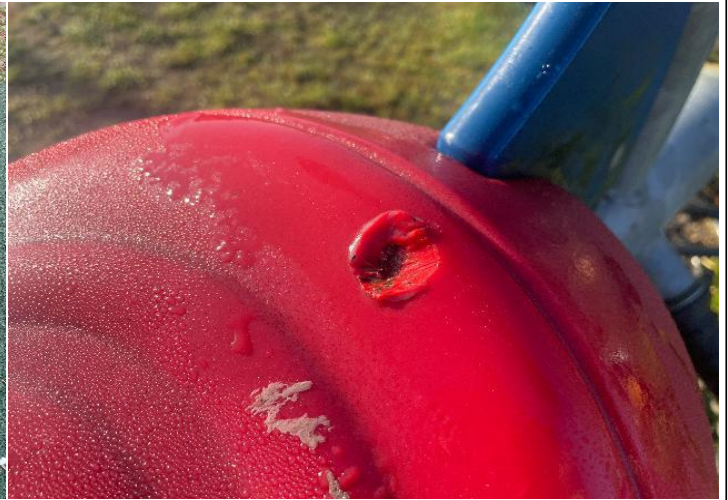
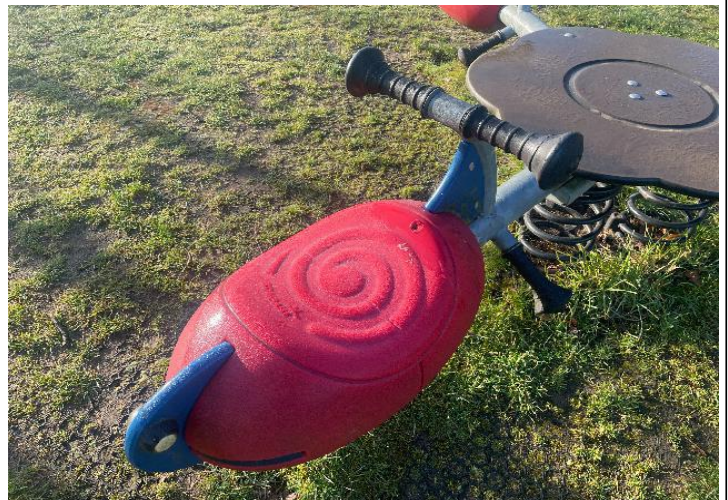
Finding: There is some evidence of fire damage to the item **Action:** Monitor for any further deterioration and repair as required

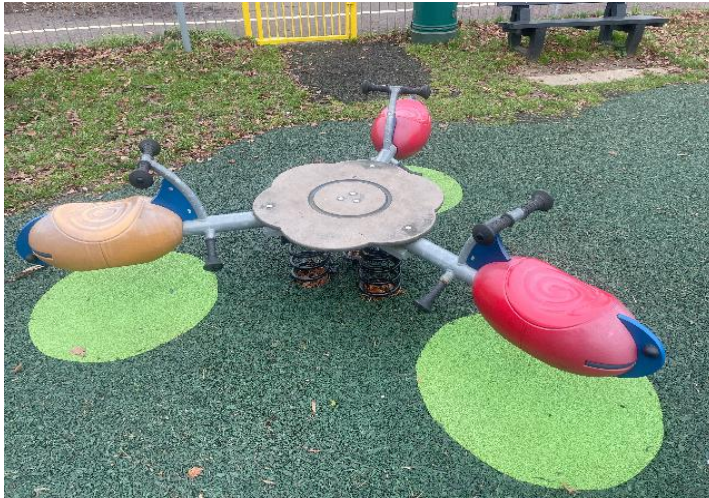
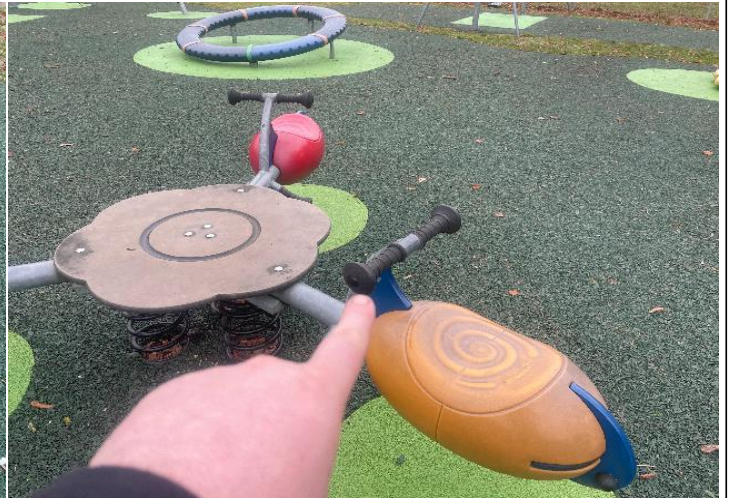
Finding: A number of Inaccessible fixing(s) have worked loose

Action: Secure all loose fixings

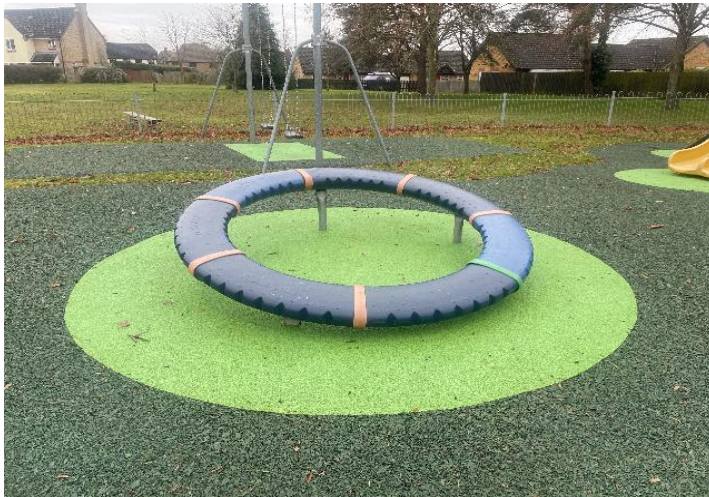
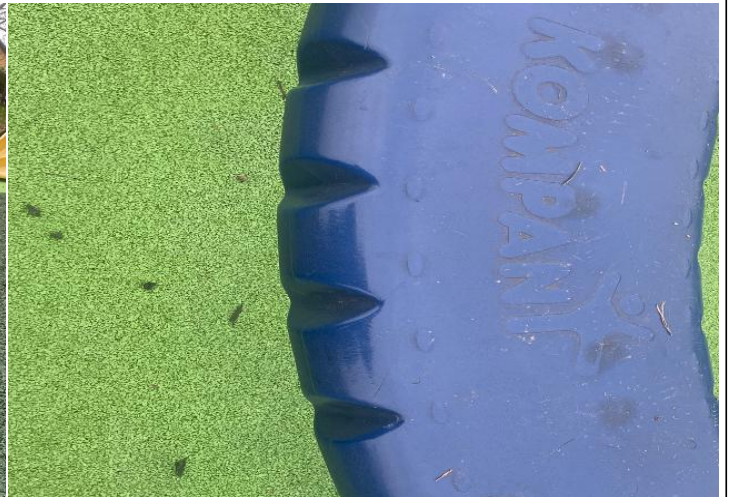
Finding: Some segments have minor damage

Action: Monitor

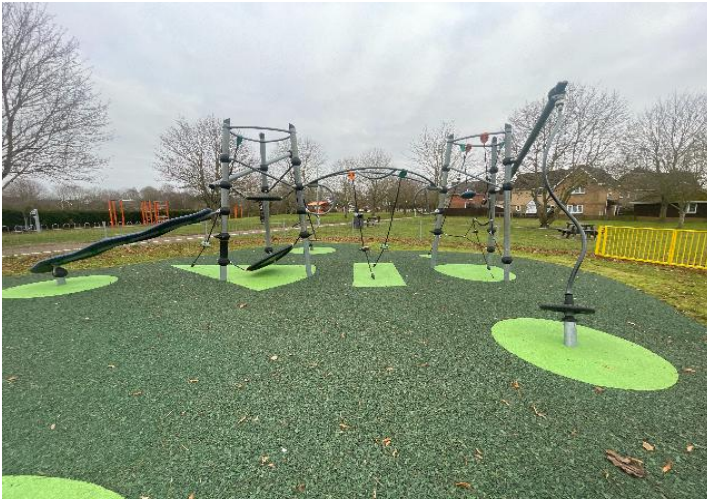
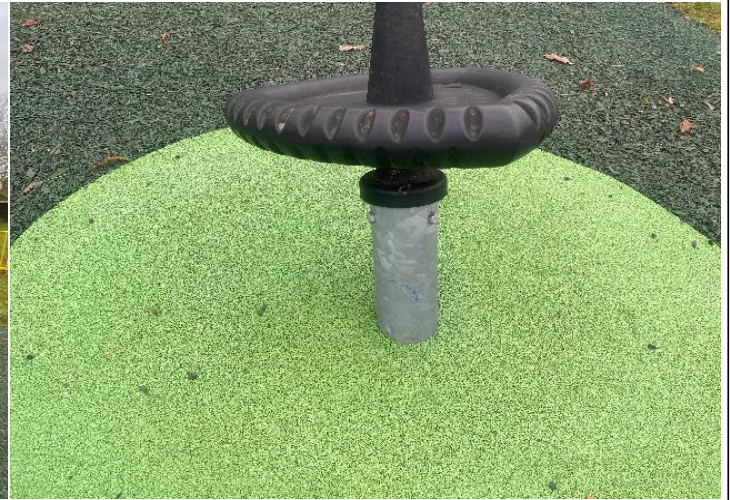
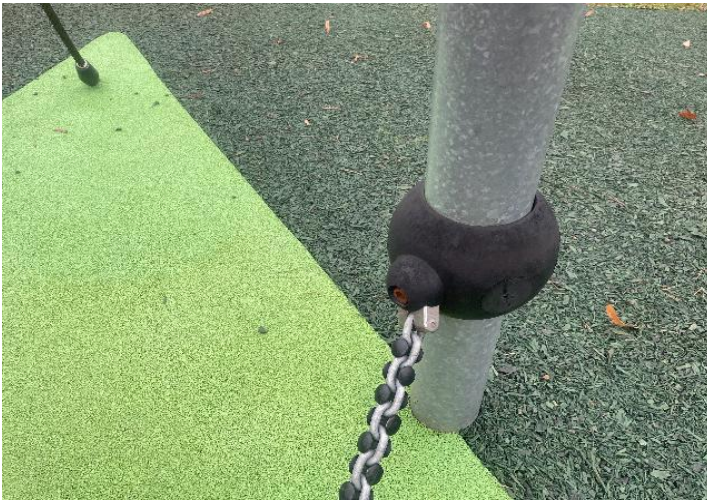
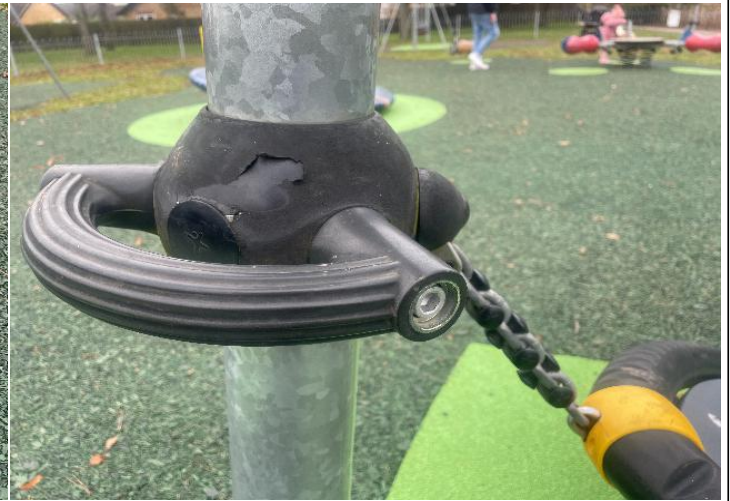
Finding: There is/are bolt cap covers missing or damaged on the item

Action: Replace missing or damaged bolt cap covers

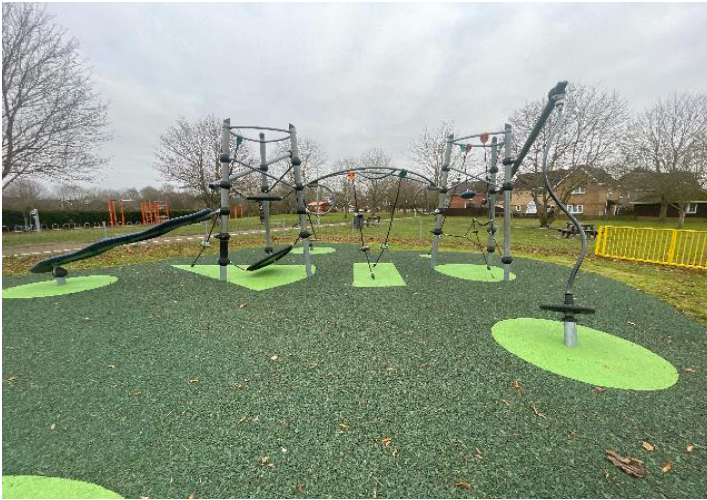
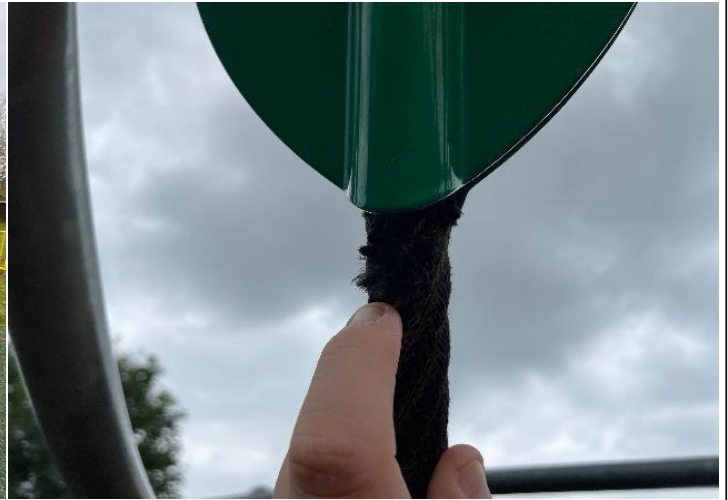
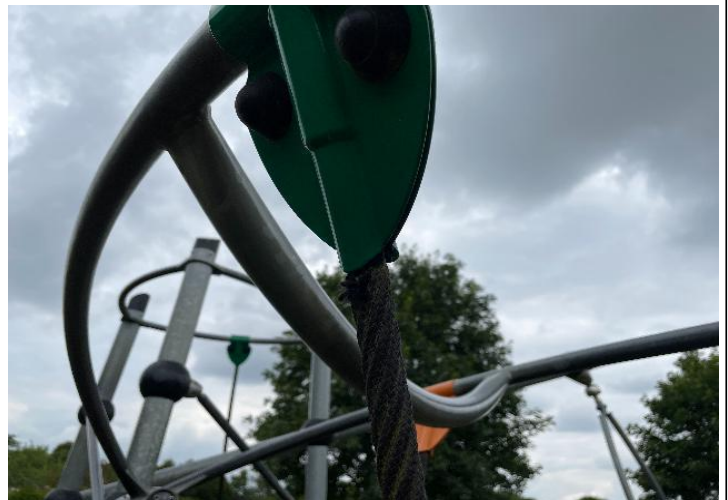
Finding: The ropes/nets are worn/damaged in places

Action: Monitor for any further deterioration and repair or replace as required

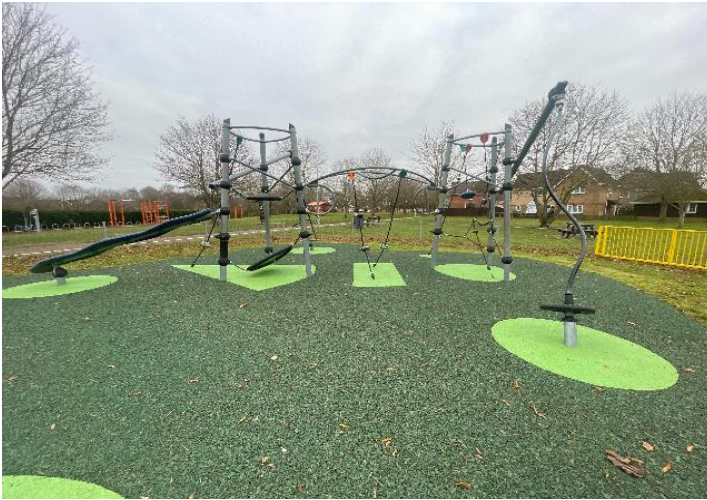
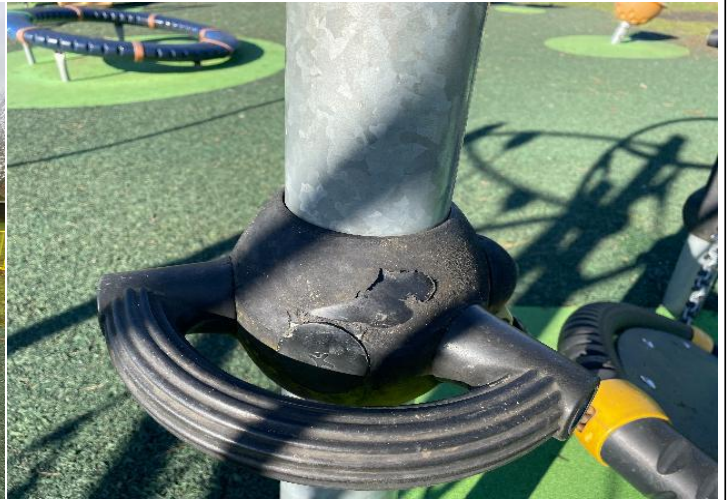
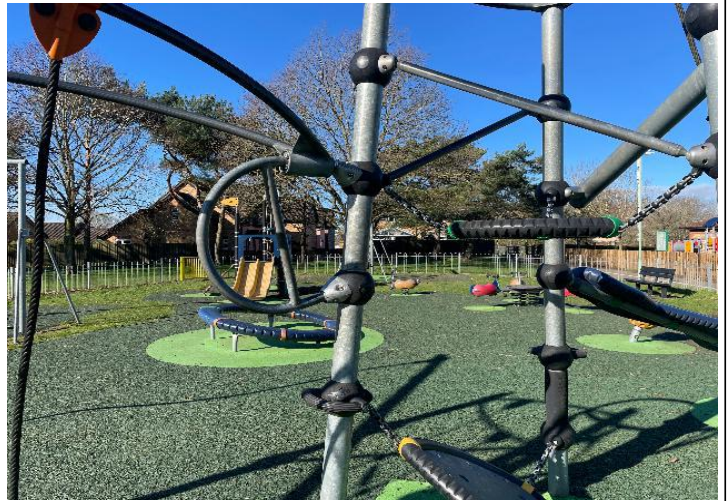
Finding: The item has been damaged

Action: Monitor for any further deterioration and replace as required

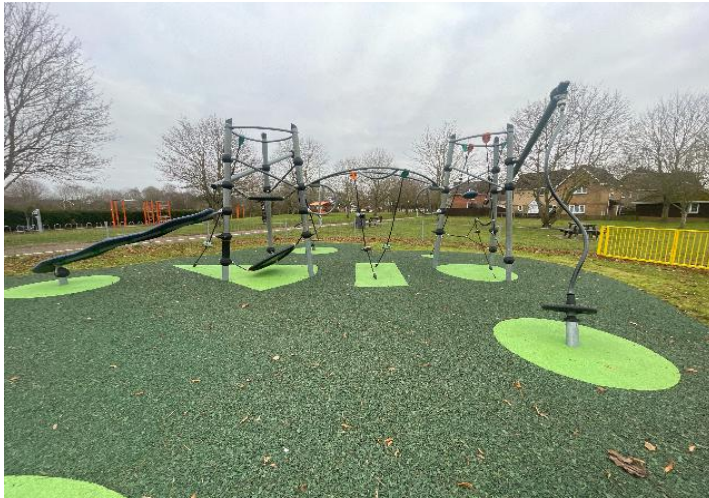
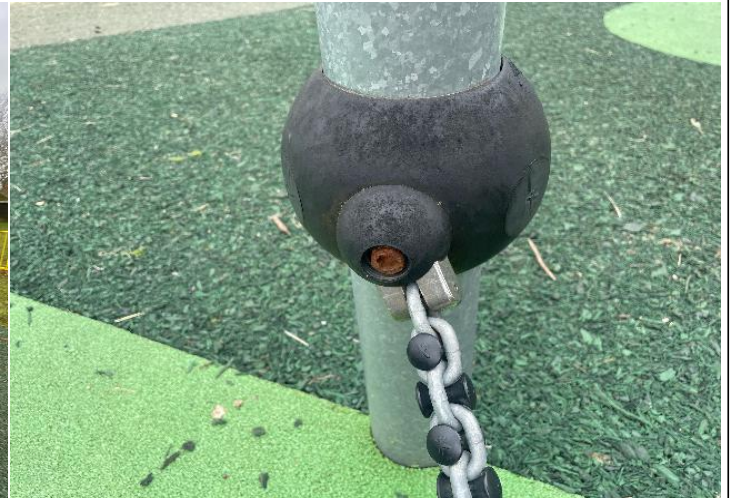
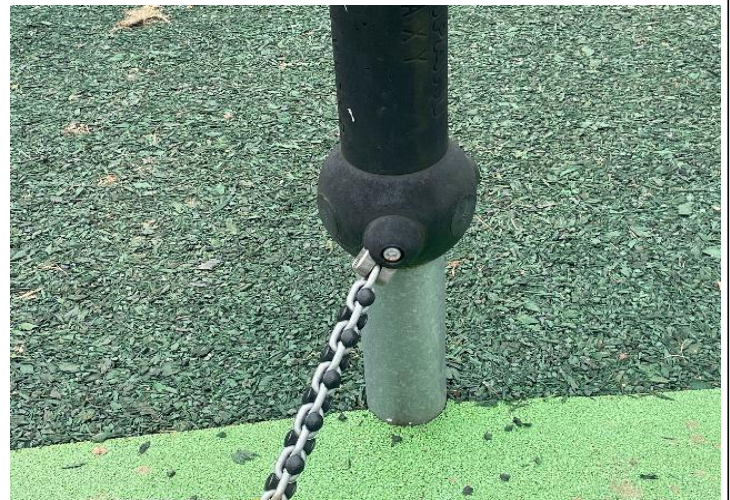
Finding: There is/are bolt cap covers missing or damaged on the item

Action: Replace missing or damaged bolt cap covers

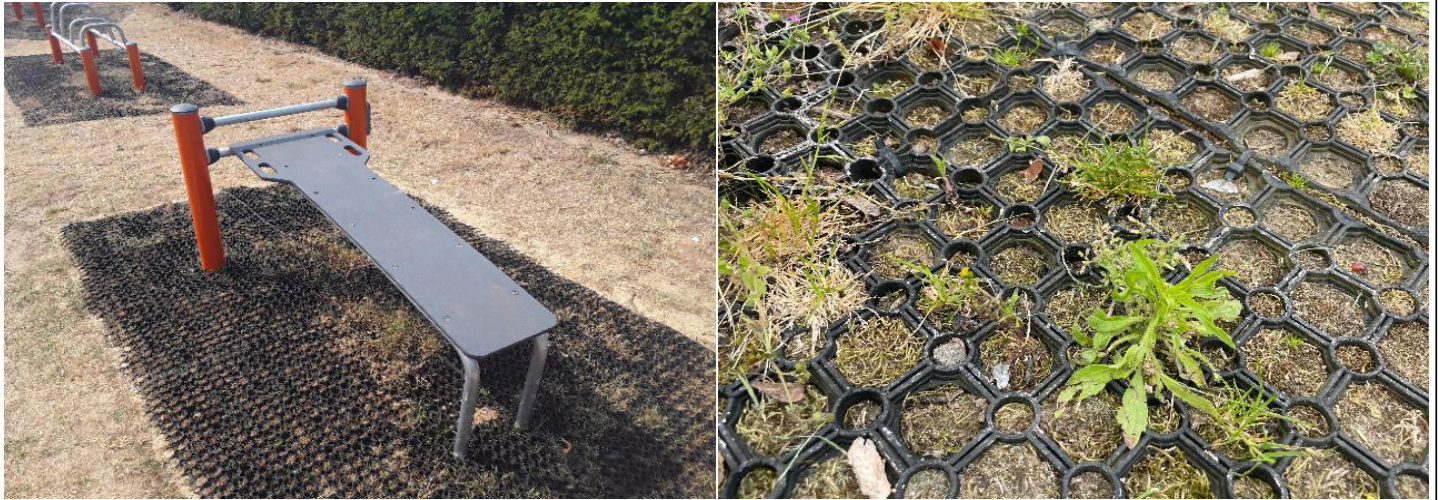
Finding: There is a significant amount of broken glass on site

Action: Remove the glass and maintain the area

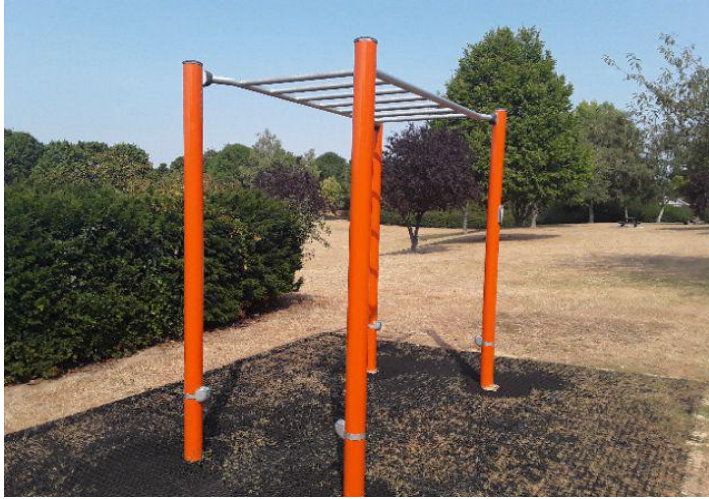
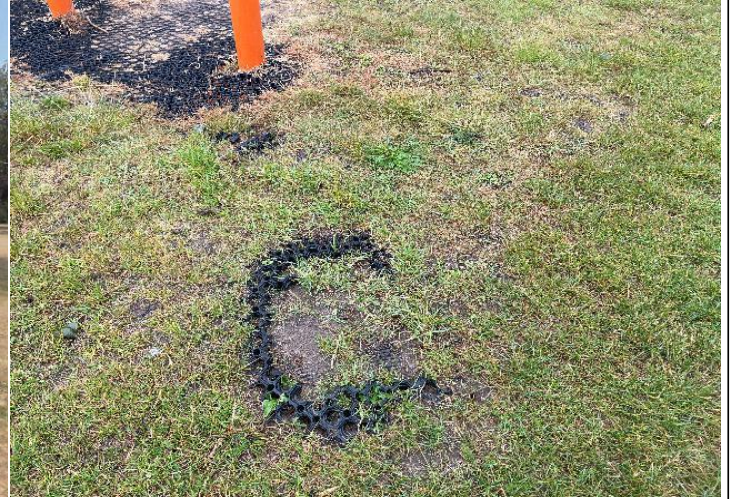
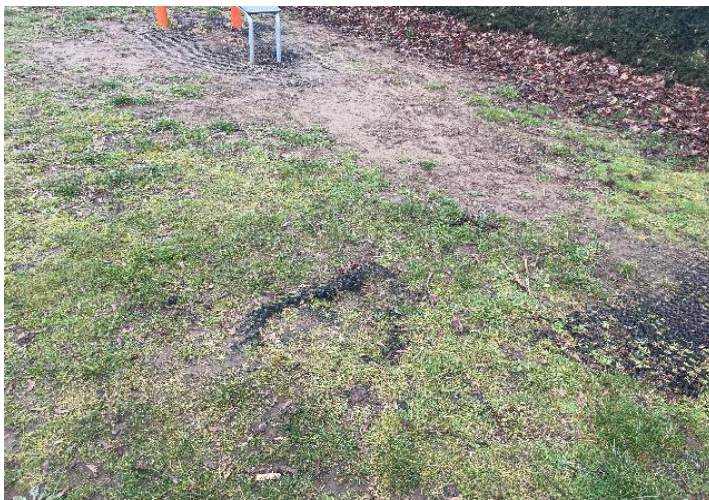
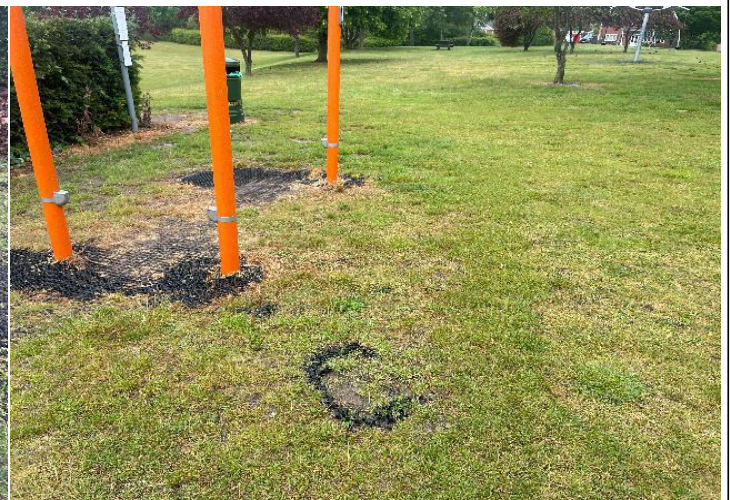
Finding: The surfacing around the item is damaged

Action: Repair the damaged areas of surfacing

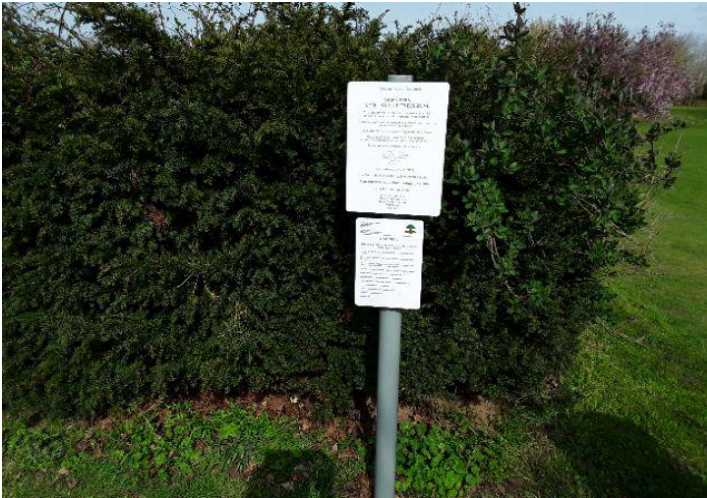
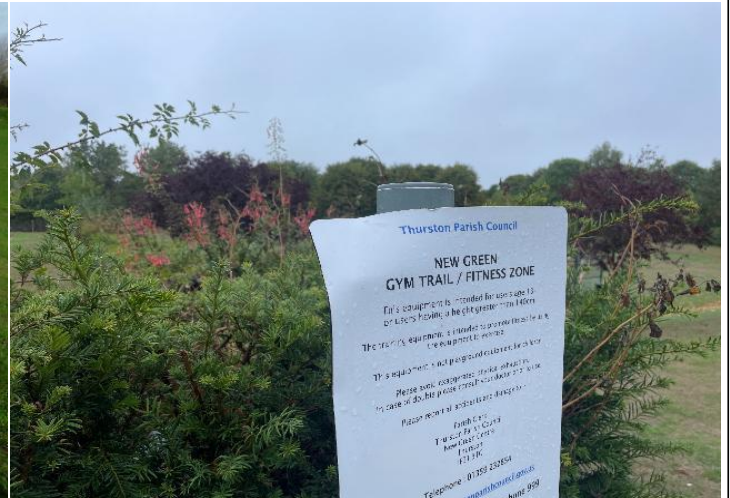
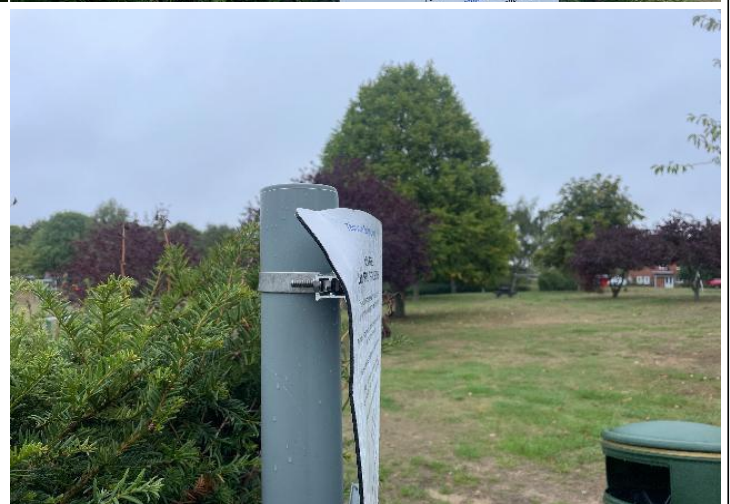
Finding: The item has been damaged

Action: Monitor for any further deterioration and replace as required

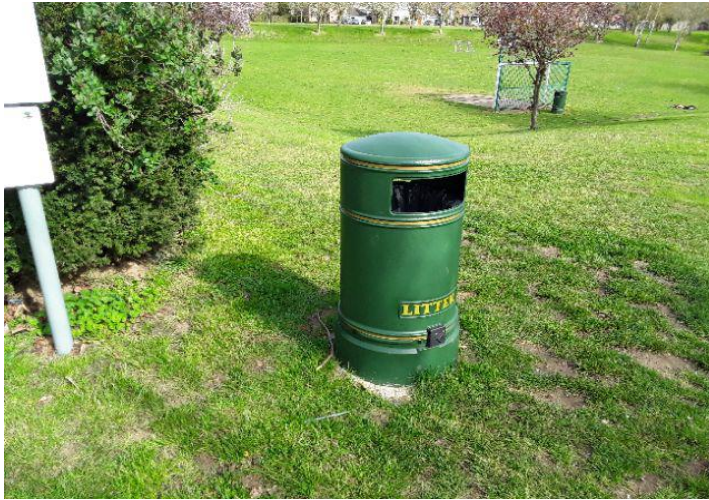
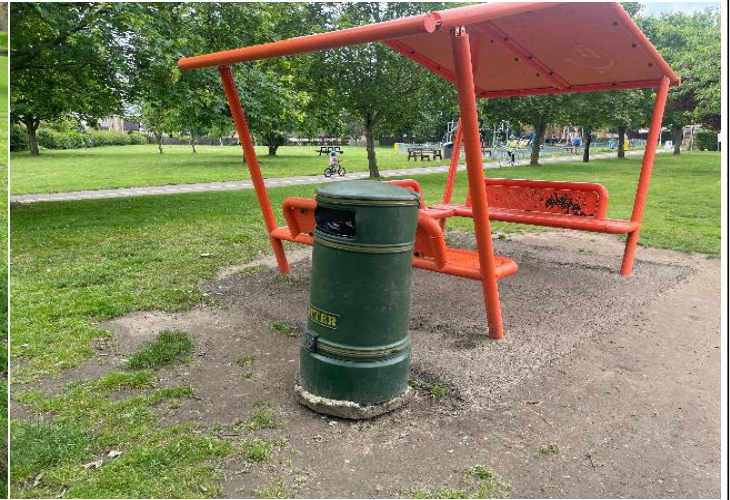
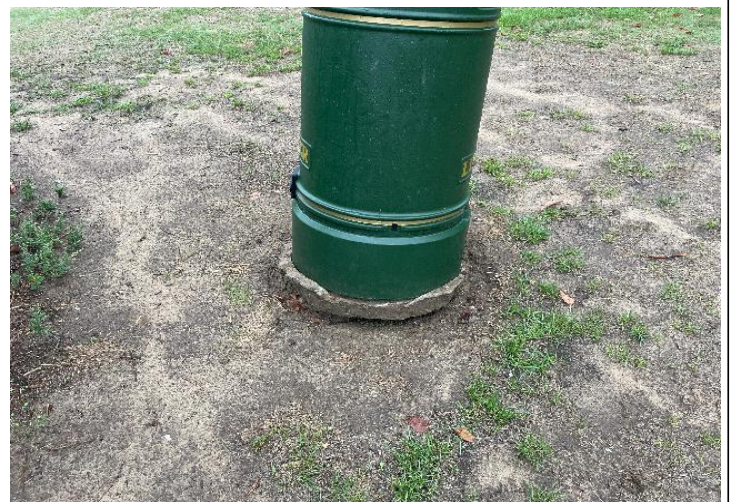
Finding: The item is loose in its foundations

Action: Reinstall item to secure

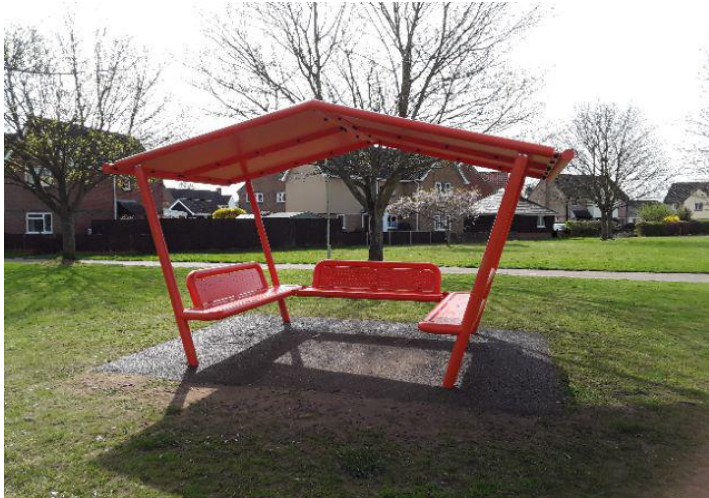
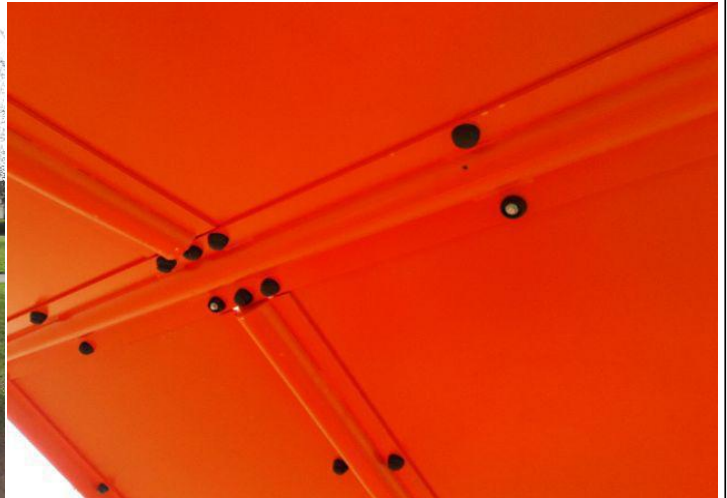
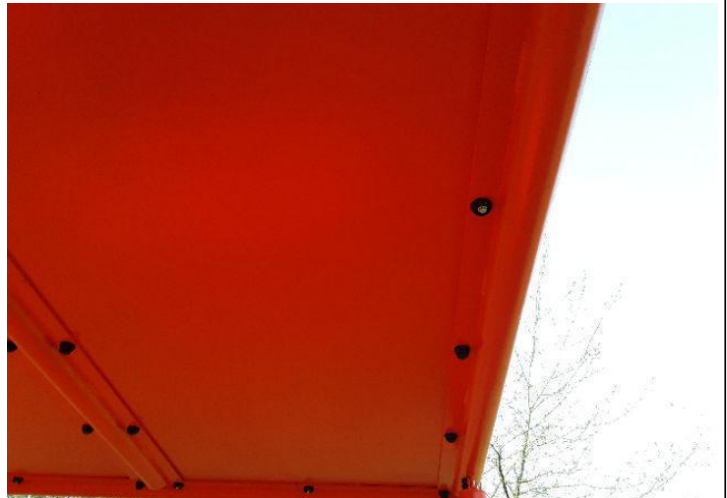
Finding: There is/are bolt cap covers missing or damaged on the item

Action: Replace 9 missing or damaged bolt cap covers
