Operational Inspection

Thurston Parish Council

New Green Centre
New Green Ave, Thurston, IP31 3TG

Operational Inspection - 2-September-2024 - 11:53 Inspector Dan Carr

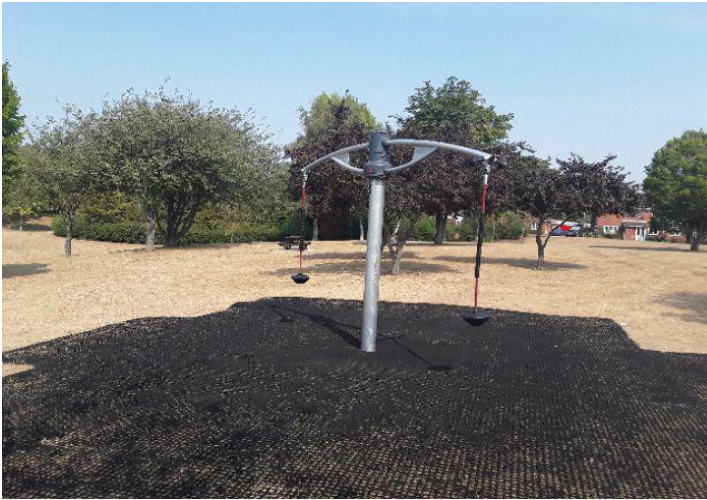
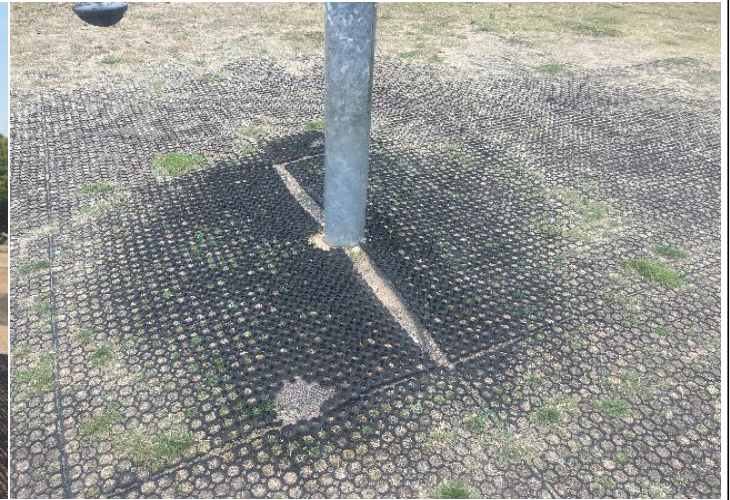
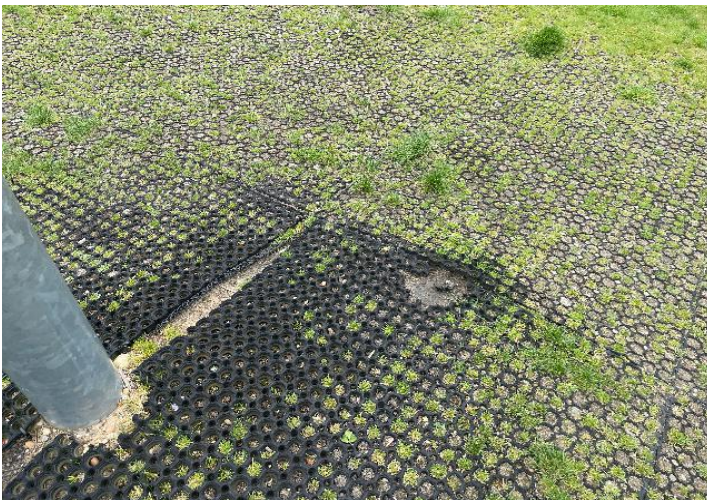
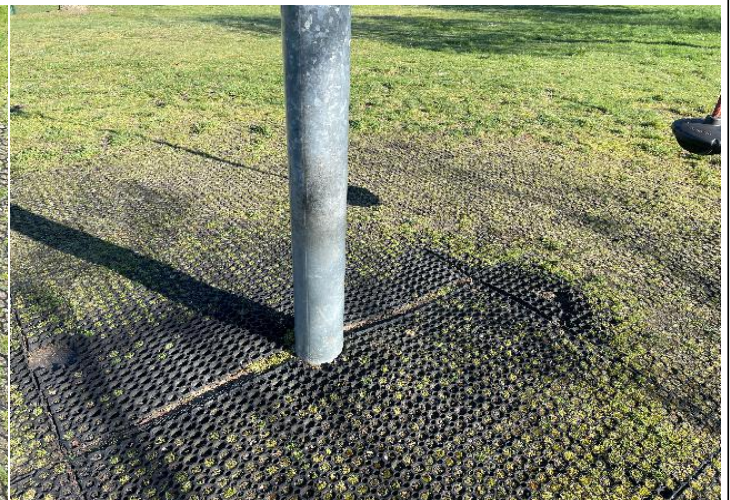
Finding: The surfacing around the item is damaged

Action: Repair the damaged areas of surfacing

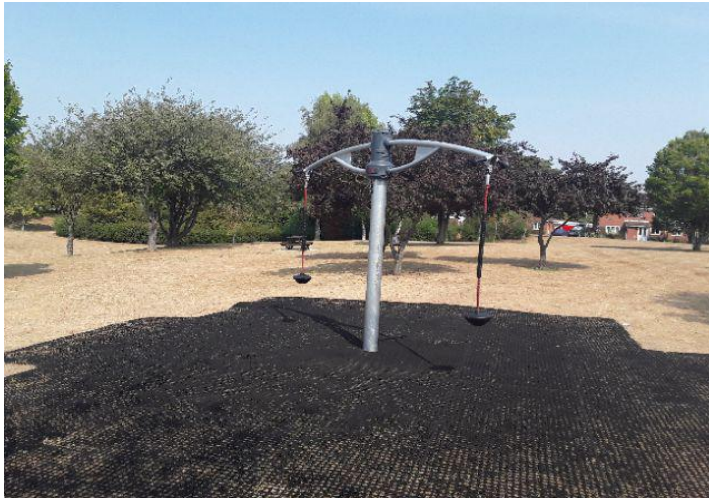
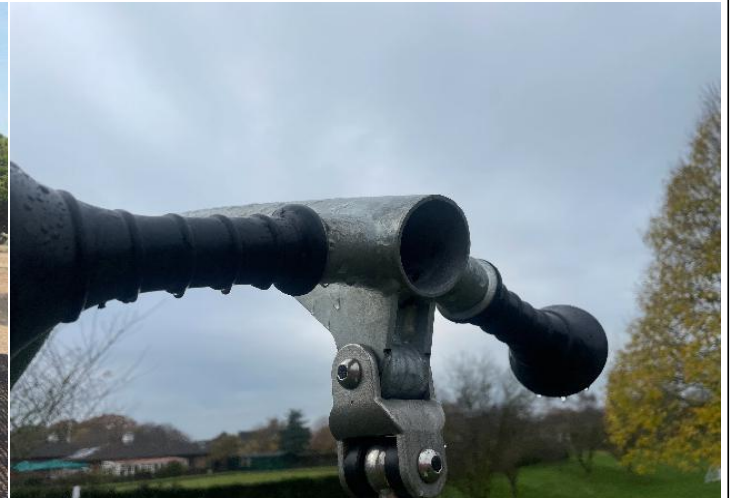
Finding: There is/are bolt cap covers missing or damaged on the item

Action: Replace missing or damaged bolt cap covers

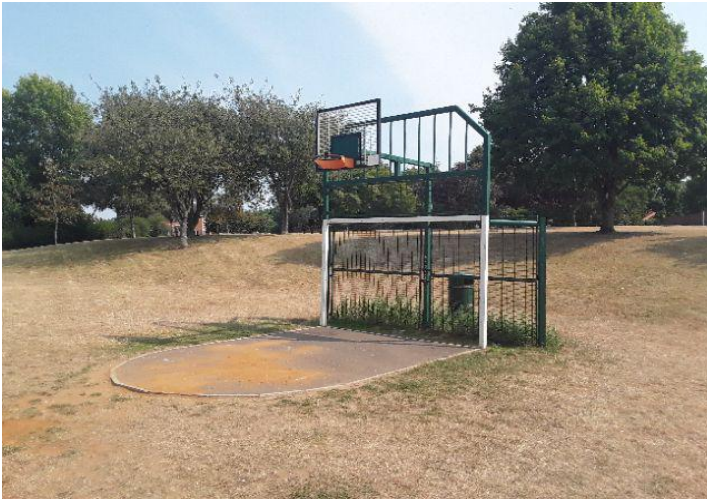
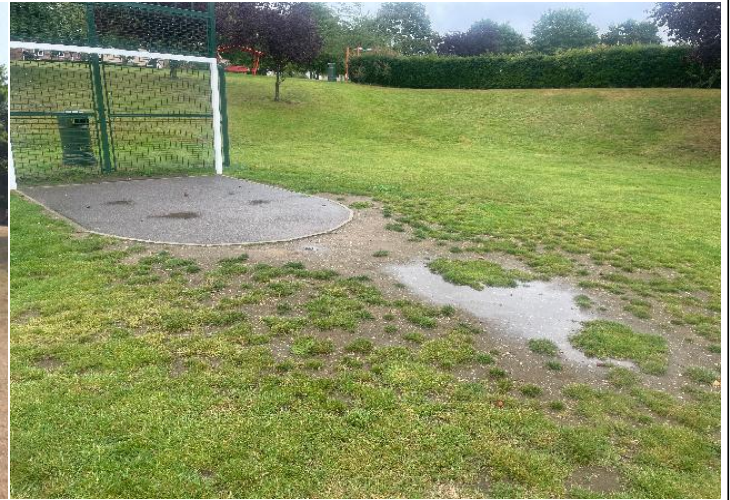
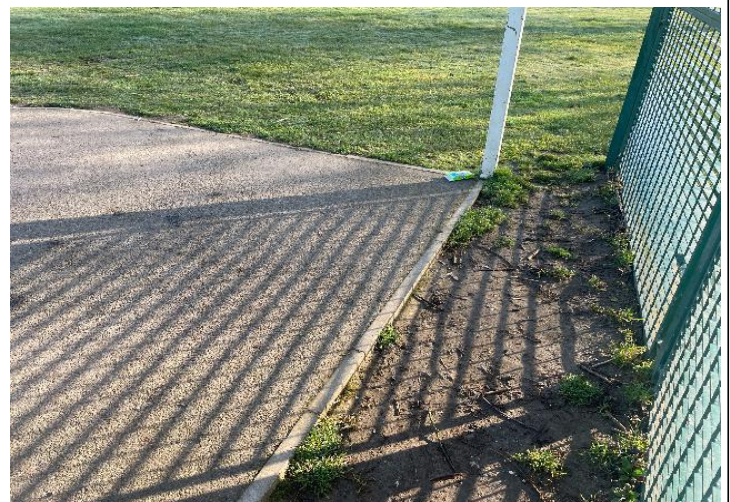
Finding: There are trip hazards at the edges of the surface

Action: Reinstate surrounding surface levels to remove the trip points

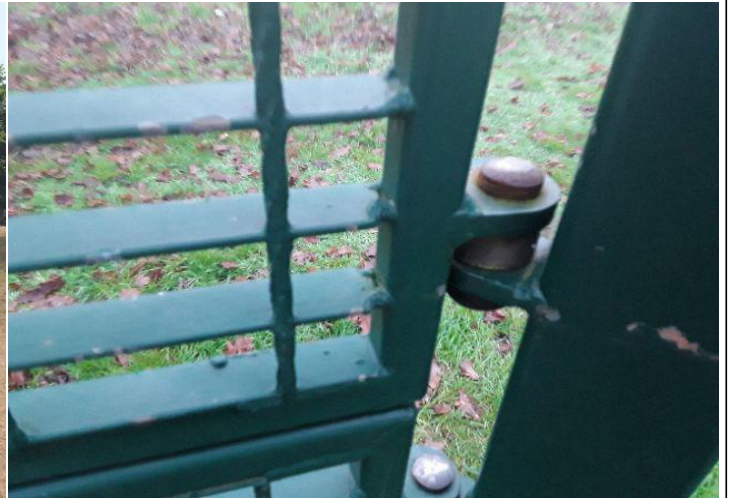
Finding: There is surface corrosion present on the item

Action: Consider treating and repainting the item

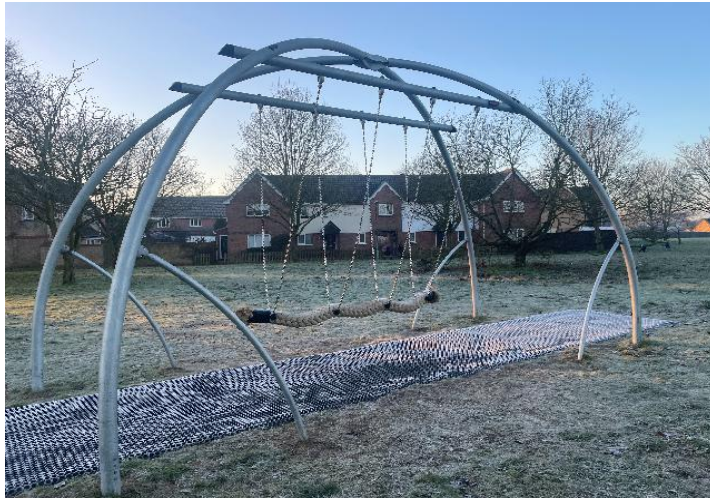
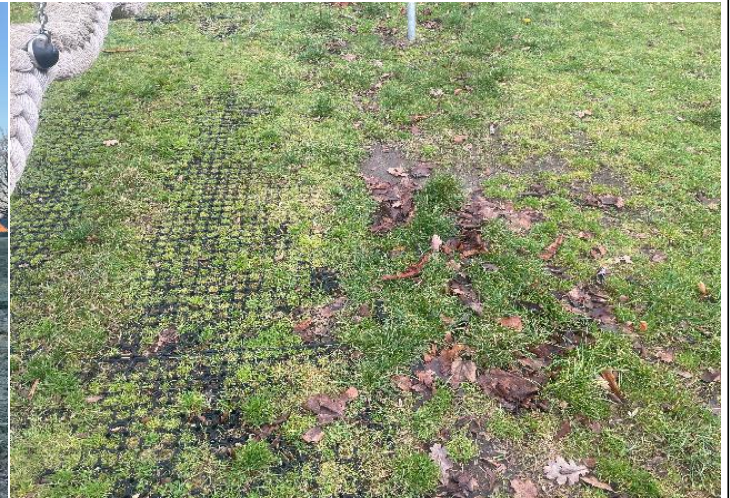
Finding: The surfacing around the item is damaged

Action: Repair the damaged areas of surfacing
