Operational Inspection

Thurston Parish Council

New Green Centre
New Green Ave, Thurston, IP31 3TG

Operational Inspection - 6-December-2024 - 08:59 Inspector Dan Carr

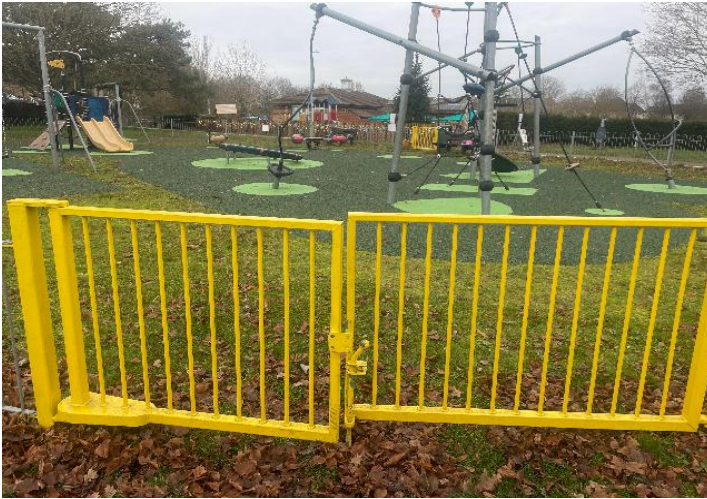
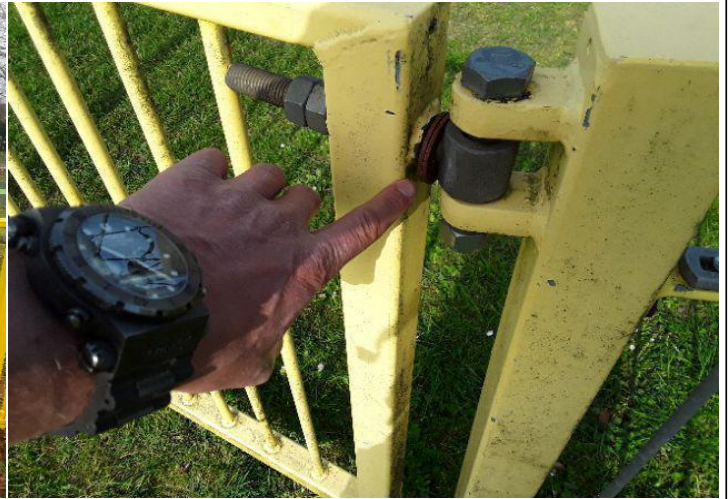
Item: Gates - Gate - Combination
Manufacturer: I.A.E. Fencing

Finding: The paintwork on this item has been damaged or worn exposing the metal underneath which is rusting

Action: Treat any rusting components and repaint

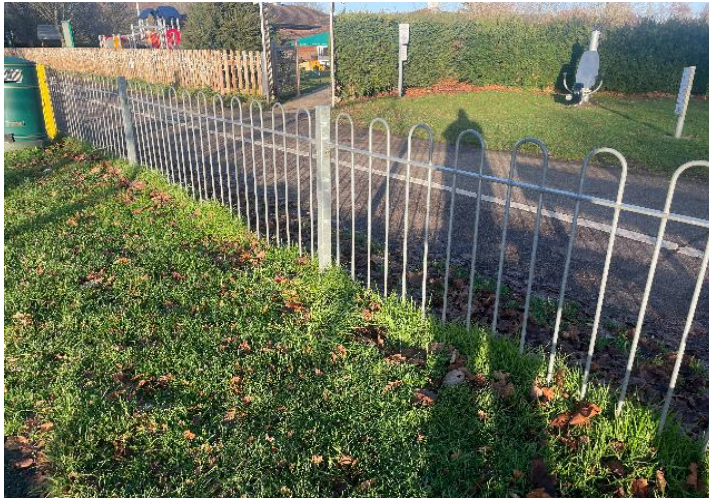
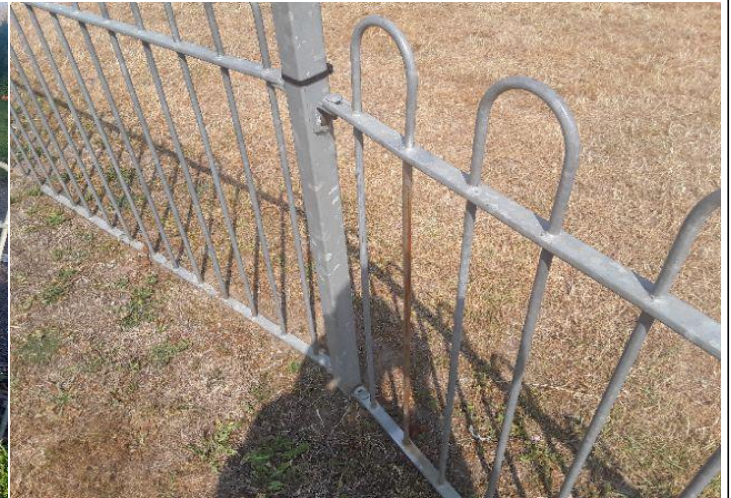
Item: Fences - Fence - Bow Top
Manufacturer: I.A.E. Fencing

Finding: The paintwork on this item has been damaged or worn exposing the metal underneath which is rusting

Action: Treat any rusting components and repaint

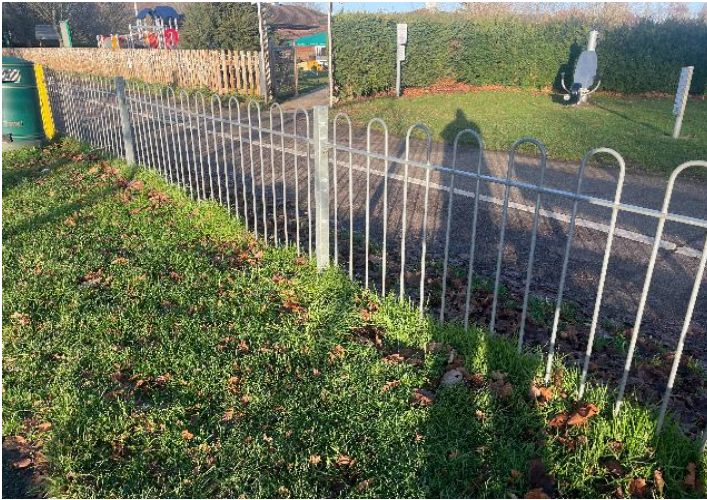
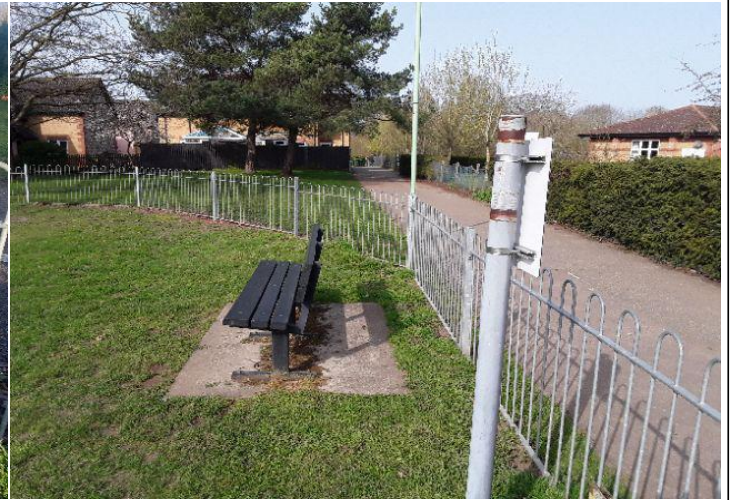
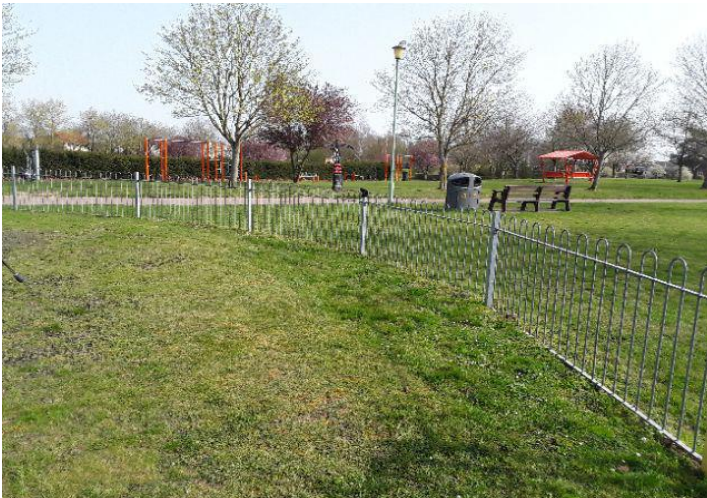
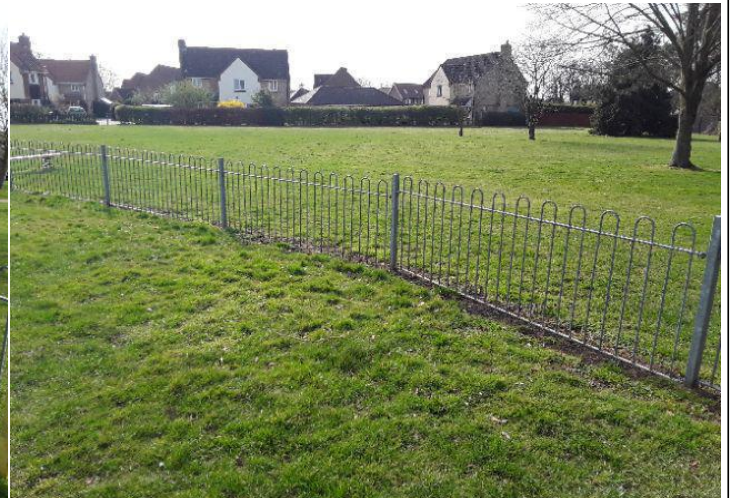
Item: Fences - Fence - Bow Top
Manufacturer: I.A.E. Fencing

Finding: There are 2 loose posts around the fence

Action: Monitor for any further deterioration and reset as required

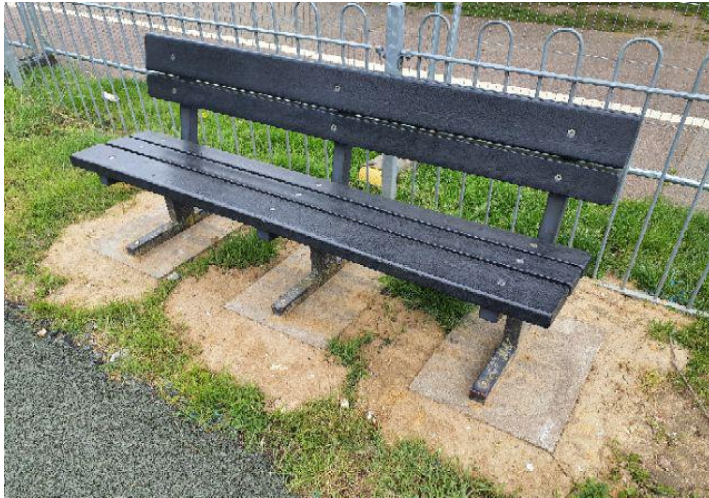
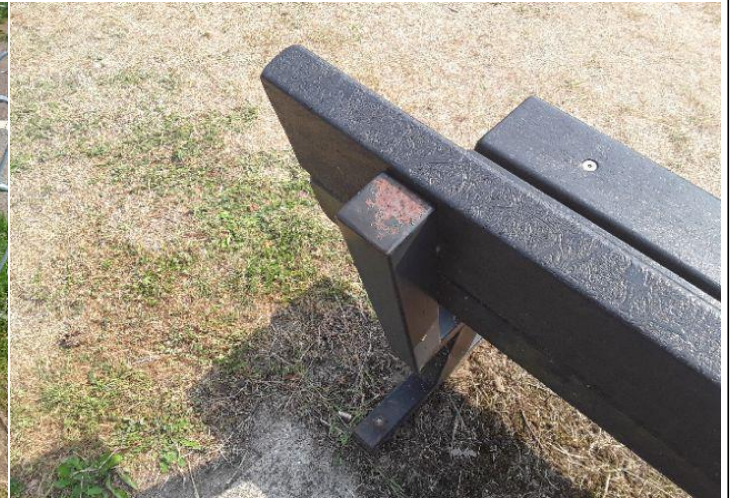
Item: Ancillary Items - Bench
Manufacturer: Not Identified

Finding: The paintwork on this item has been damaged or worn exposing the metal underneath which is rusting

Action: Treat any rusting components and repaint

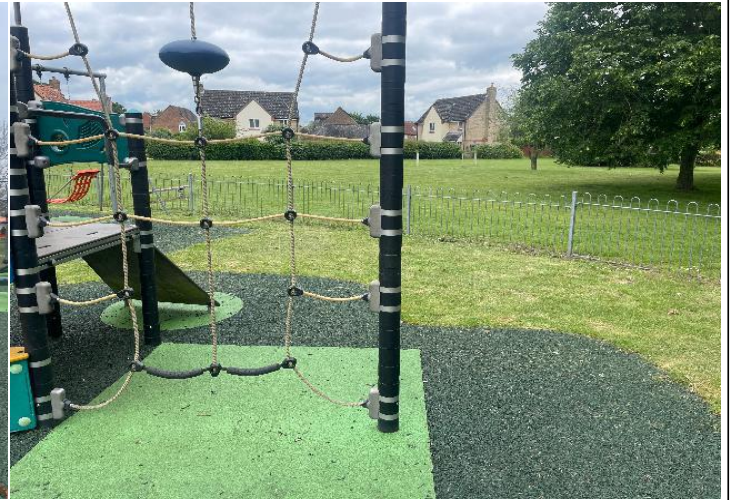
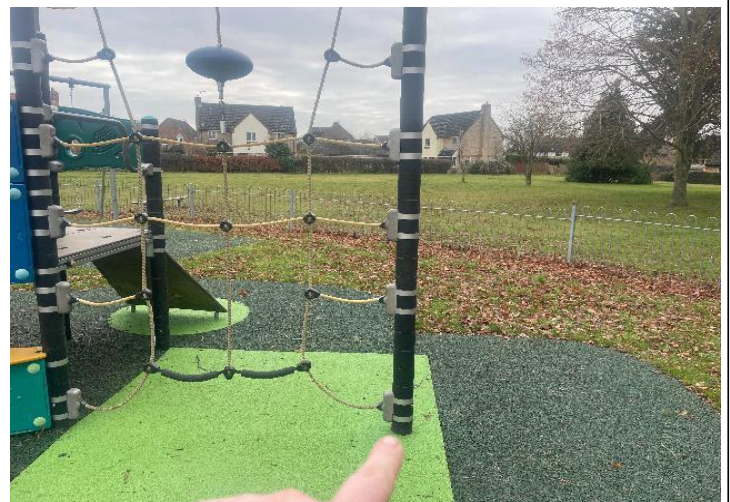
Item: Activity Equipment - Multi Play (Senior)
Manufacturer: Kompan Ltd

Finding: The item is slightly loose in its foundations

Action: Monitor for any further deterioration and repair as required

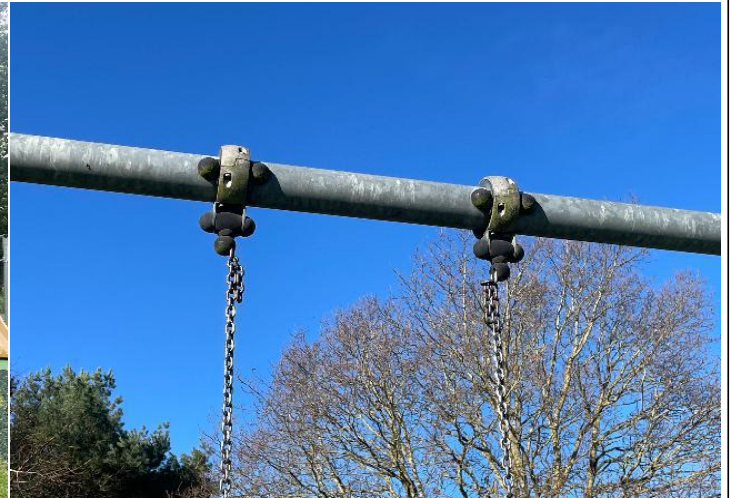
Item: Swings - 1 Bay 2 Seat (Flat)
Manufacturer: Kompan Ltd

Finding: There is some notable evidence of chain wear

Action: Monitor for any further deterioration and replace when 40% worn

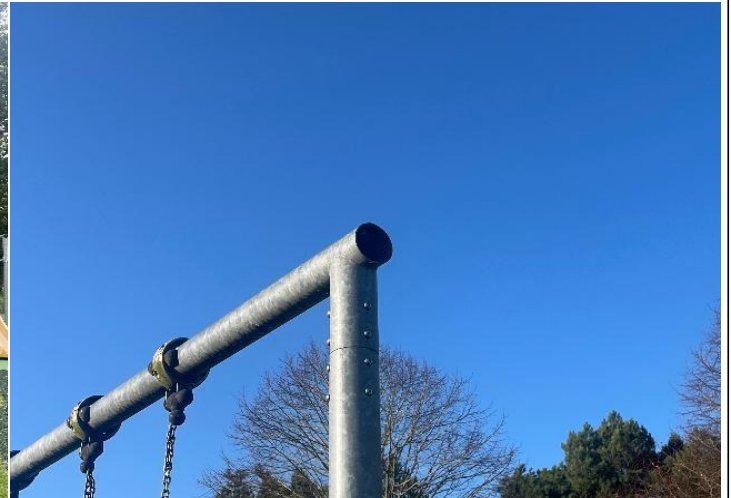
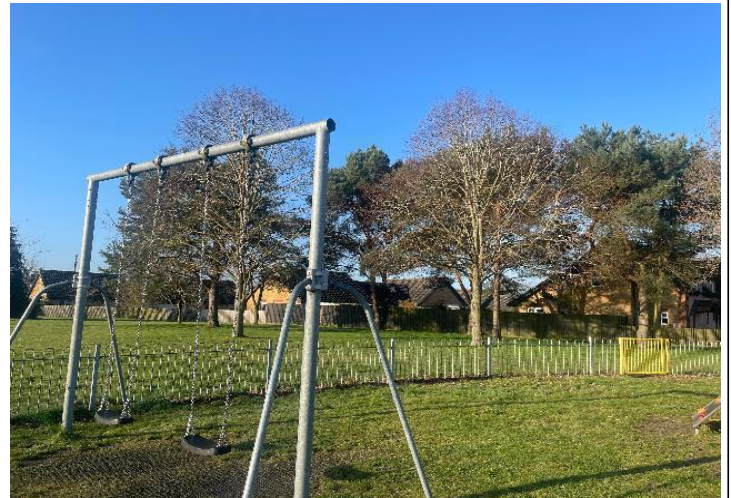
Item: Swings - 1 Bay 2 Seat (Flat)
Manufacturer: Kompan Ltd

Finding: There is/are bolt cap covers missing or damaged on the item

Action: Replace missing or damaged bolt cap covers

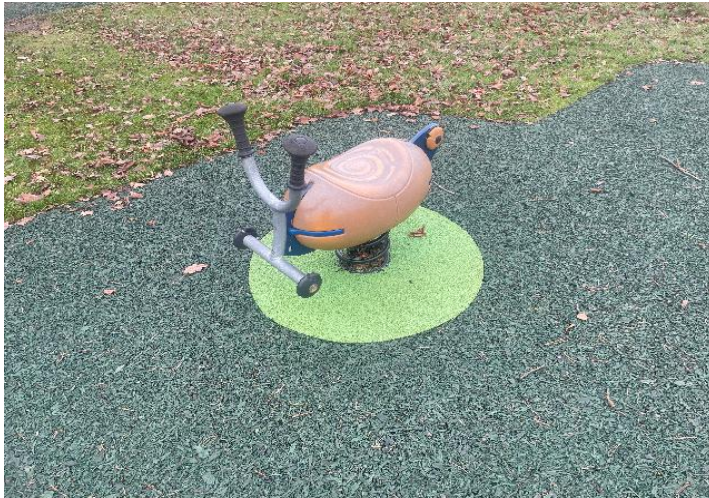
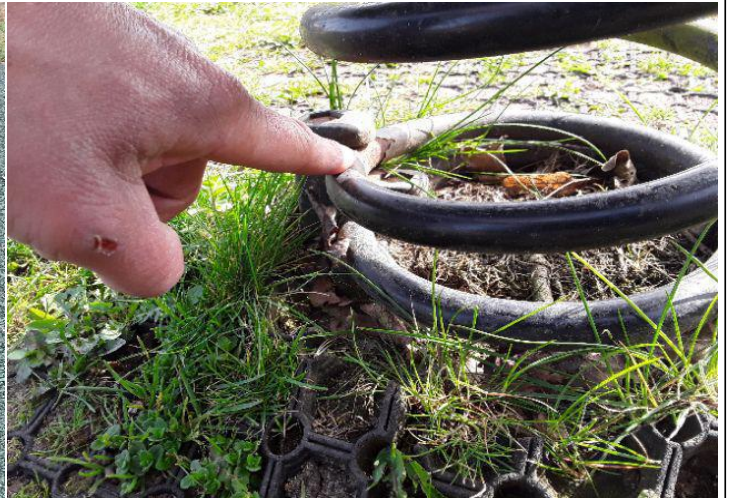
Item: Rocking Equipment - Misc Springer
Manufacturer: Kompan Ltd

Finding: The paintwork on the spring has been damaged or worn exposing the metal underneath which is rusting
Action: Treat any rusting components and repaint

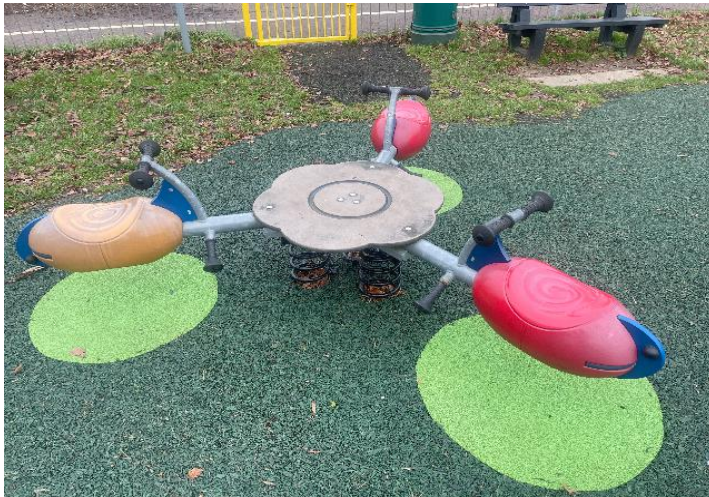
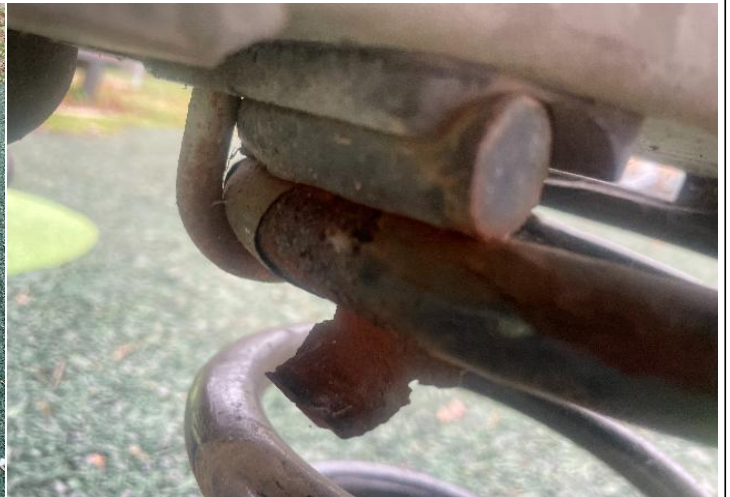
Item: Rocking Equipment - Three Way Springer
Manufacturer: Kompan Ltd

Finding: The paintwork on the spring has been damaged or worn exposing the metal underneath which is rusting
Action: Treat any rusting components and repaint

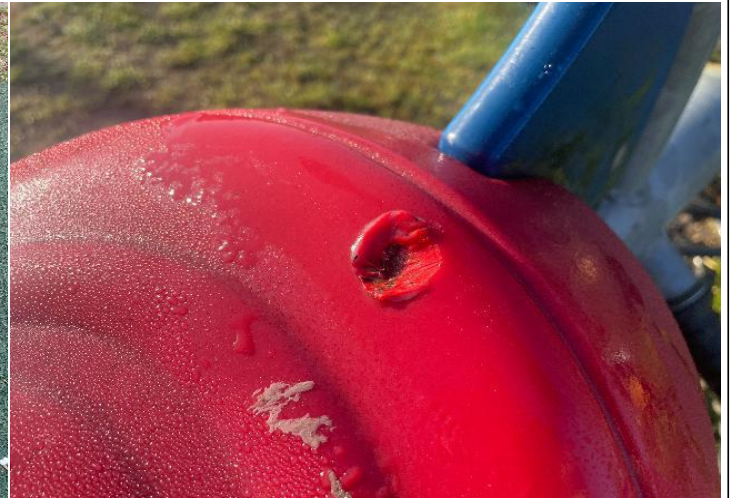
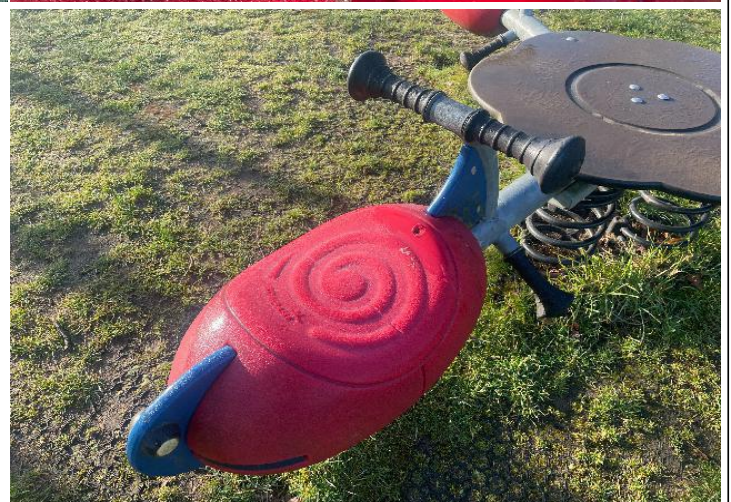
Item: Rocking Equipment - Three Way Springer
Manufacturer: Kompan Ltd

Finding: There is some evidence of fire damage to the item **Action:** Monitor for any further deterioration and repair as required

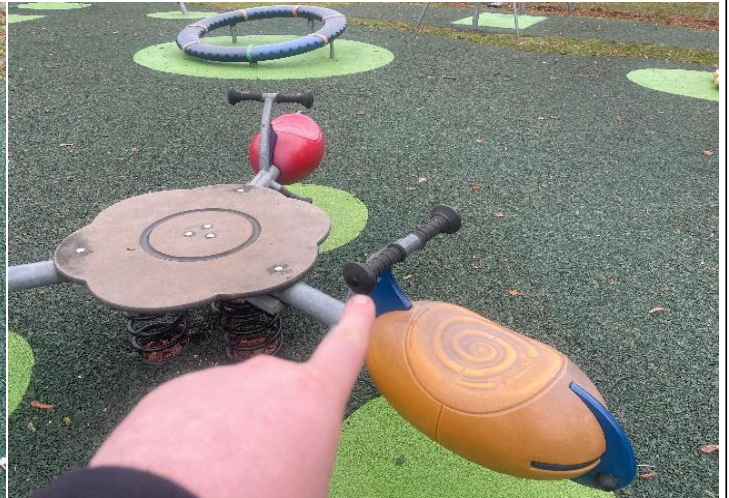
Item: Rocking Equipment - Three Way Springer
Manufacturer: Kompan Ltd

Finding: A number of Inaccessible fixing(s) have worked loose

Action: Secure all loose fixings

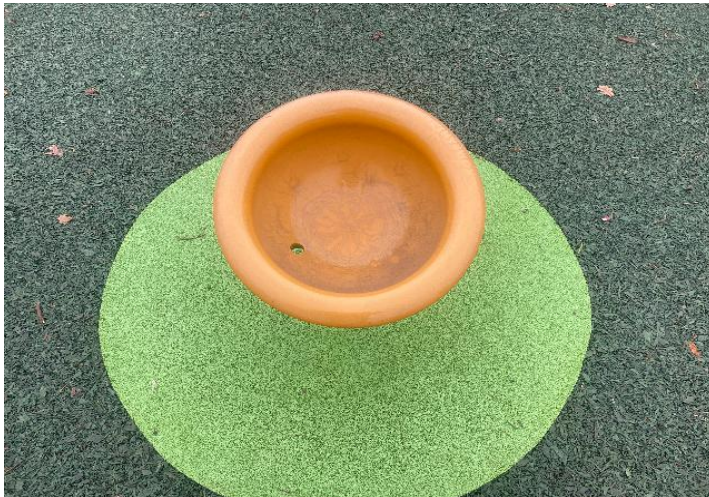
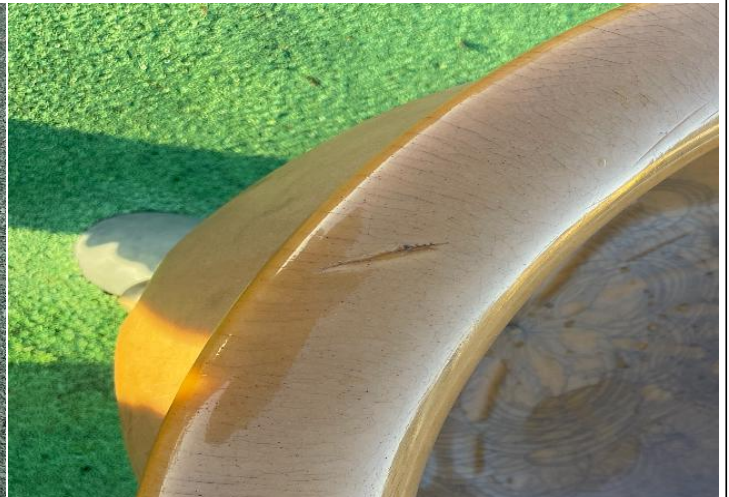
Item: Rotor Play - Spinner Bowl
Manufacturer: Kompan Ltd

Finding: The item has been damaged

Action: Monitor for any further deterioration and replace as required

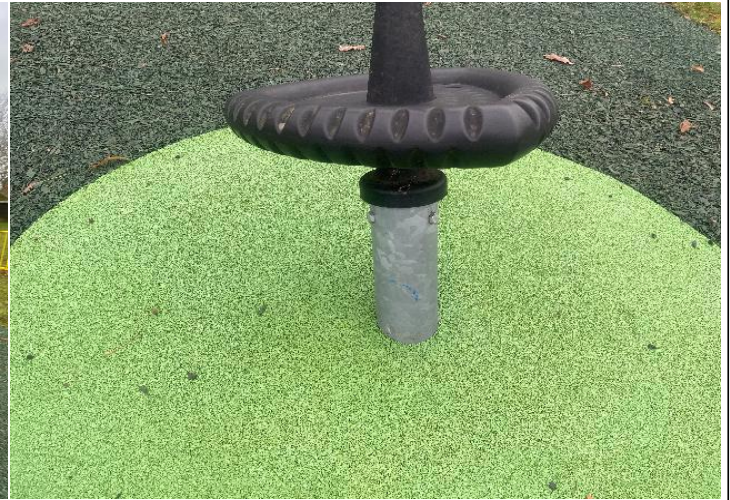
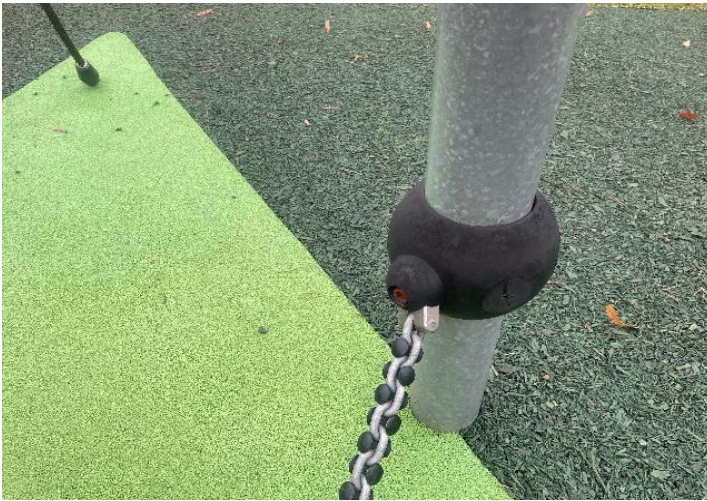
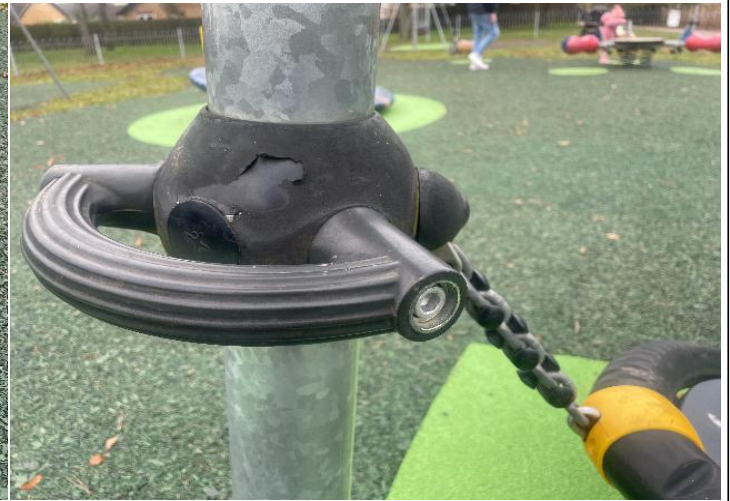
Item: Activity Equipment - Multi Play (Senior)
Manufacturer: Kompan Ltd

Finding: There is/are bolt cap covers missing or damaged on the item

Action: Replace missing or damaged bolt cap covers

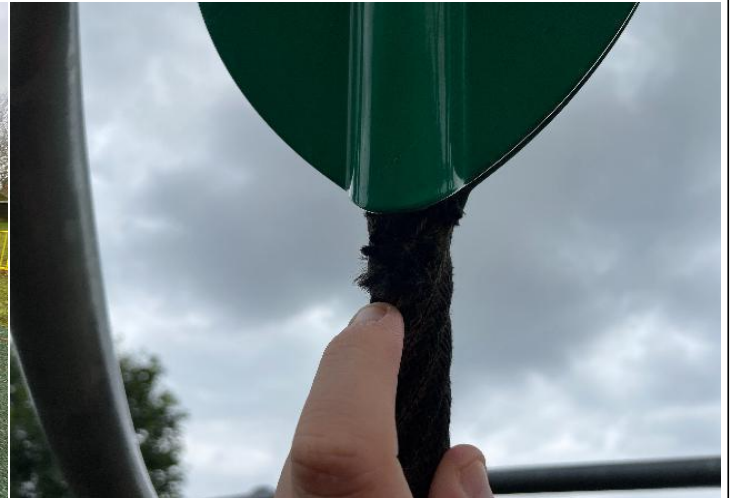
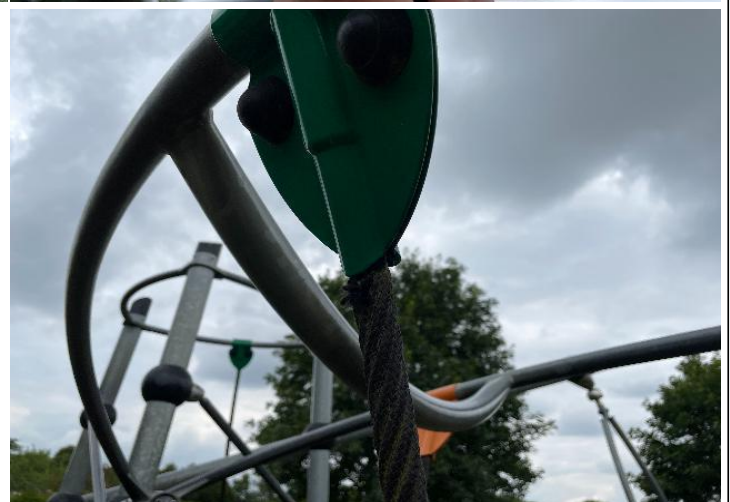
Item: Activity Equipment - Multi Play (Senior)
Manufacturer: Kompan Ltd

Finding: The ropes/nets are worn/damaged in places

Action: Monitor for any further deterioration and repair or replace as required

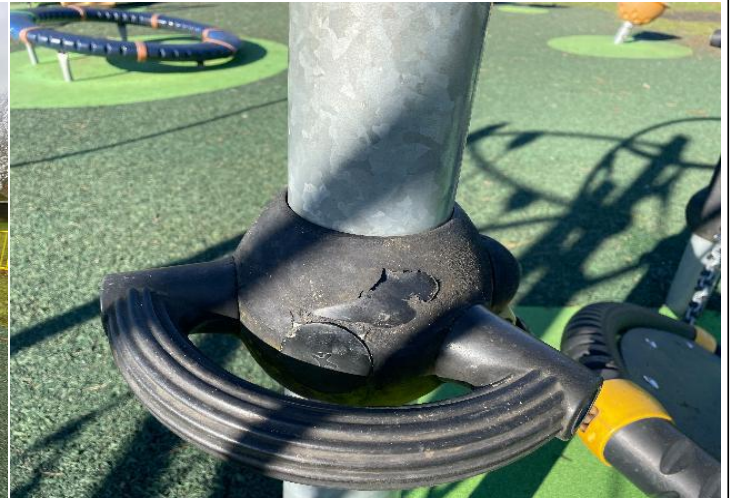
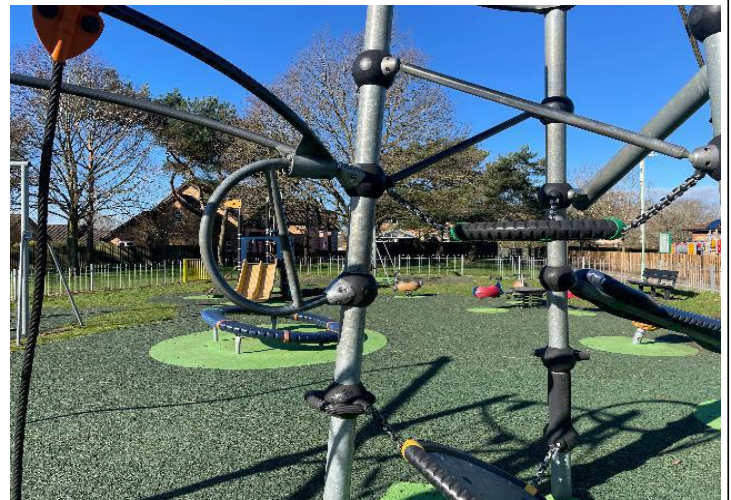
Item: Activity Equipment - Multi Play (Senior)
Manufacturer: Kompan Ltd

Finding: The item has been damaged

Action: Monitor for any further deterioration and replace as required

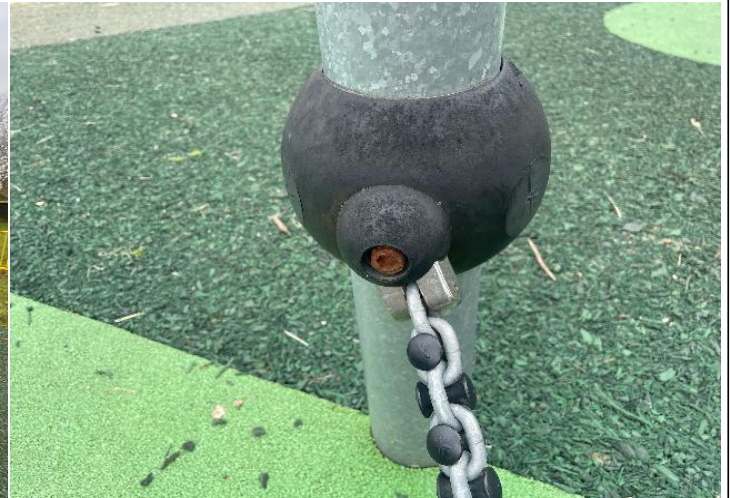
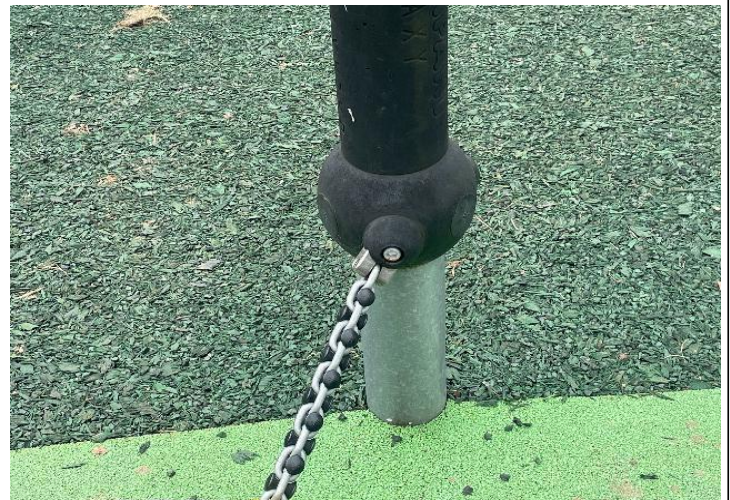
Item: Activity Equipment - Multi Play (Senior)
Manufacturer: Kompan Ltd

Finding: There is/are bolt cap covers missing or damaged on the item

Action: Replace missing or damaged bolt cap covers

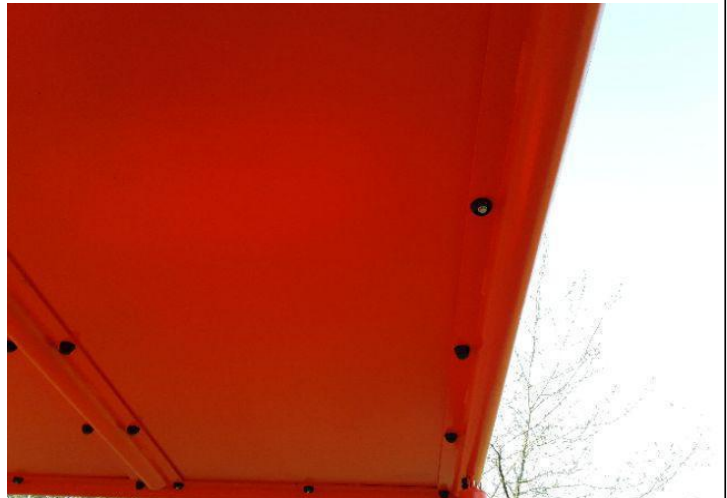
Item: Ancillary Items - Shelter
Manufacturer: Caloo

Finding: There is/are bolt cap covers missing or damaged on the item

Action: Replace 9 missing or damaged bolt cap covers

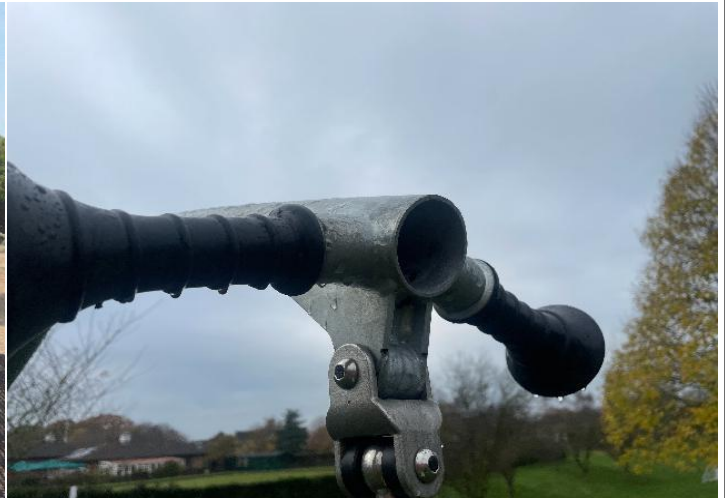
Item: Activity Equipment - Overhead Rotator
Manufacturer: Kompan Ltd

Finding: There is/are bolt cap covers missing or damaged on the item

Action: Replace missing or damaged bolt cap covers

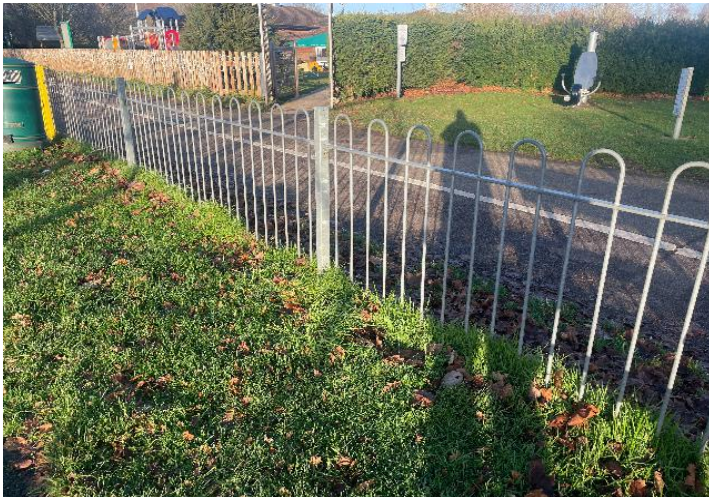
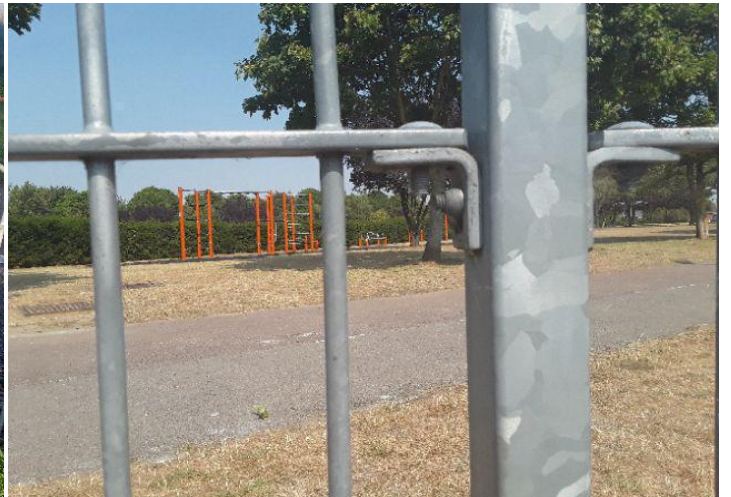
Item: Fences - Fence - Bow Top
Manufacturer: I.A.E. Fencing

Finding: There is or are fixings missing on the item

Action: Replace 2 missing fixings

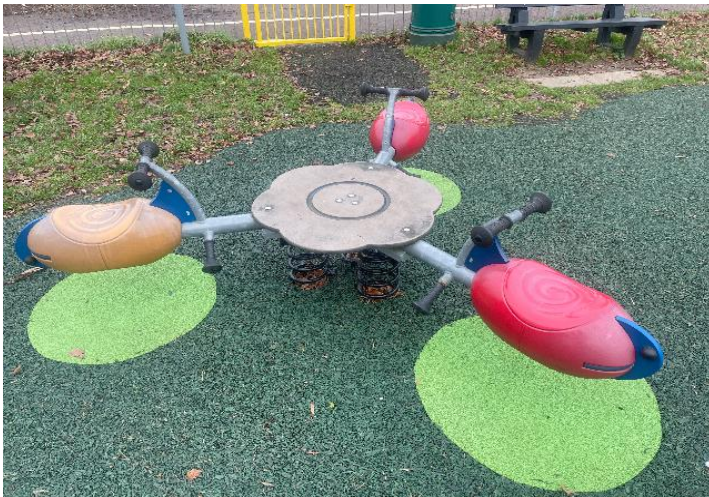
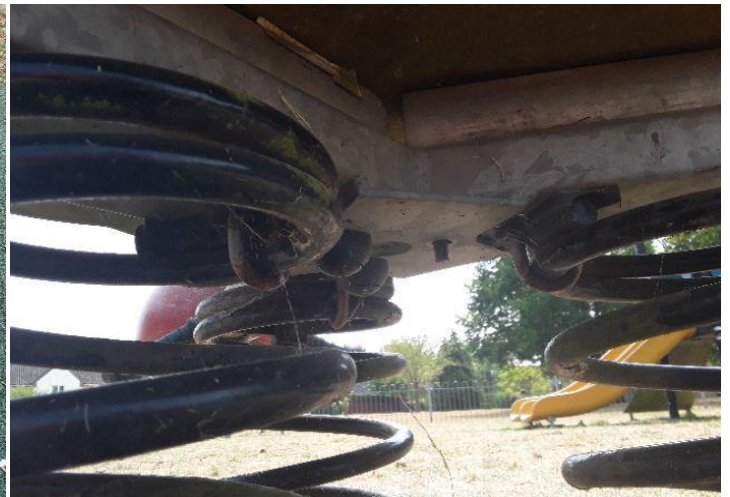
Item: Rocking Equipment - Three Way Springer
Manufacturer: Kompan Ltd

Finding: There is or are fixings missing on the item

Action: Replace all missing fixings

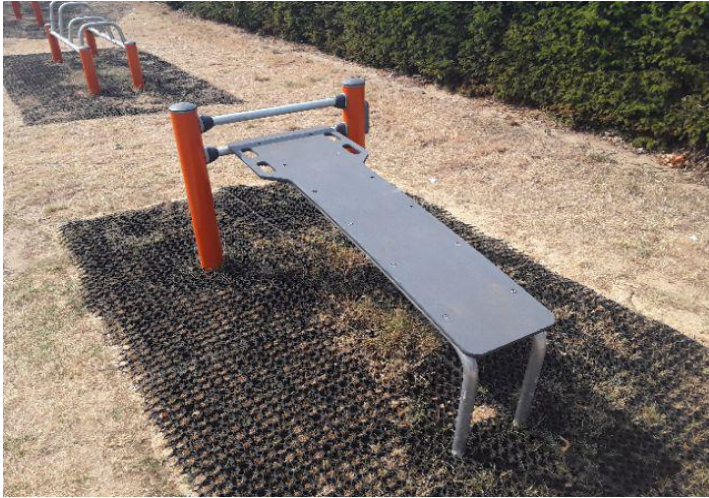
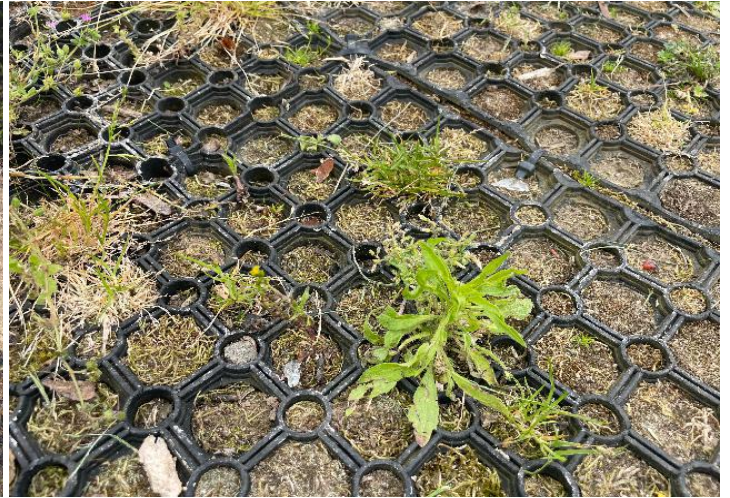
Item: Outdoor Fitness Equipment - Sit Up Station **Risk Level:** L - Low Risk
Manufacturer: Kompan Ltd **Surface:** Grass Matrix Tiles

Finding: There is a significant amount of broken glass on site

Action: Remove the glass and maintain the area

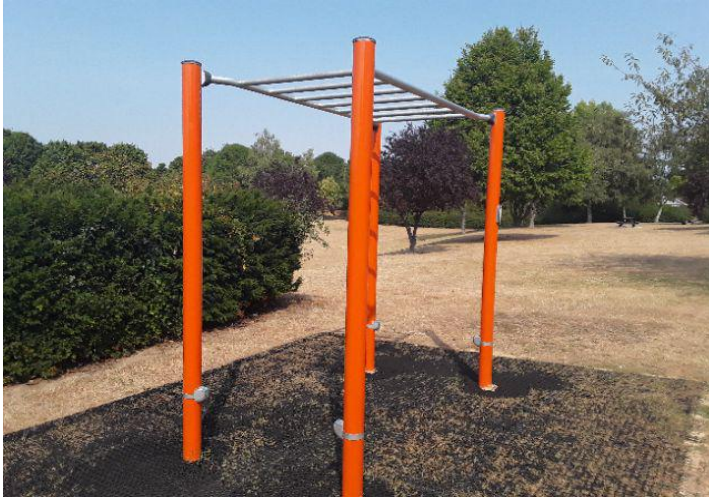
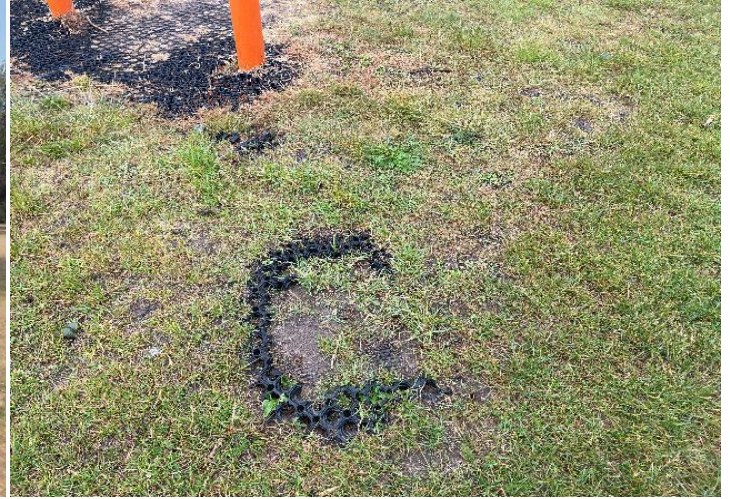
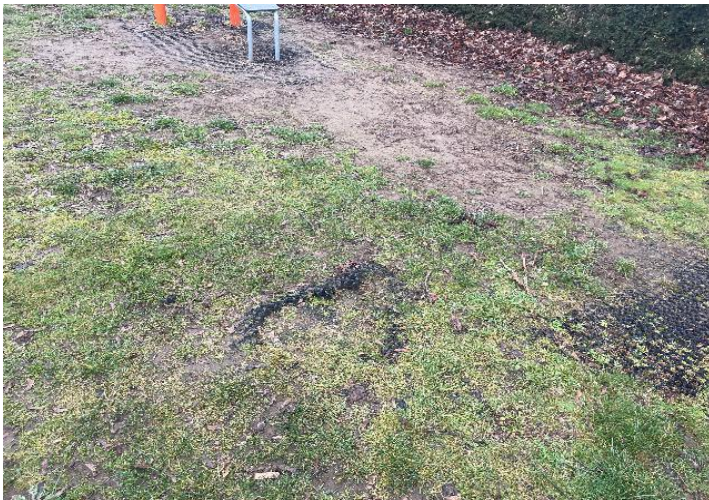
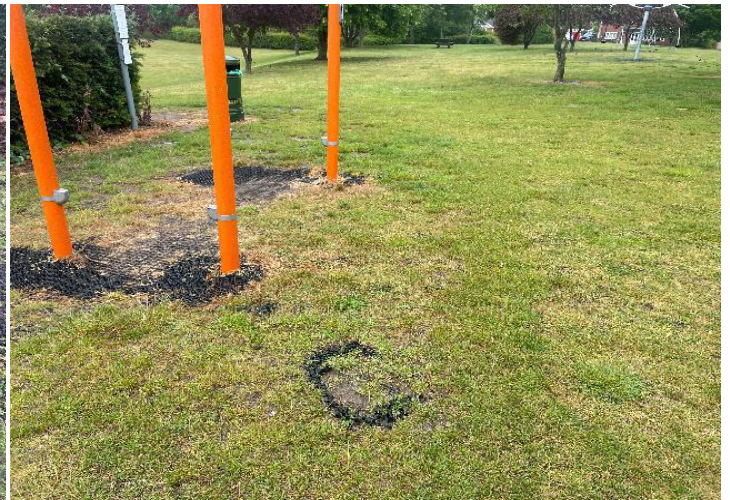
Item: Outdoor Fitness Equipment - Overhead Bars
Manufacturer: Kompan Ltd

Finding: The surfacing around the item is damaged

Action: Repair the damaged areas of surfacing

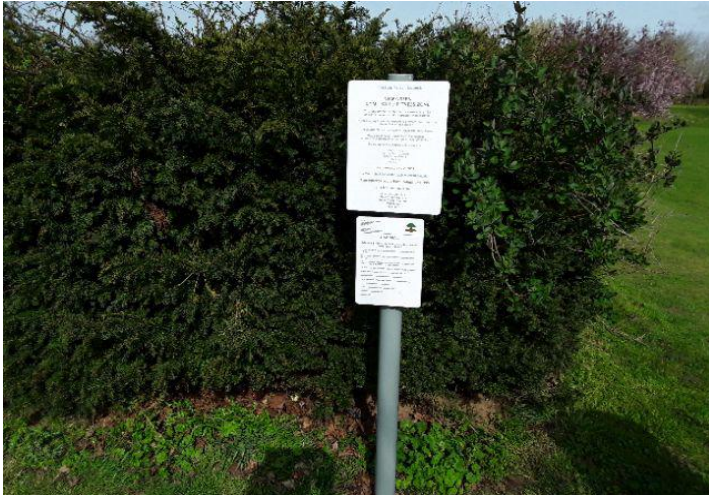
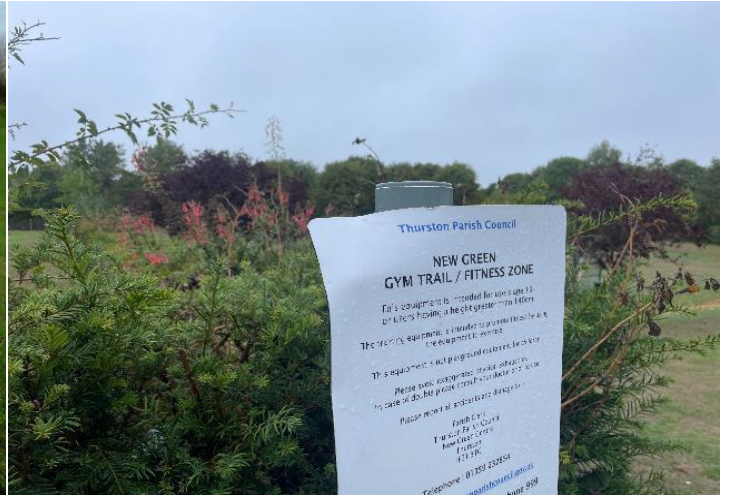
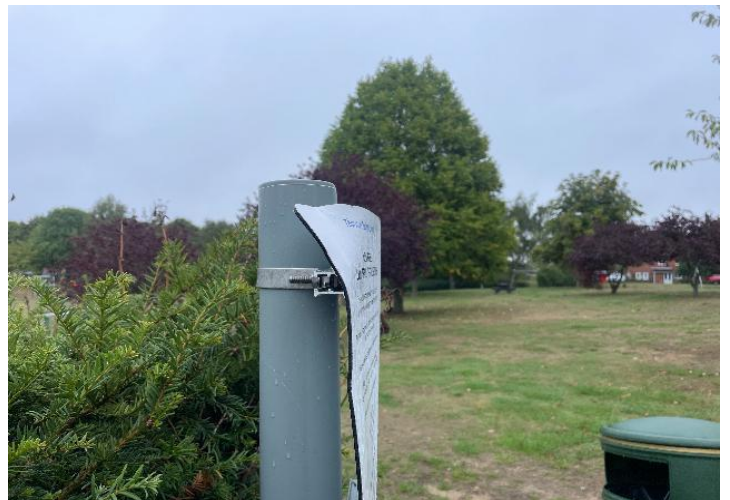
Item: Ancillary Items - Sign
Manufacturer: Unknown

Finding: The item has been damaged

Action: Monitor for any further deterioration and replace as required

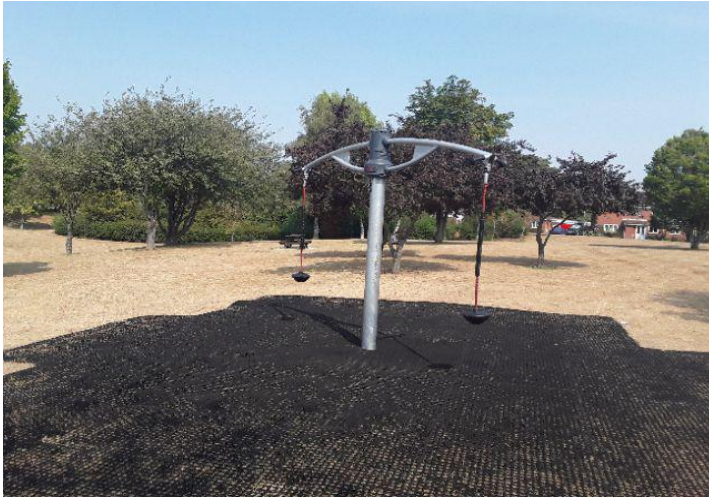
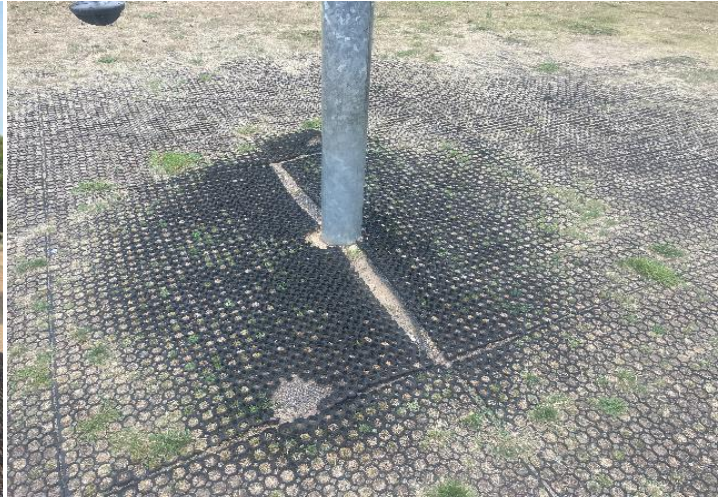
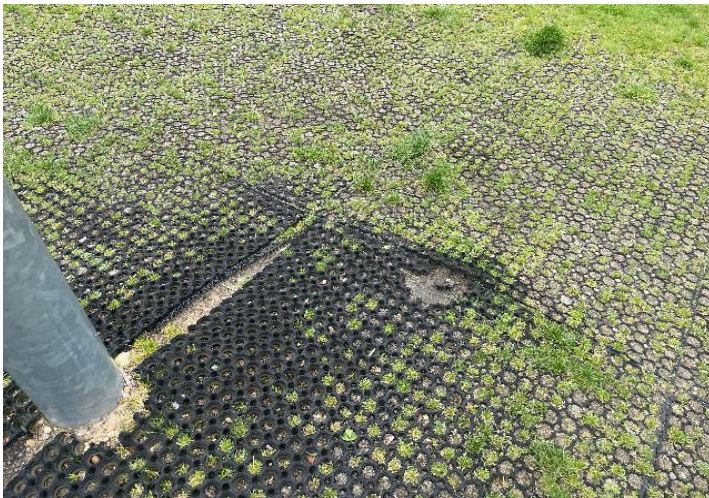
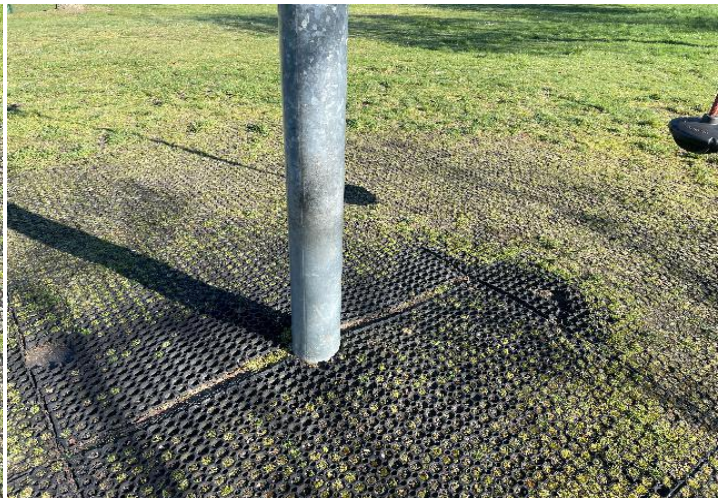
Item: Activity Equipment - Overhead Rotator
Manufacturer: Kompan Ltd

Finding: The surfacing around the item is damaged

Action: Repair the damaged areas of surfacing

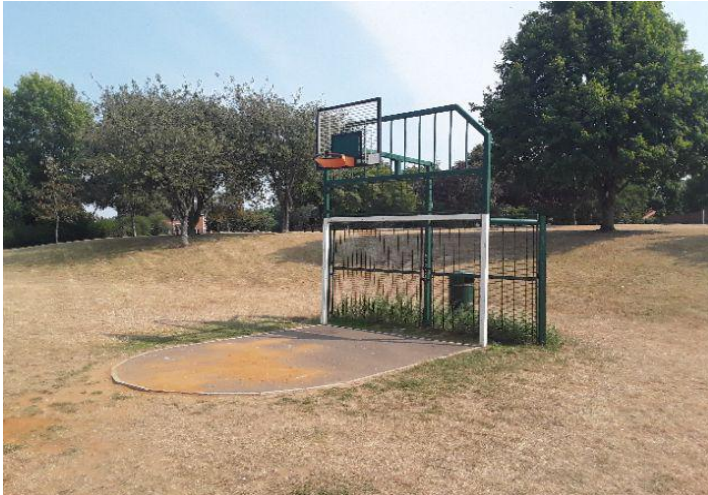
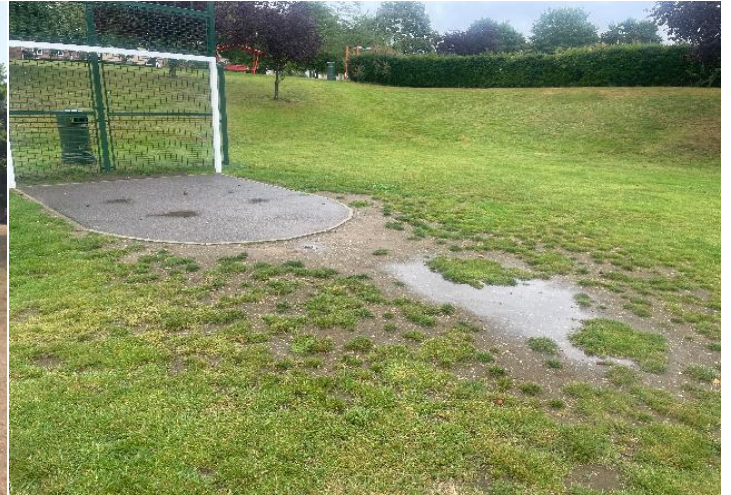
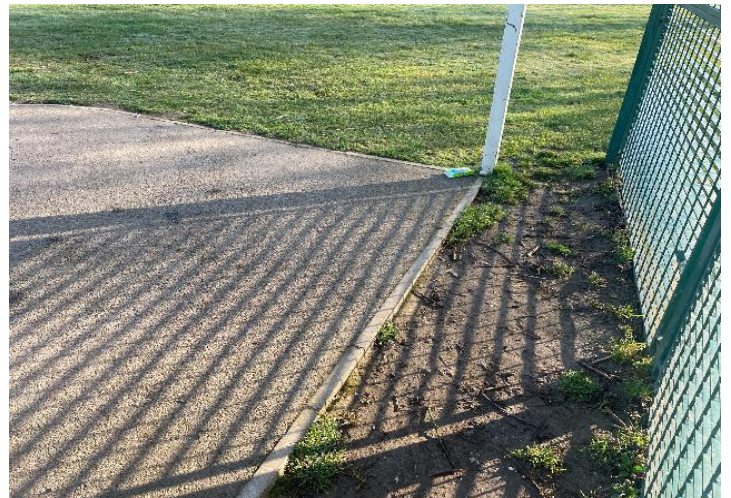
Item: Multi Use Games Area - Goal End
Manufacturer: Unknown

Finding: There are trip hazards at the edges of the surface

Action: Reinststate surrounding surface levels to remove the trip points

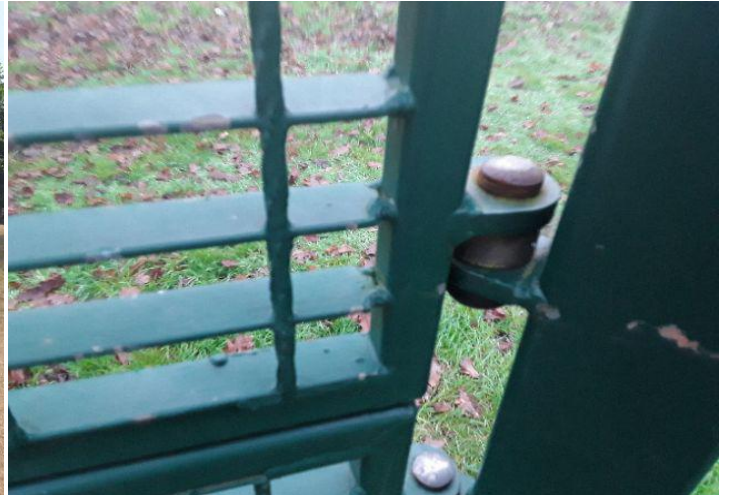
Item: Multi Use Games Area - Goal End
Manufacturer: Unknown

Finding: There is surface corrosion present on the item

Action: Consider treating and repainting the item

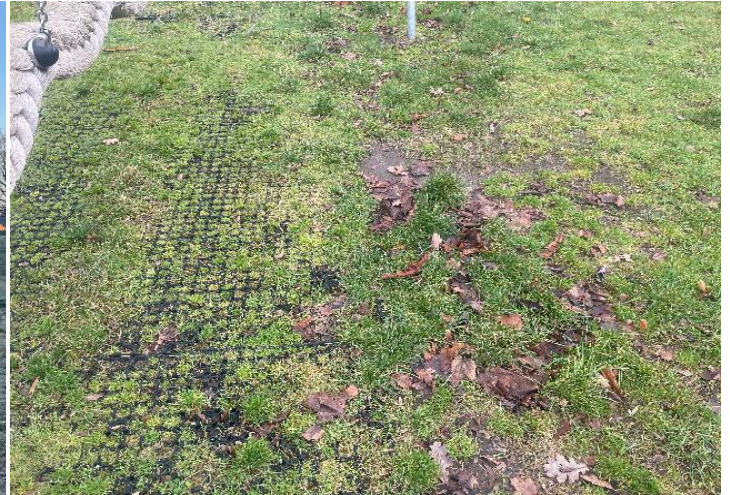
Item: Swings - Giant Rope Swing
Manufacturer: Kompan Ltd

Finding: The surfacing around the item is damaged

Action: Repair the damaged areas of surfacing
