Operational Inspection

Thurston Parish Council

Thurst Coffee Shop Playground New Green Centre, New Green Ave, Thurston, IP31 3TG

Inspection Ref: 2557393 Site Ref: 105133

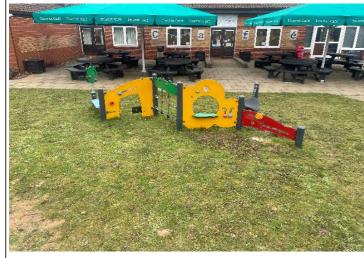
There is/are bolt cap covers missing or damaged on the item - Replace missing or damaged bolt cap covers

Item: Activity Equipment - Activity Trail

Finding: There is/are bolt cap covers missing or damaged on the item

Action: Replace missing or damaged bolt cap covers

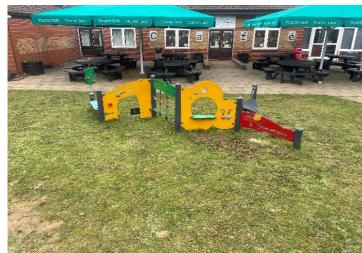
Activity Equipment - Activity Trail

Finding: The item has missing component(s)

Action: Consider replacing missing components

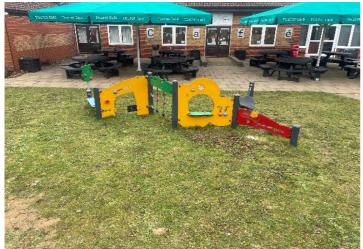
6 - Low Risk (Finding 2) - Marked as complete on 6-December-2024

Item: Activity Equipment - Activity Trail

Finding: A number of inaccessible fixing(s) have worked loose

Action: Secure all loose fixings
