## Operational Inspection

Thurston Parish Council

New Green Centre  
New Green Ave, Thurston, IP31 3TG

Operational Inspection - 3-June-2024 - 12:53 Inspector Dan Carr

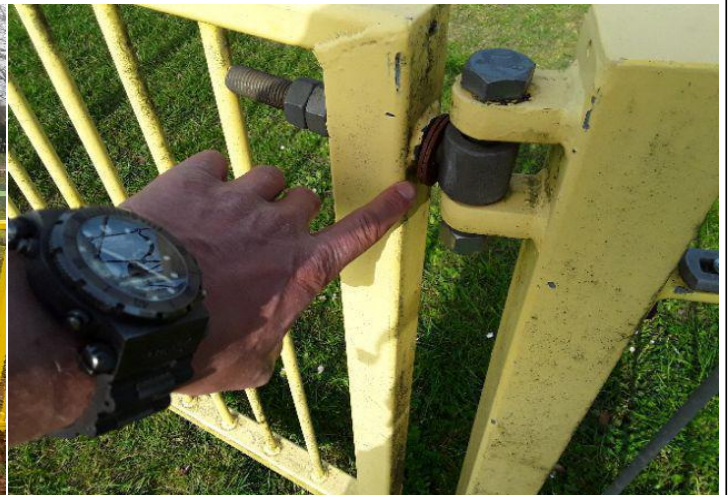
**Item:** Gates - Gate - Combination  
**Manufacturer:** I.A.E. Fencing

**Finding:** The paintwork on this item has been damaged or worn exposing the metal underneath which is rusting

**Action:** Treat any rusting components and repaint

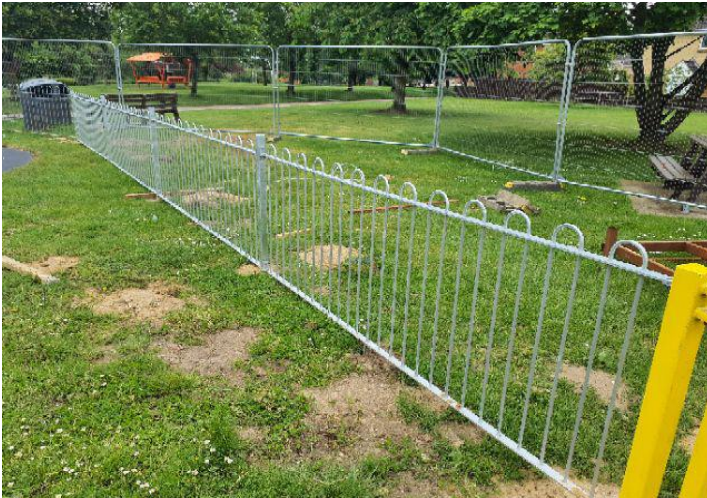
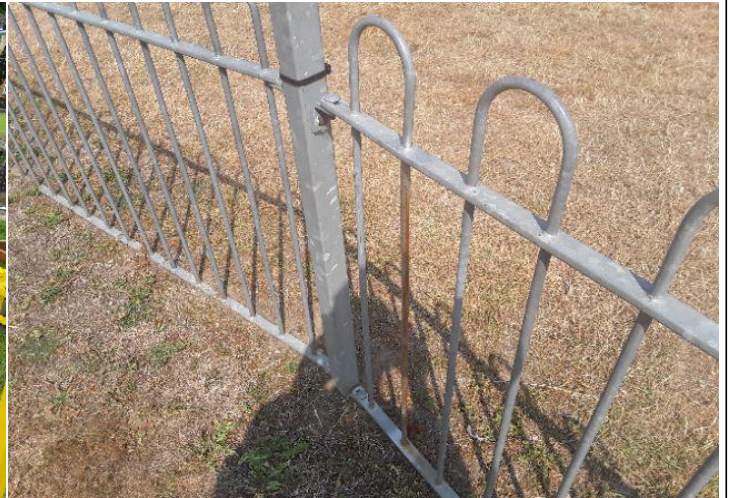
**Item:** Fences - Fence - Bow Top  
**Manufacturer:** I.A.E. Fencing

**Finding:** The paintwork on this item has been damaged or worn exposing the metal underneath which is rusting

**Action:** Treat any rusting components and repaint

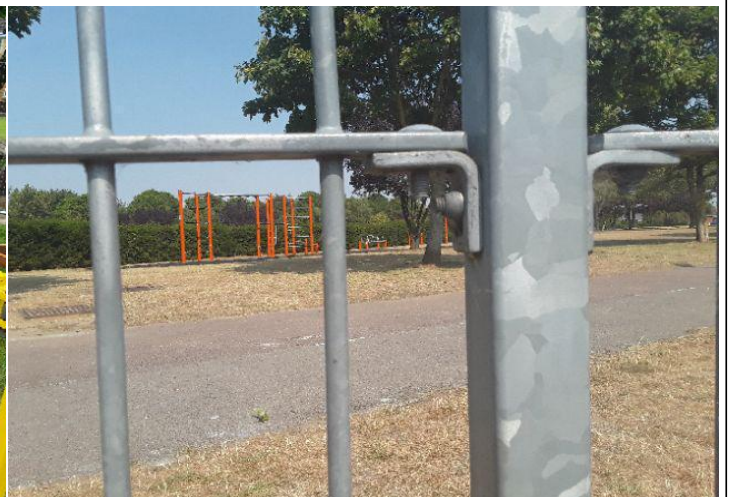
**Item:** Fences - Fence - Bow Top  
**Manufacturer:** I.A.E. Fencing

**Finding:** There is or are fixings missing on the item

**Action:** Replace 2 missing fixings

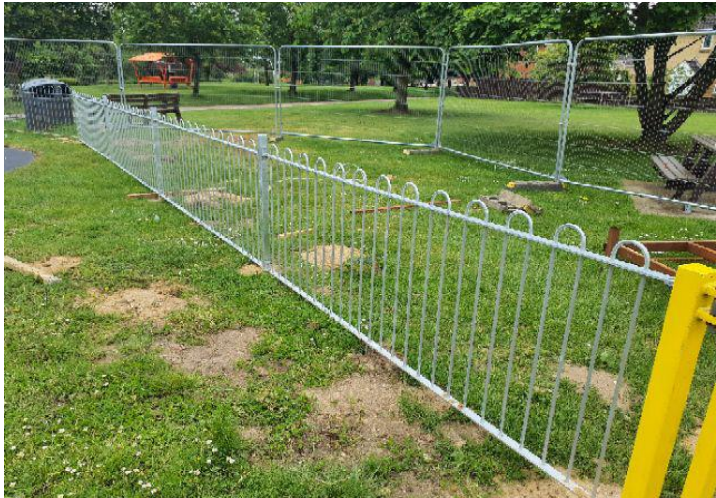
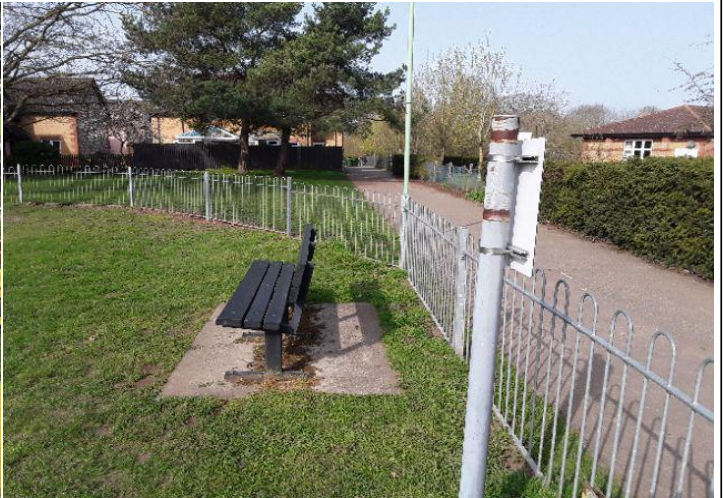
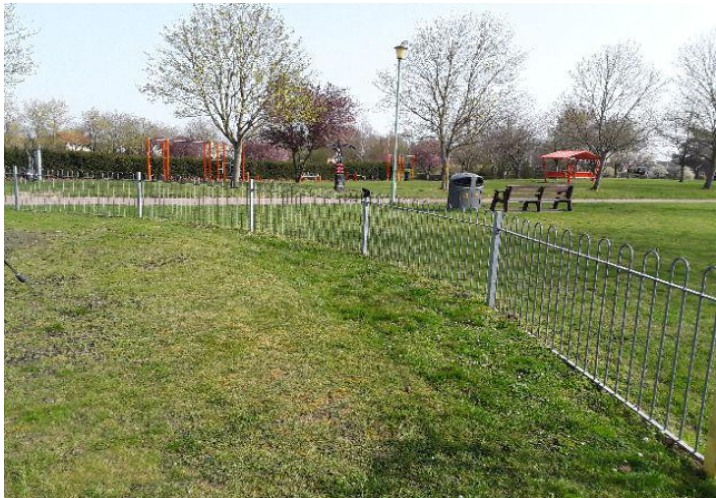
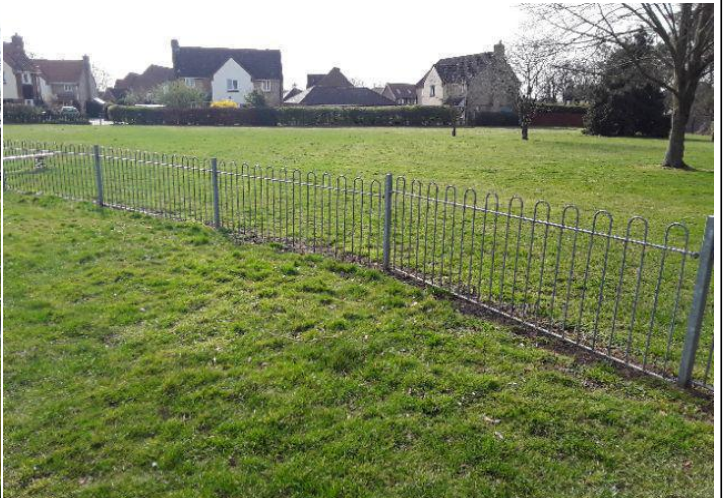
**Item:** Fences - Fence - Bow Top  
**Manufacturer:** I.A.E. Fencing

**Finding:** There are 2 loose posts around the fence

**Action:** Monitor for any further deterioration and reset as required

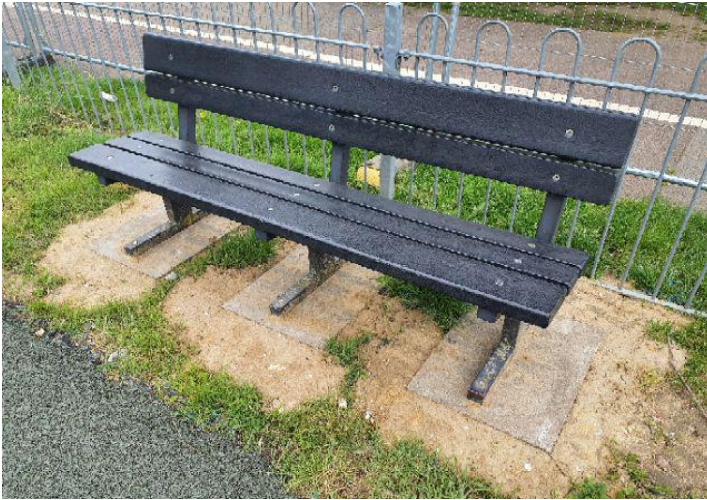
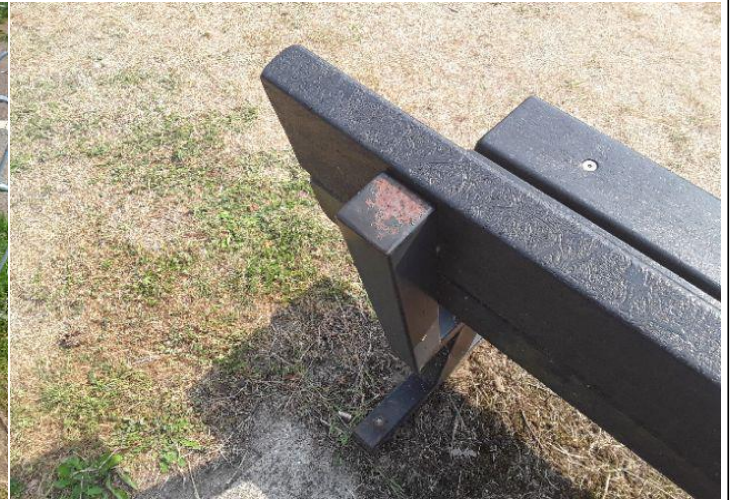
**Item:** Ancillary Items - Bench  
**Manufacturer:** Not Identified

**Finding:** The paintwork on this item has been damaged or worn exposing the metal underneath which is rusting

**Action:** Treat any rusting components and repaint

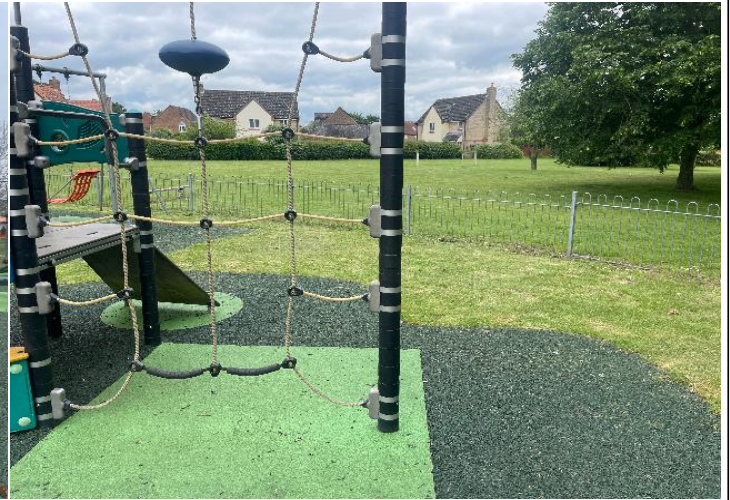
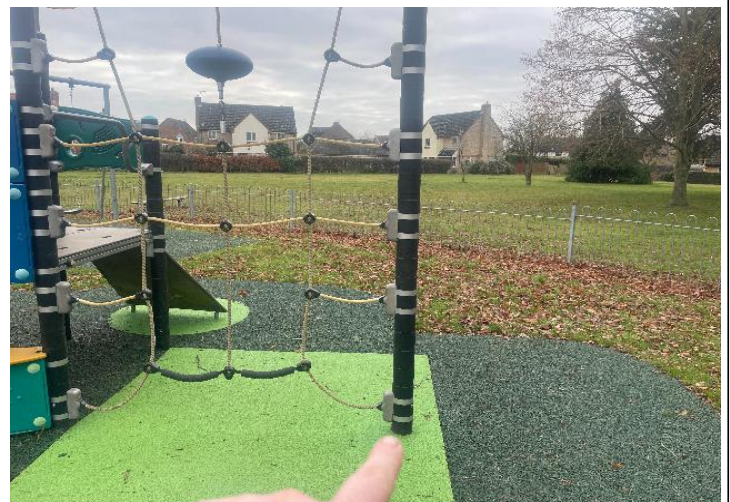
**Item:** Activity Equipment - Multi Play (Senior)  
**Manufacturer:** Kompan Ltd

**Finding:** The item is slightly loose in its foundations

**Action:** Monitor for any further deterioration and repair as required

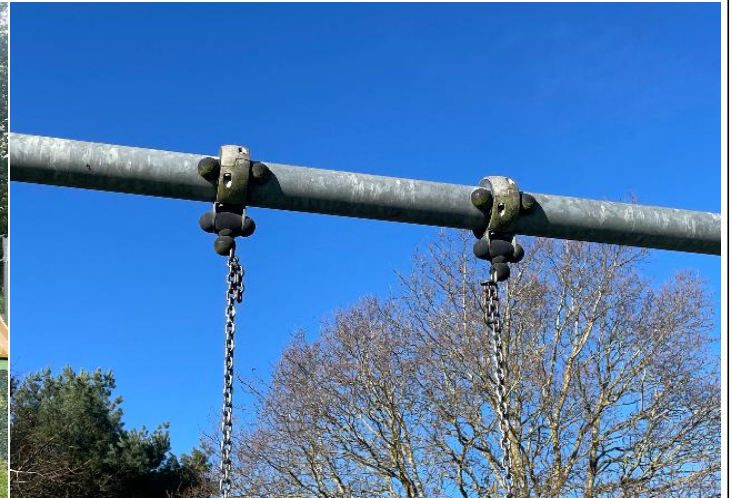
**Item:** Swings - 1 Bay 2 Seat (Flat)  
**Manufacturer:** Kompan Ltd

**Finding:** There is some notable evidence of chain wear

**Action:** Monitor for any further deterioration and replace when 40% worn

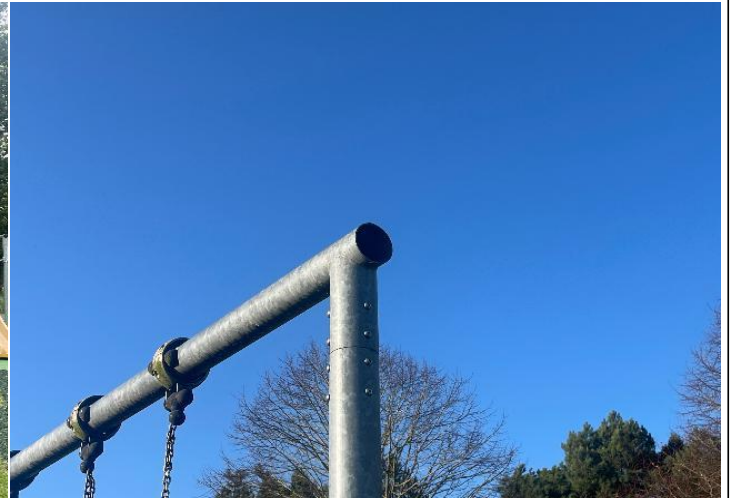
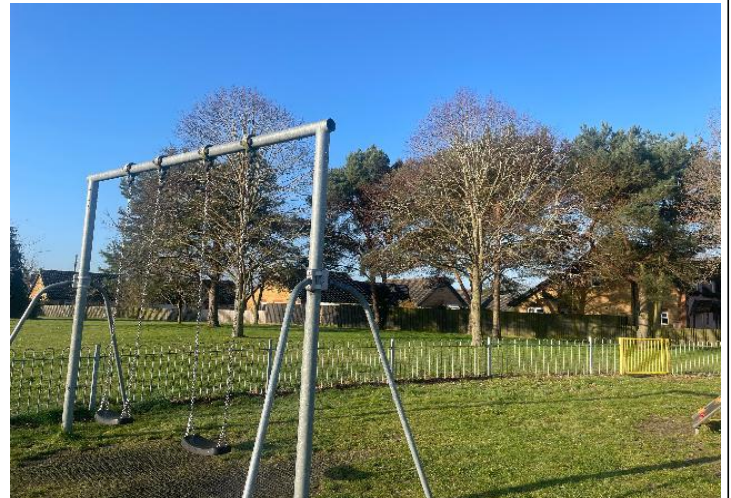
**Item:** Swings - 1 Bay 2 Seat (Flat)  
**Manufacturer:** Kompan Ltd

**Finding:** There is/are bolt cap covers missing or damaged on the item

**Action:** Replace missing or damaged bolt cap covers

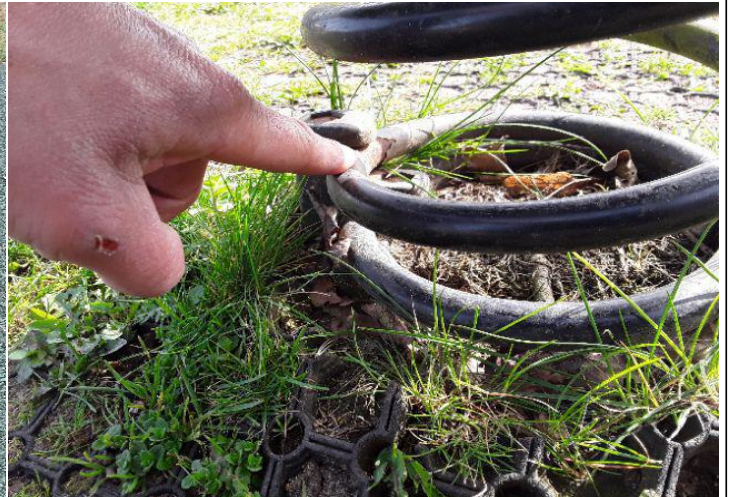
**Item:** Rocking Equipment - Misc Springer  
**Manufacturer:** Kompan Ltd

**Finding:** The paintwork on the spring has been damaged or worn exposing the metal underneath which is rusting

**Action:** Treat any rusting components and repaint

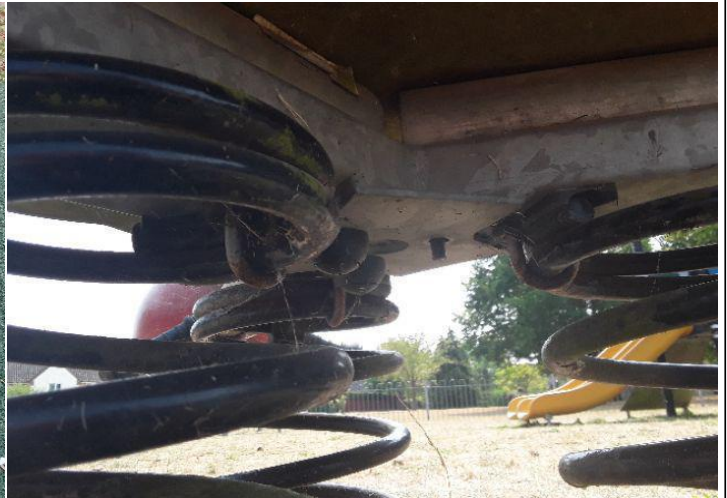
**Item:** Rocking Equipment - Three Way Springer  
**Manufacturer:** Kompan Ltd

**Finding:** There is or are fixings missing on the item

**Action:** Replace all missing fixings

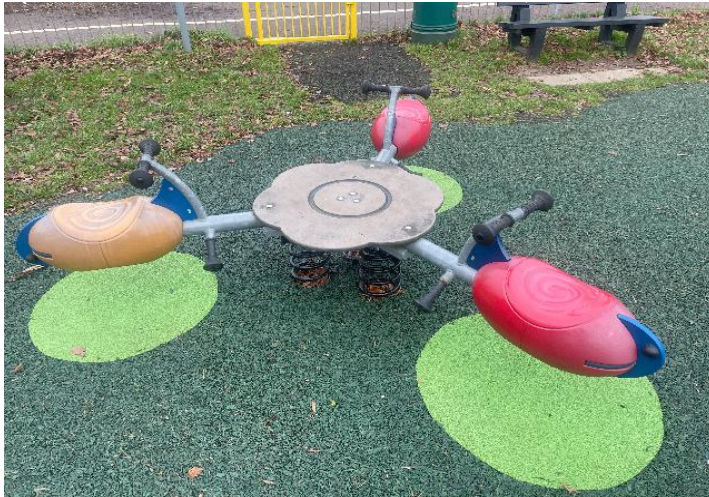
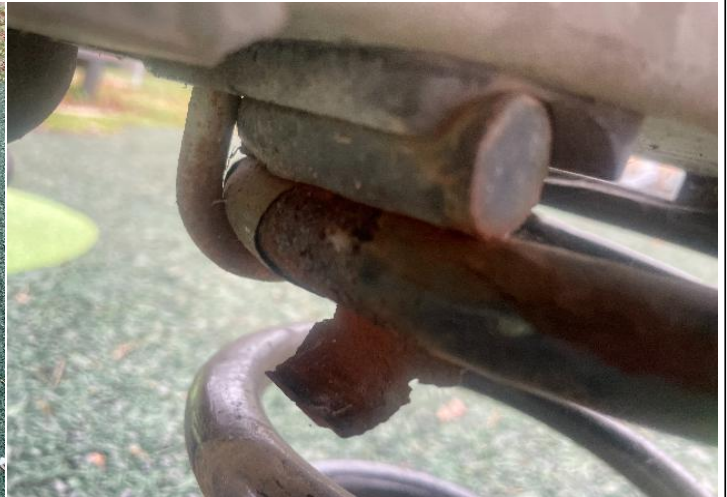
**Item:** Rocking Equipment - Three Way Springer  
**Manufacturer:** Kompan Ltd

**Finding:** The paintwork on the spring has been damaged or worn exposing the metal underneath which is rusting

**Action:** Treat any rusting components and repaint

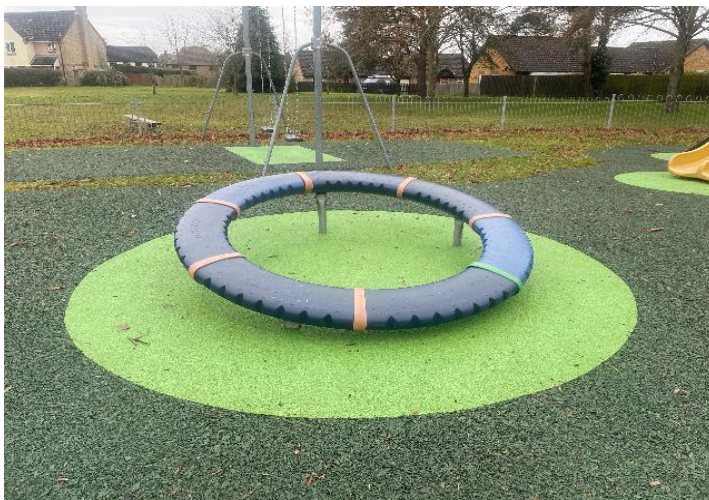
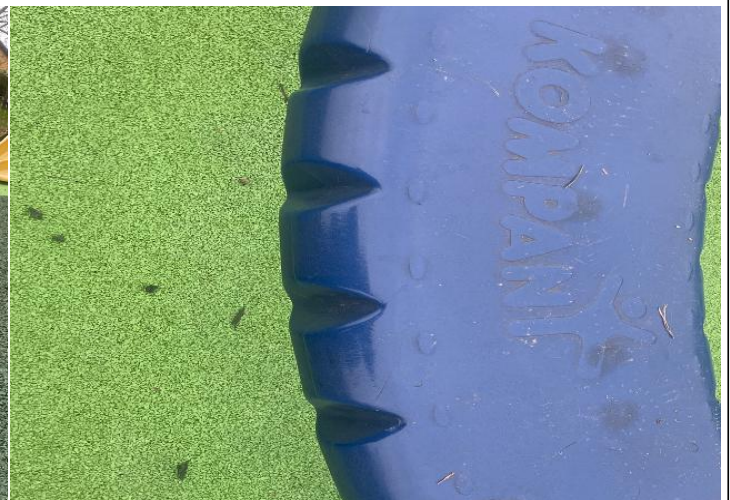
**Item:** Rotor Play - Supernova  
**Manufacturer:** Kompan Ltd

**Finding:** Some segments have minor damage

**Action:** Monitor

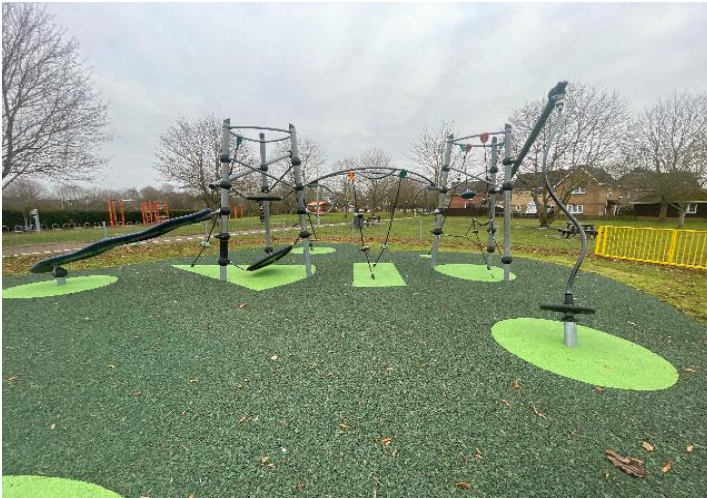
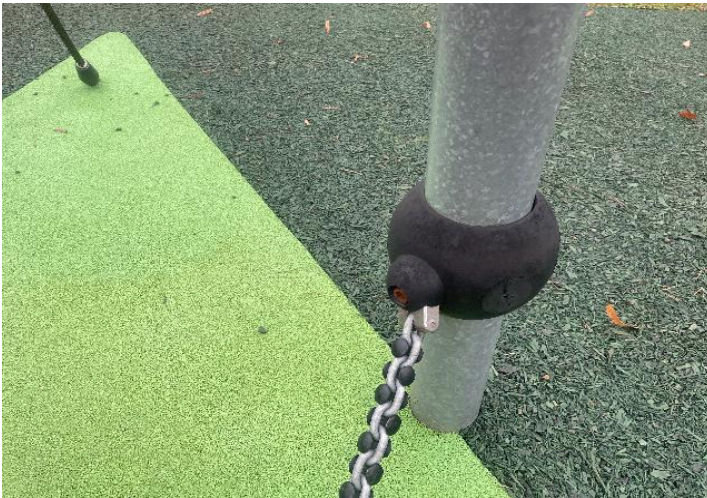
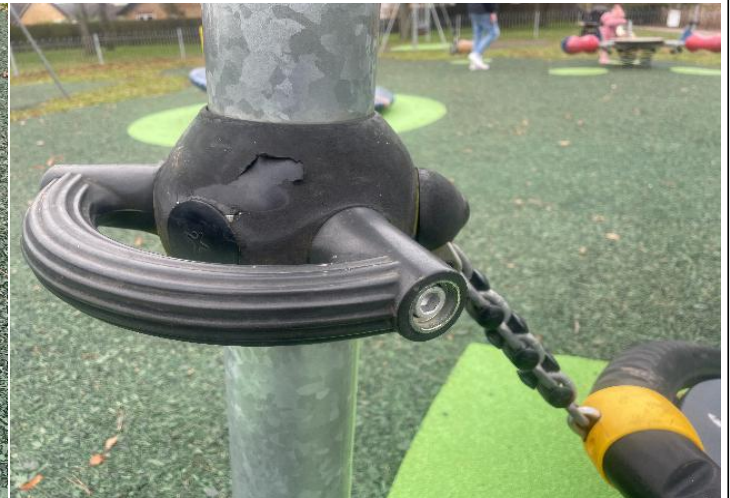
**Item:** Activity Equipment - Multi Play (Senior)  
**Manufacturer:** Kompan Ltd

**Finding:** There is/are bolt cap covers missing or damaged on the item

**Action:** Replace missing or damaged bolt cap covers

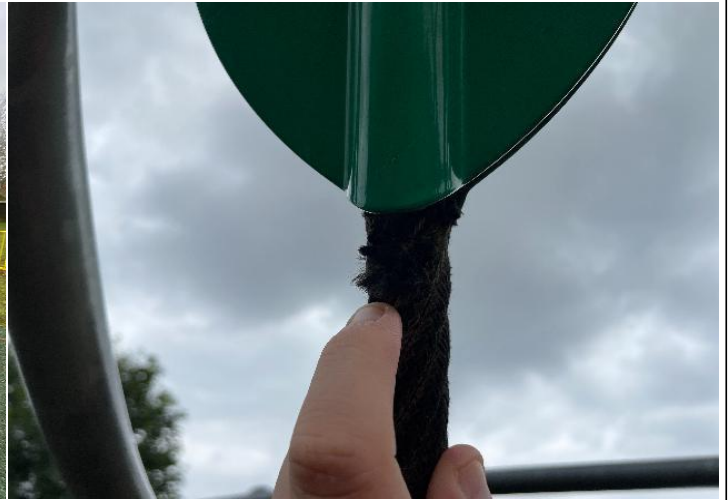
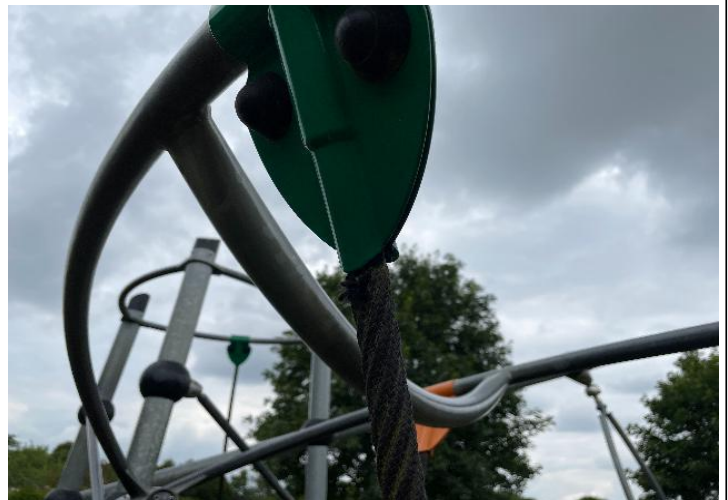
**Item:** Activity Equipment - Multi Play (Senior)  
**Manufacturer:** Kompan Ltd

**Finding:** The ropes/nets are worn/damaged in places

**Action:** Monitor for any further deterioration and repair or replace as required

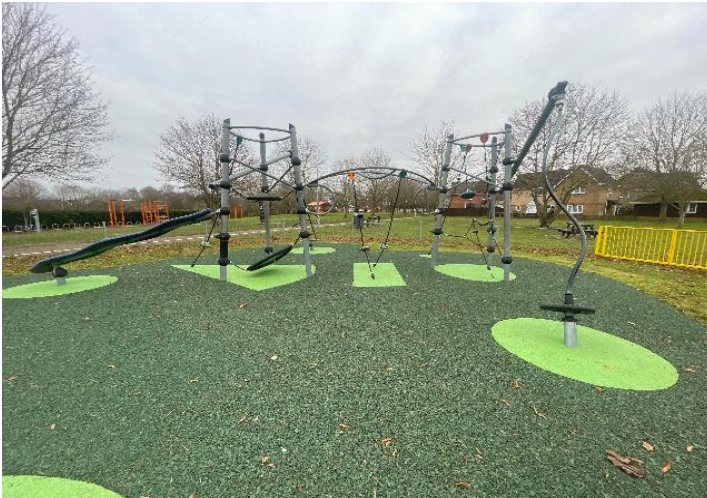
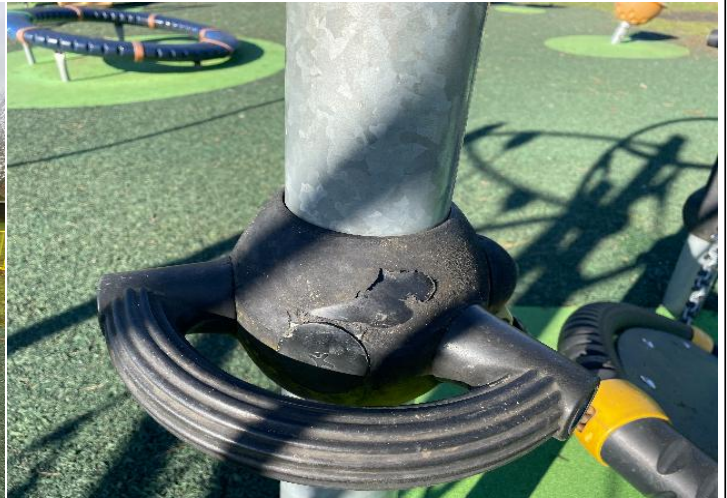
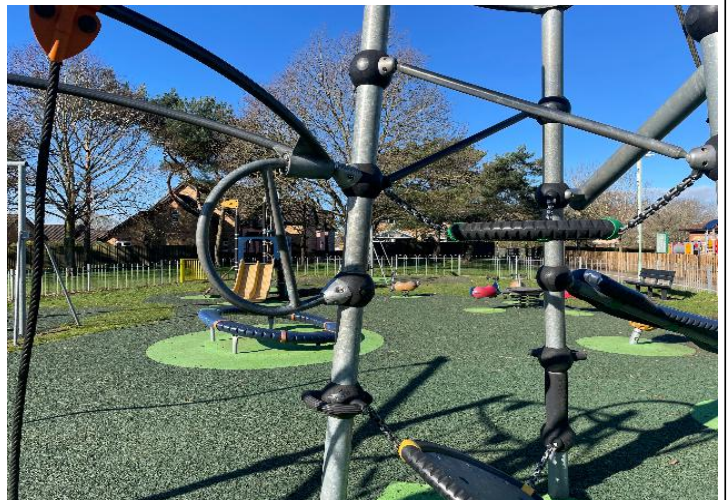
**Item:** Activity Equipment - Multi Play (Senior)  
**Manufacturer:** Kompan Ltd

**Finding:** The item has been damaged

**Action:** Monitor for any further deterioration and replace as required

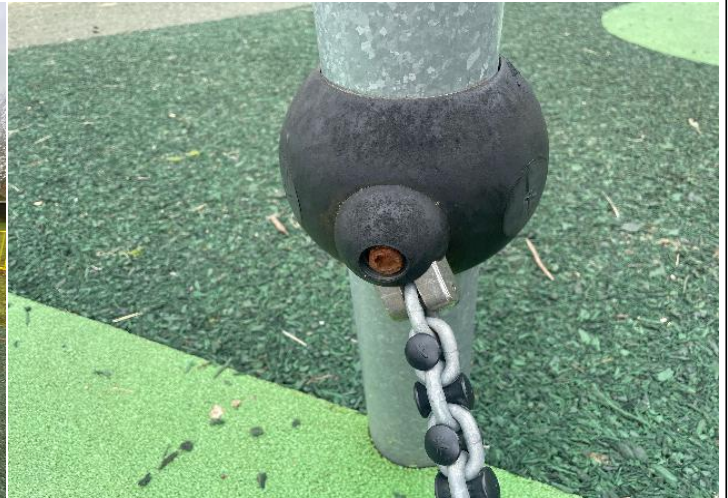
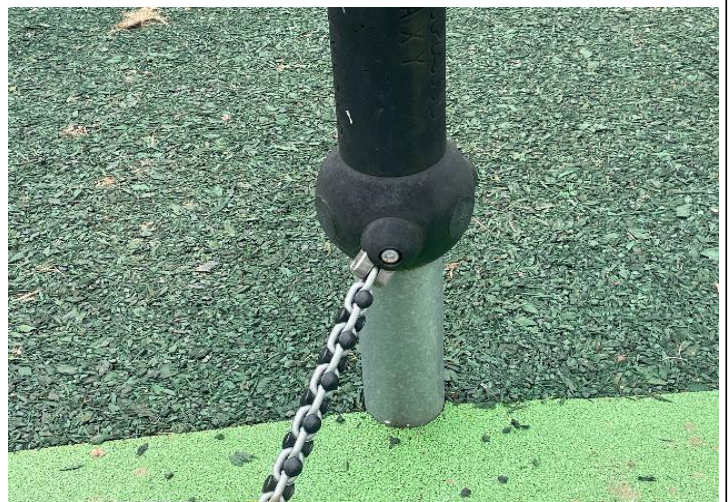
**Item:** Activity Equipment - Multi Play (Senior)  
**Manufacturer:** Kompan Ltd

**Finding:** There is/are bolt cap covers missing or damaged on the item

**Action:** Replace missing or damaged bolt cap covers

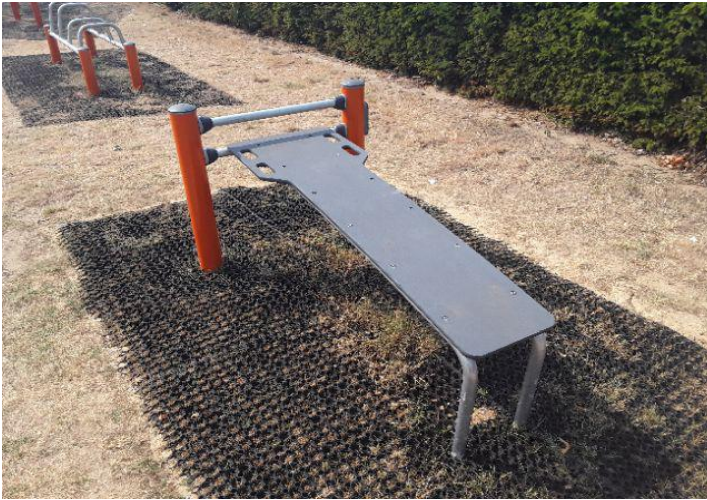
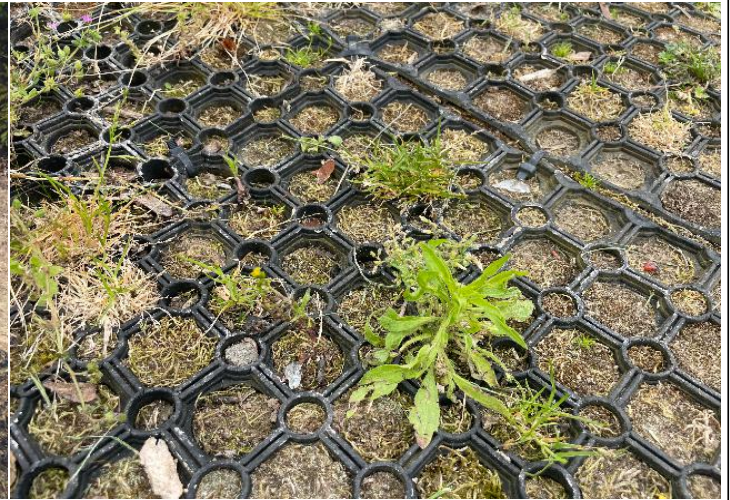
**Item:** Outdoor Fitness Equipment - Sit Up Station **Risk Level:** L - Low Risk  
**Manufacturer:** Kompan Ltd **Surface:** Grass Matrix Tiles

**Finding:** There is a significant amount of broken glass on site

**Action:** Remove the glass and maintain the area

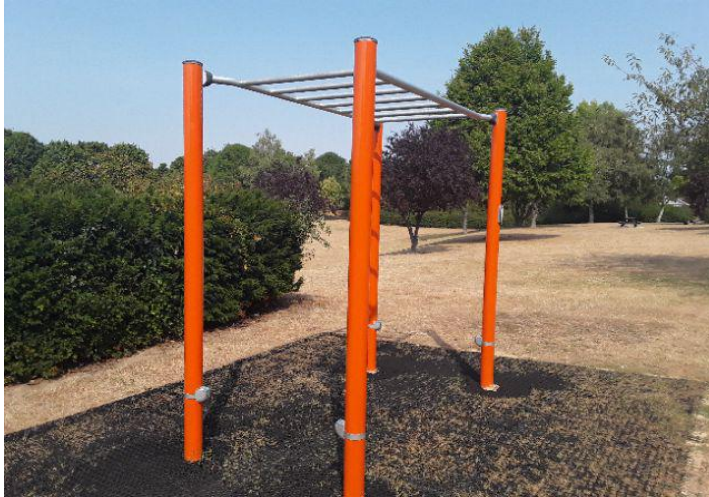
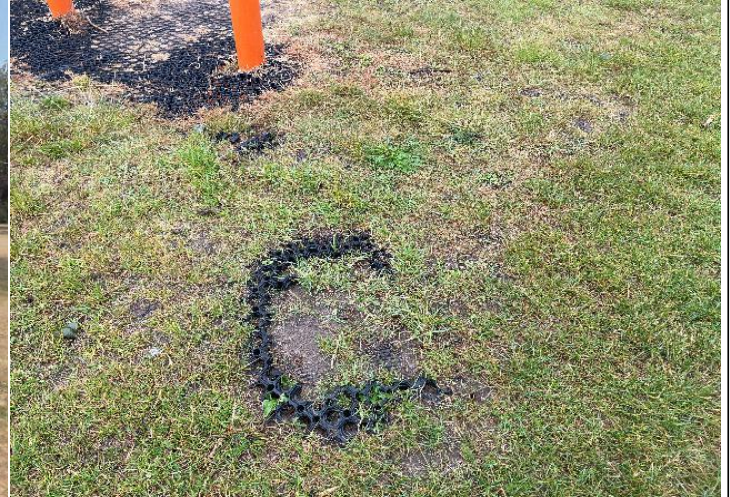
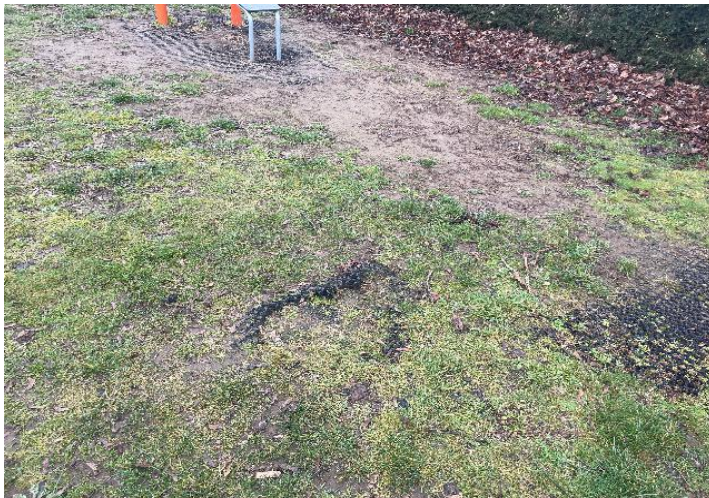
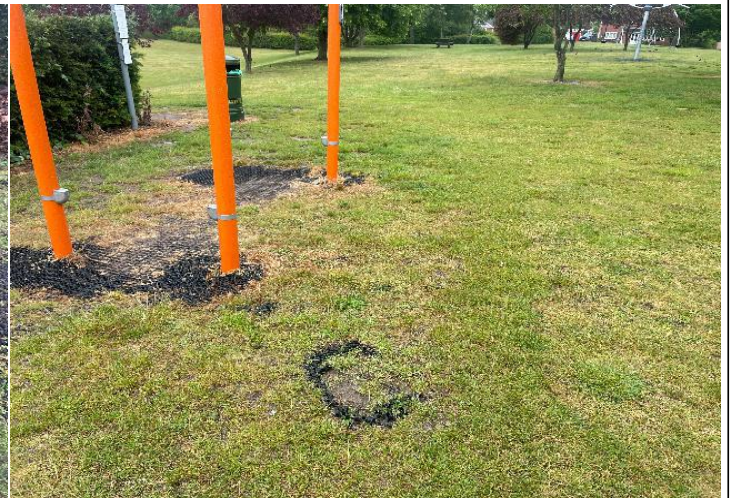
**Item:** Outdoor Fitness Equipment - Overhead Bars  
**Manufacturer:** Kompan Ltd

**Finding:** The surfacing around the item is damaged

**Action:** Repair the damaged areas of surfacing

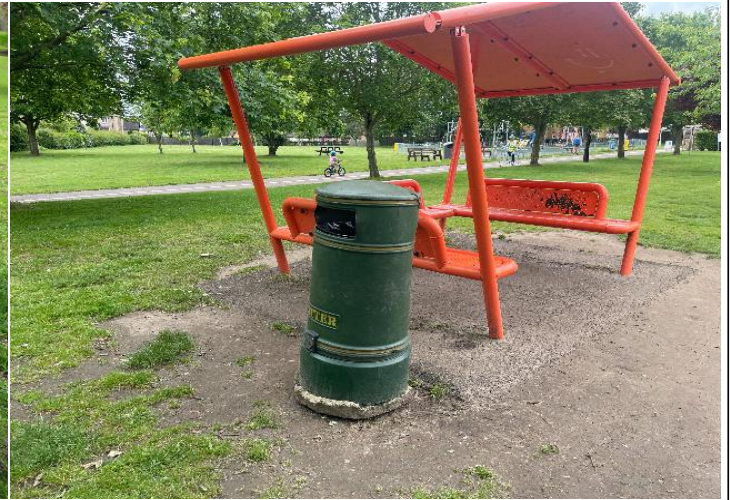
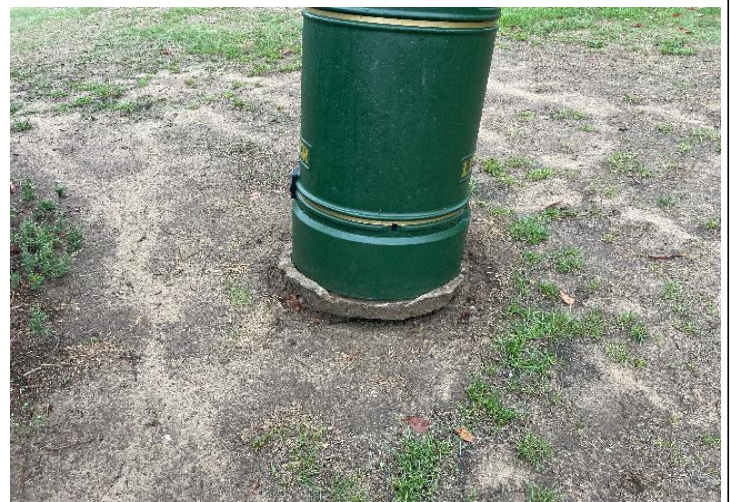
**Item:** Ancillary Items - Litter Bin  
**Manufacturer:** Glasdon

**Finding:** The item is loose in its foundations

**Action:** Reinstall item to secure

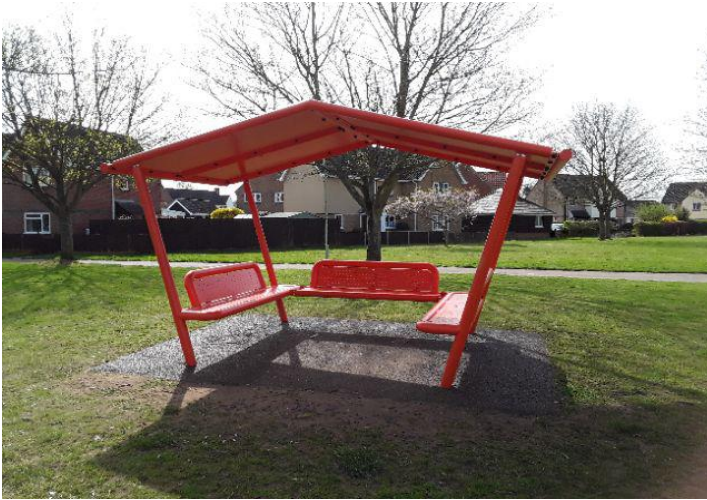
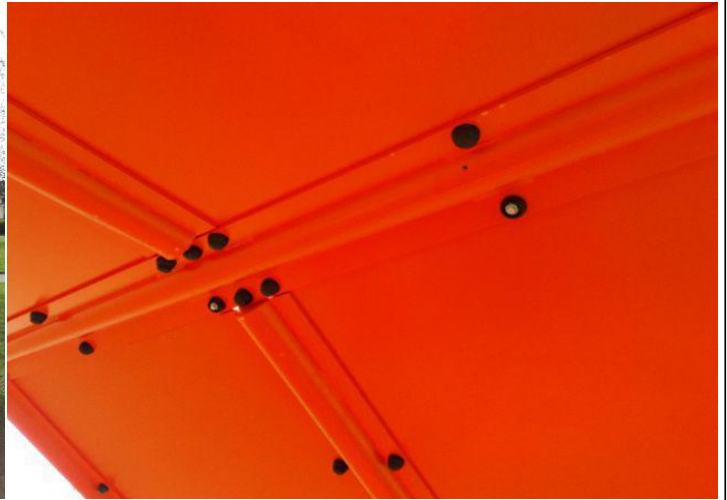
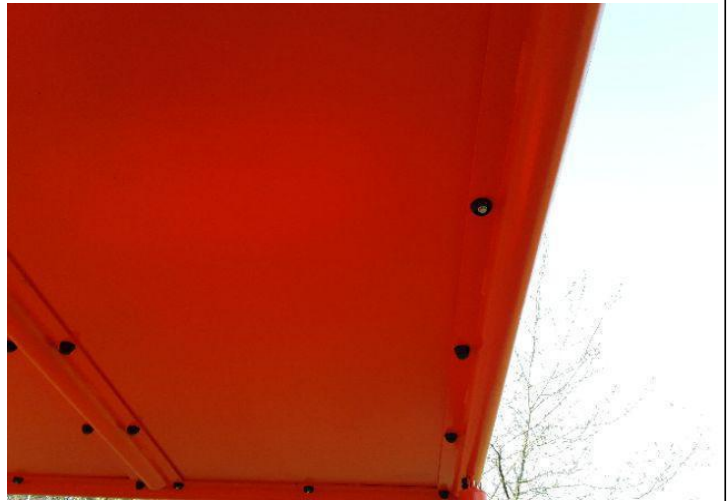
**Item:** Ancillary Items - Shelter  
**Manufacturer:** Caloo

**Finding:** There is/are bolt cap covers missing or damaged on the item

**Action:** Replace 9 missing or damaged bolt cap covers

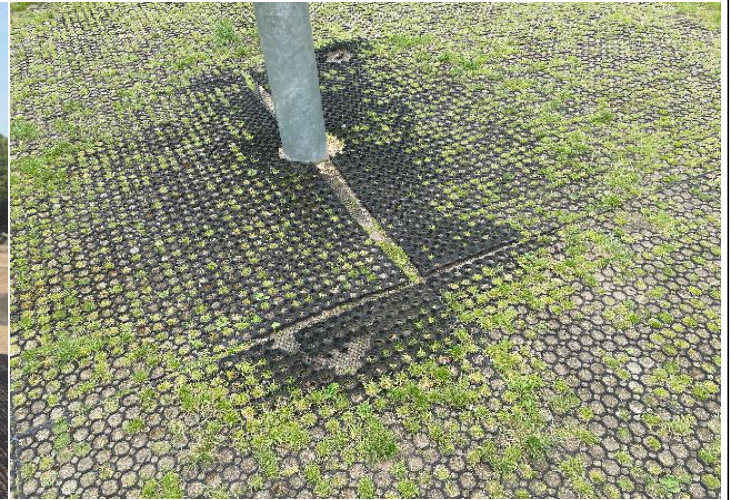
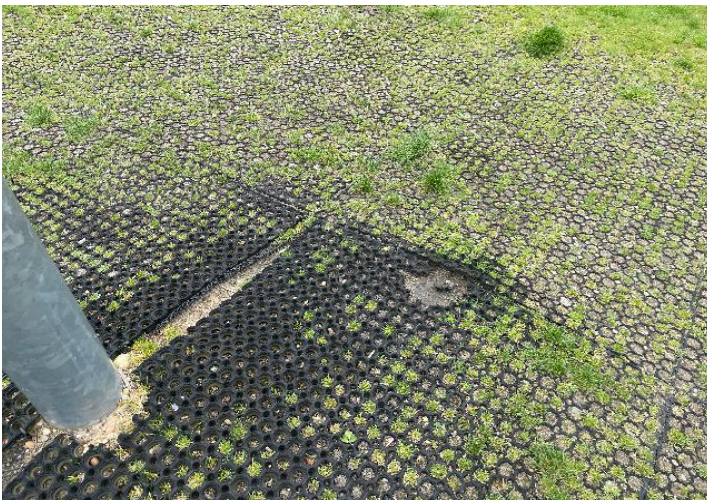
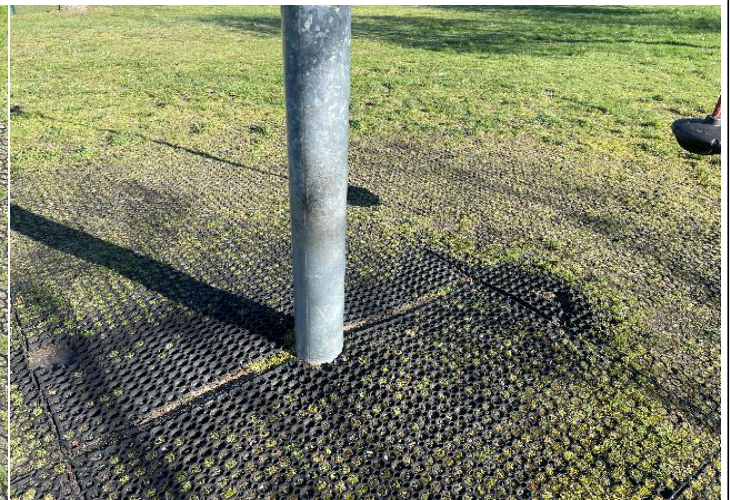
**Item:** Activity Equipment - Overhead Rotator  
**Manufacturer:** Kompan Ltd

**Finding:** The surfacing around the item is damaged

**Action:** Repair the damaged areas of surfacing

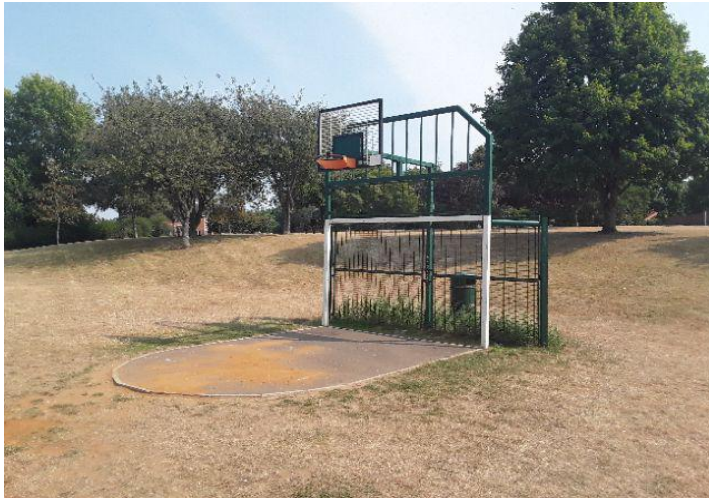
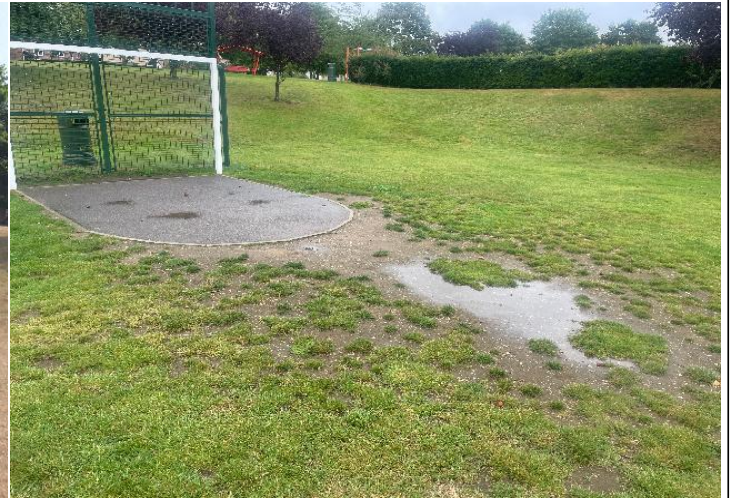
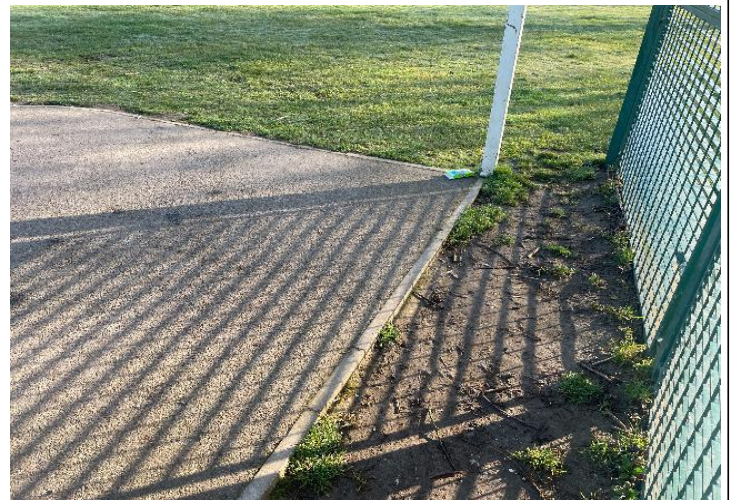
**Item:** Multi Use Games Area - Goal End  
**Manufacturer:** Unknown

**Finding:** There are trip hazards at the edges of the surface

**Action:** Reinstate surrounding surface levels to remove the trip points

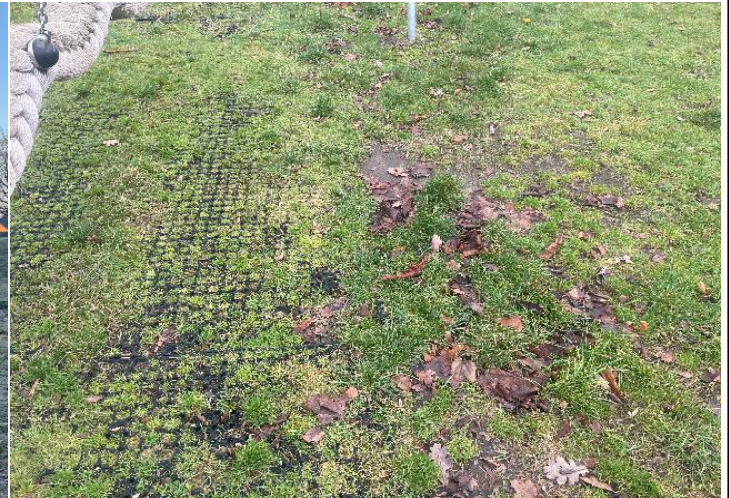
**Item:** Swings - Giant Rope Swing  
**Manufacturer:** Kompan Ltd

**Finding:** The surfacing around the item is damaged

**Action:** Repair the damaged areas of surfacing
