## Operational Inspection

Thurston Parish Council

Thurst Coffee Shop Playground  
New Green Centre, New Green Ave, Thurston , IP31  
3TG

Inspection Ref: 2390537

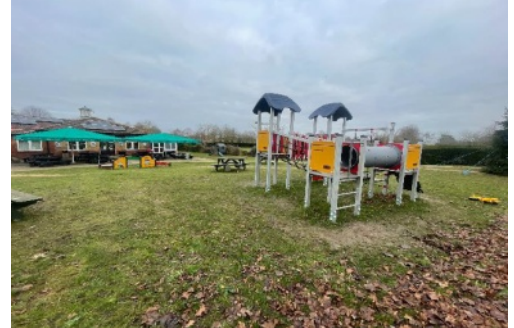
**Item:** Multi Play (Junior)  
**Manufacturer:** Kompan Ltd  
**Surface Type:** Grass Matrix Tiles  
**Item Quantity:** 1  
**Equipment Compliance:** N/A  
**Surface Area Compliance:** N/A

This item is satisfactory - no work required -

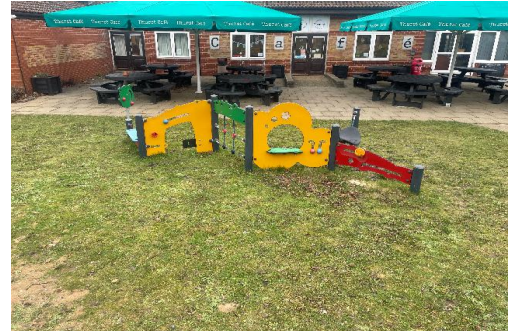
**Item:** Activity Trail  
**Manufacturer:** Kompan Ltd  
**Surface Type:** Grass  
**Item Quantity:** 1  
**Equipment Compliance:** N/A  
**Surface Area Compliance:** N/A

There is/are bolt cap covers missing or damaged on the item - Replace missing or damaged bolt cap covers

The item has missing component(s) - Consider replacing missing components

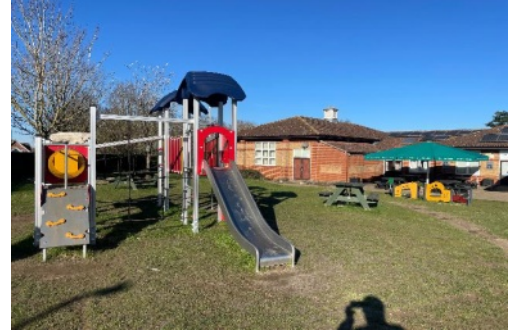
**Item:** Site General  
**Manufacturer:** Not Identified  
**Surface Type:** Grass  
**Item Quantity:** 1  
**Equipment Compliance:** N/A  
**Surface Area Compliance:** N/A

This item is satisfactory - no work required -

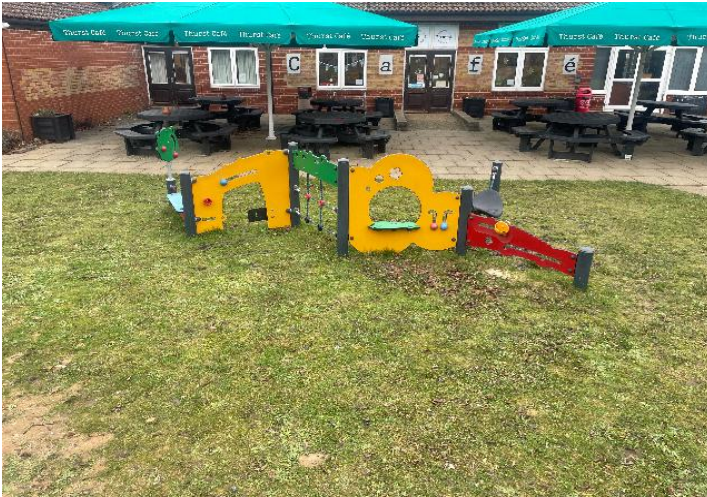
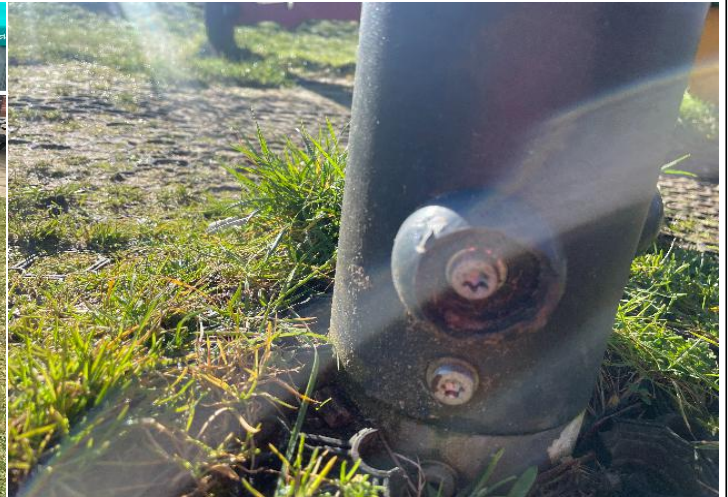
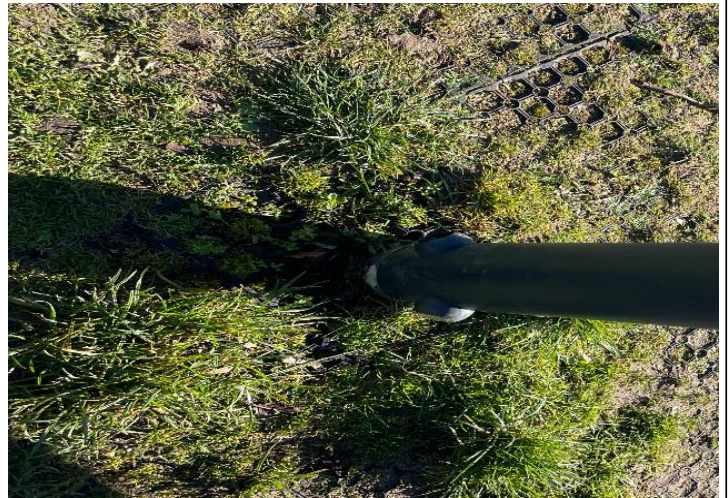
**i** 4 - Very Low Risk (Finding 1)

**Item:** Activity Equipment - Activity Trail  
**Manufacturer:** Kompan Ltd

**Risk Level:** V - Very Low Risk  
**Surface:** Grass

**Finding:** There is/are bolt cap covers missing or damaged on the item

**Action:** Replace missing or damaged bolt cap covers

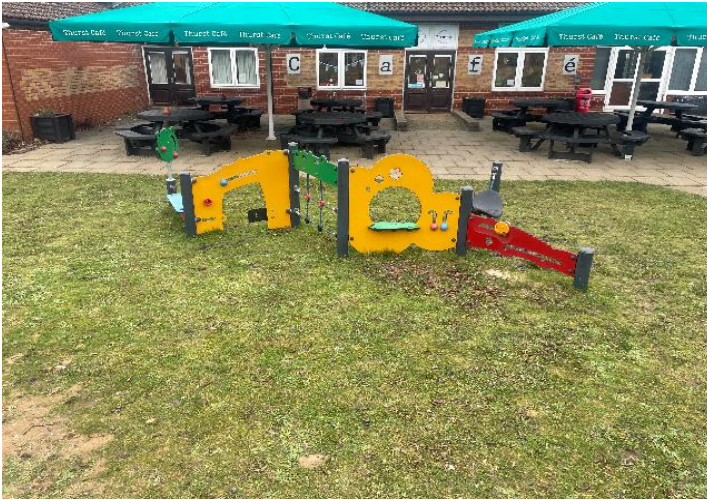
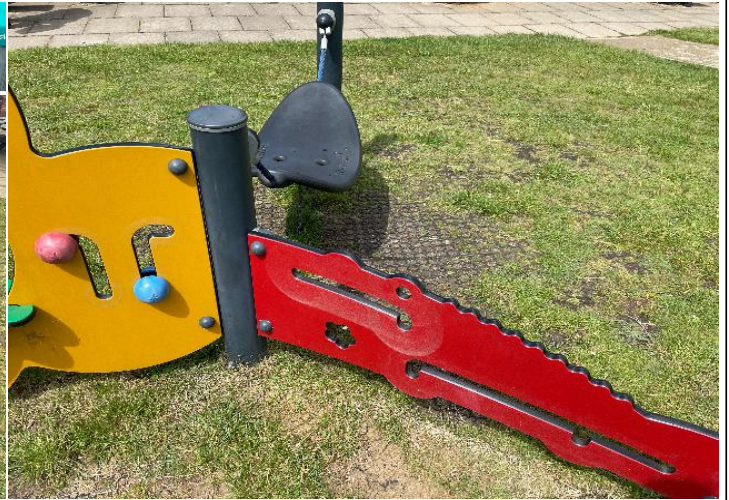
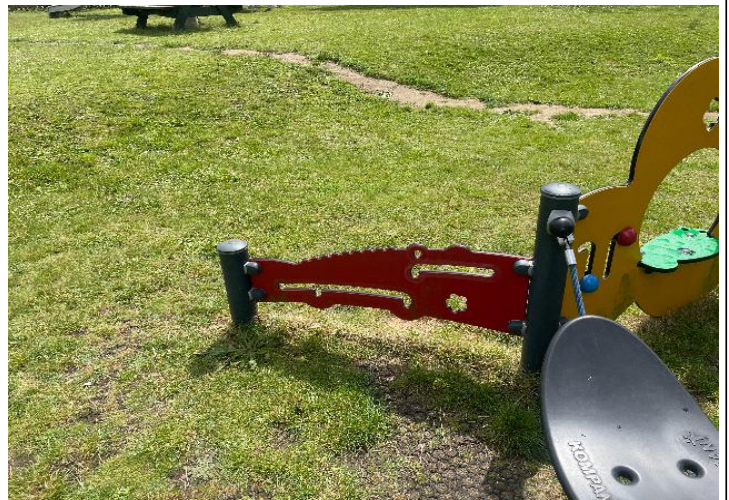
**i** 6 - Low Risk (Finding 2)

**Item:** Activity Equipment - Activity Trail  
**Manufacturer:** Kompan Ltd

**Risk Level:** L - Low Risk  
**Surface:** Grass

**Finding:** The item has missing component(s)

**Action:** Consider replacing missing components
