Annual Inspection

Mid Suffolk District Council

Thurston Recreation Ground

Church Road, Thurston, Suffolk, IP31 3RP

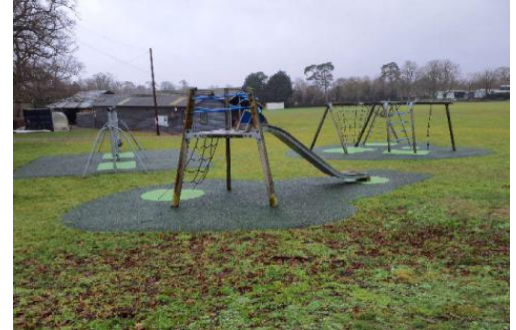
There is weed / vegetation growth on, between, or around the edges of the surfacing - Remove weed / vegetation growth

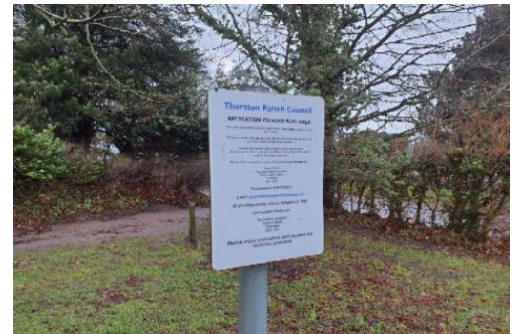
There are post / end caps missing from the item - Replace missing post caps

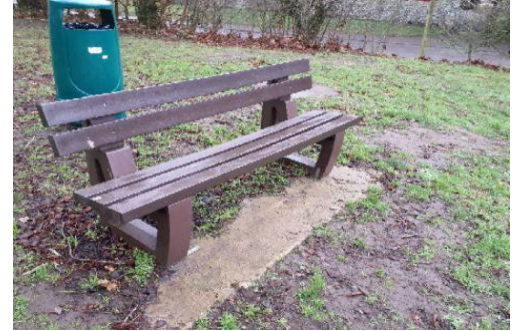
The surface has eroded in some areas and may be slippery in wet conditions - Reinstate the surface

There are trip hazards at the edges of the surface - Reinstate surrounding surface levels to remove the trip points

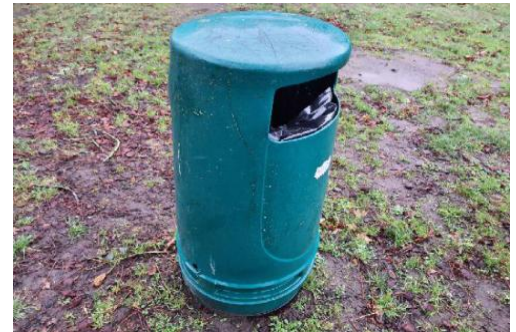
There is some damage to the item - Monitor for any further deterioration and repair as required

The lid or door of the litter bin is not secured - Ensure the lid or door is kept locked

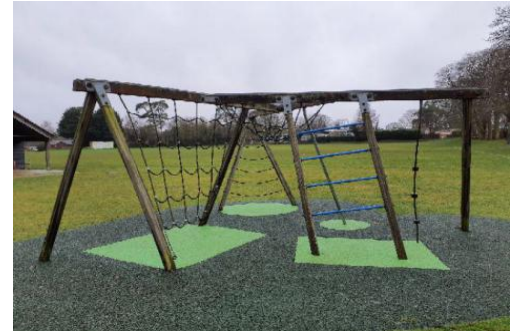
The ropes/nets are worn/damaged in places - Monitor for any further deterioration and repair or replace as required

There is algae or moss on the surface of the equipment - Clean and treat appropriately

There is/are bolt cap covers missing or damaged on the item - Replace missing or damaged bolt cap covers

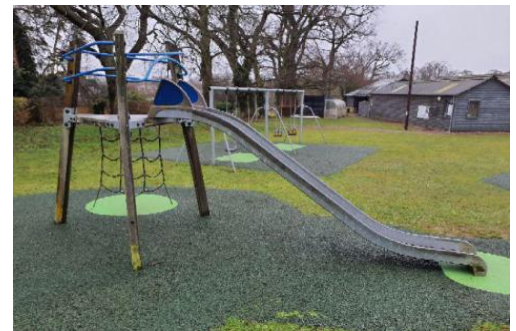
There are a number of dents in the slide surface - Monitor for any further deterioration and repair as required

There is/are bolt cap covers missing or damaged on the item - Replace missing or damaged bolt cap covers

There is/are finger entrapment/s in the slide starting section and the item fails to meet the requirements of BS EN 1176 Part 1 4.2.7.6 Entrapment of fingers - Monitor - No remedial work recommended

There is algae or moss on the surface of the equipment - Clean and treat appropriately

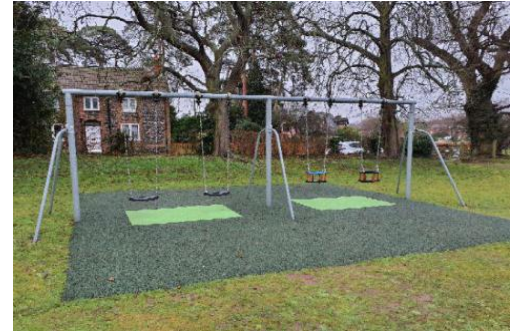
The seat clearance from finished surface level to the underside of the seat is too low and does not meet the requirements of BS EN 1176 Part 2 (350mm minimum clearance required) - Adjust seat height/s (400mm-500mm is recommended)

The chain openings are in excess of 8.6mm and do not meet the recommendations of BS EN 1176 Part 1 - Monitor - No remedial work recommended

The connecting links are in excess of 8.6mm and less than 12mm and fail the requirements of BS EN 1176 Part 1; clause 4.2.13, Chains - Monitor use and replace with compliant links at the next maintenance cycle

There is some notable evidence of chain wear - Monitor for any further deterioration and replace when 40% worn

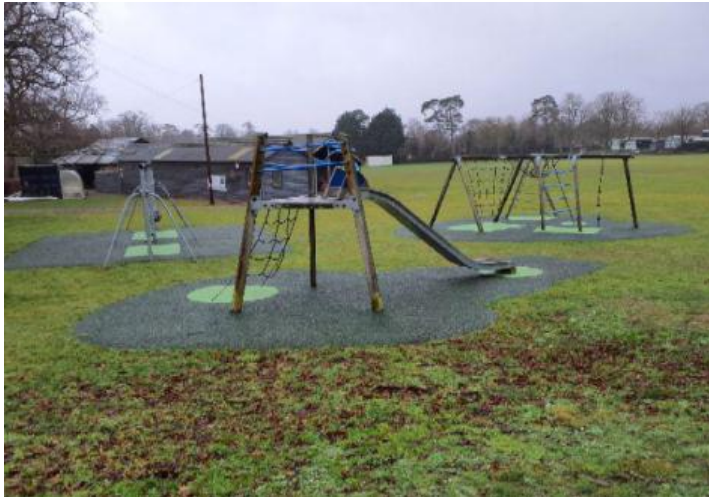
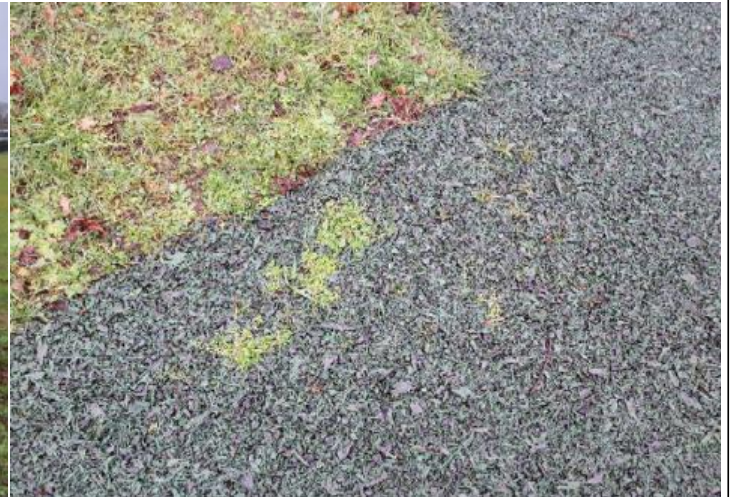
Finding: There is weed / vegetation growth on, between, or around the edges of the surfacing
Action: Remove weed / vegetation growth

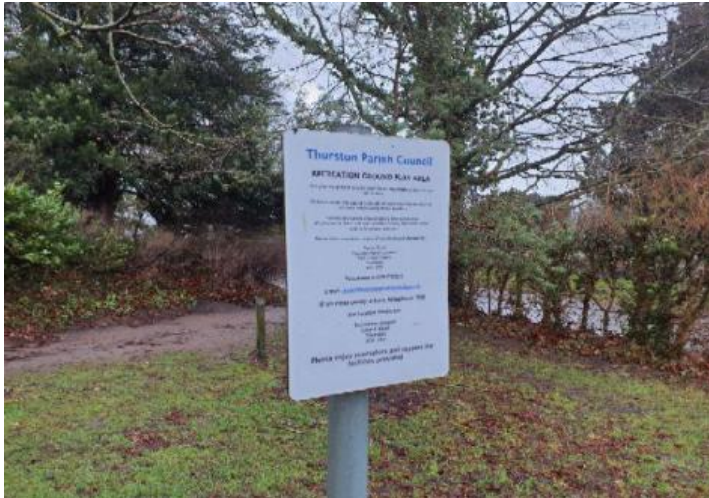
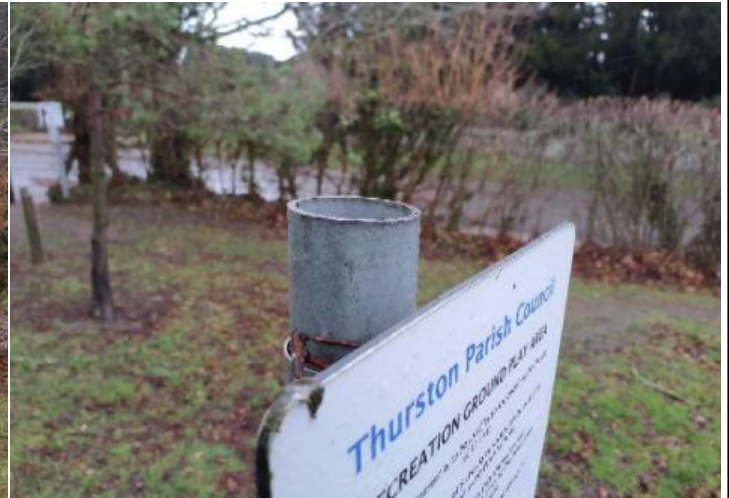
Finding: There are post / end caps missing from the item

Action: Replace missing post caps

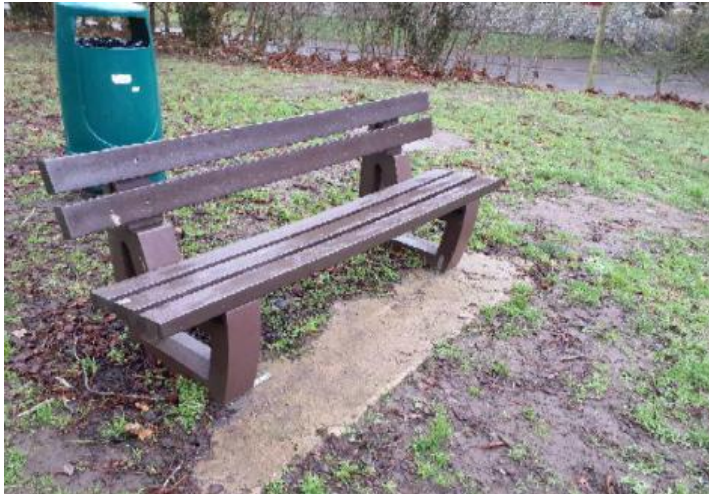
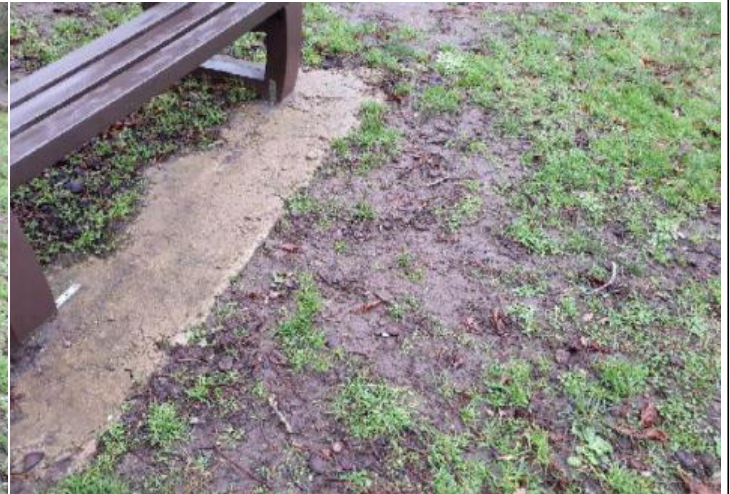
Finding: The surface has eroded in some areas and may be slippery in wet conditions

Action: Reinstate the surface

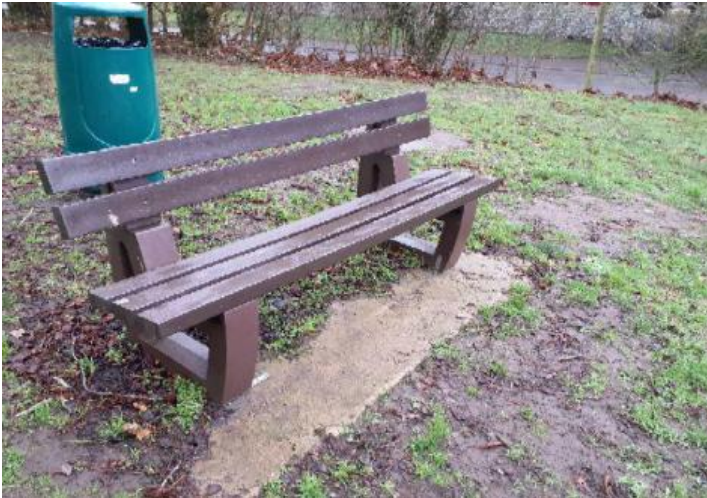
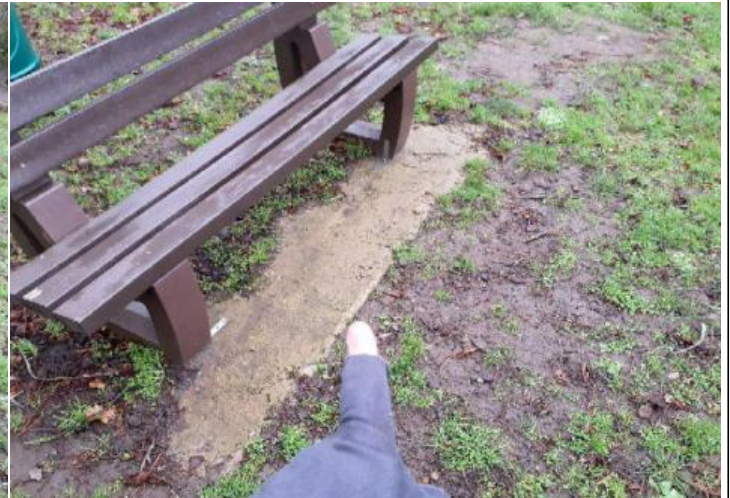
Finding: There are trip hazards at the edges of the surface

Action: Reinstate surrounding surface levels to remove the trip points

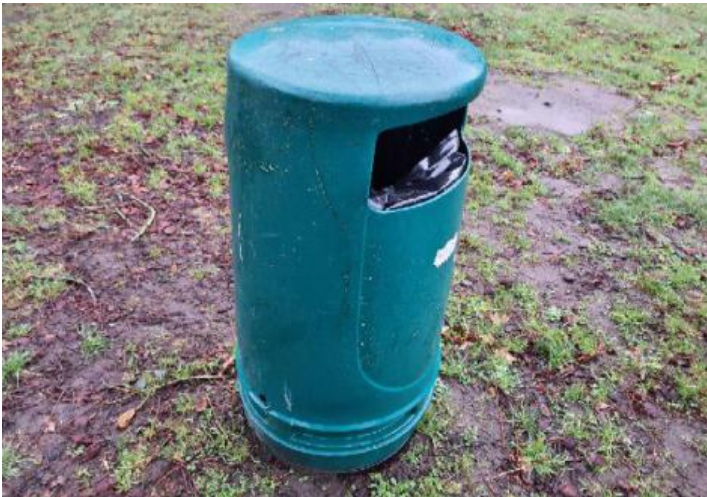
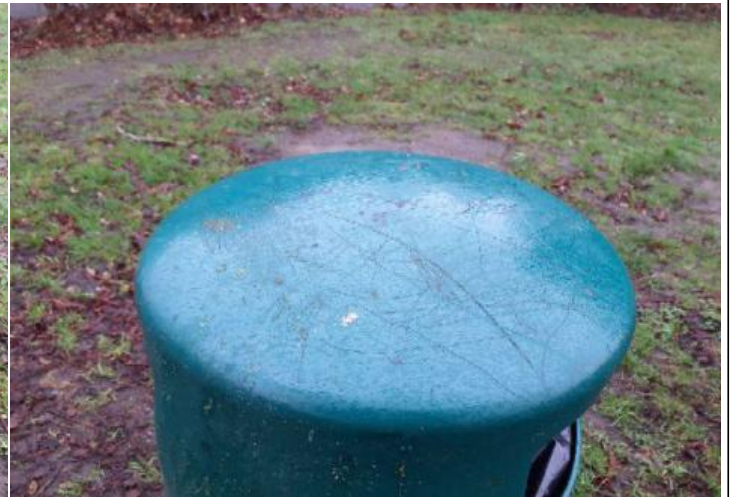
Finding: There is some damage to the item

Action: Monitor for any further deterioration and repair as required

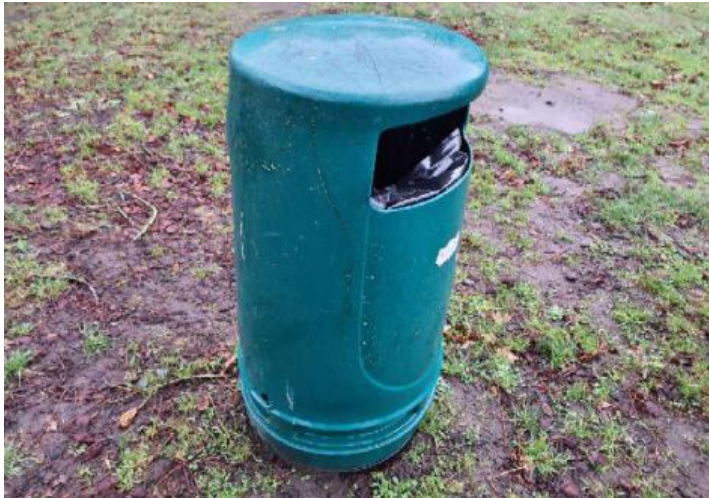
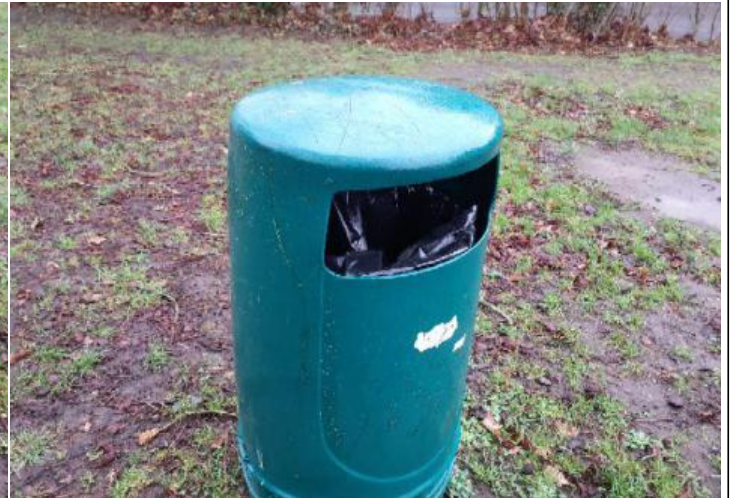
Finding: The lid or door of the litter bin is not secured

Action: Ensure the lid or door is kept locked

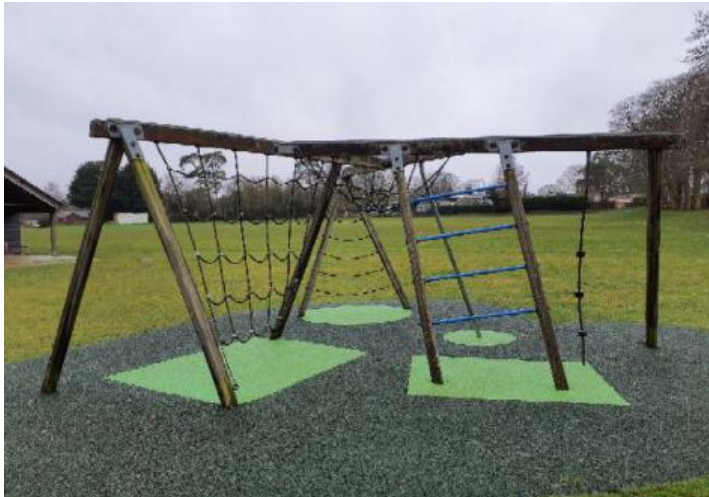
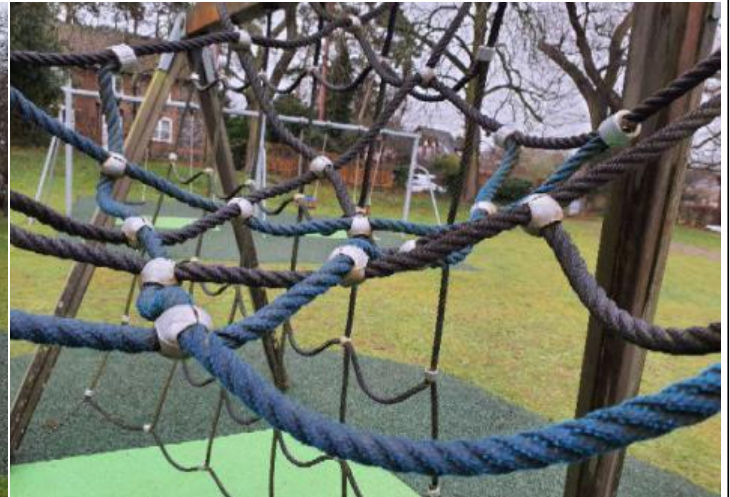
Finding: The ropes/nets are worn/damaged in places

Action: Monitor for any further deterioration and repair or replace as required

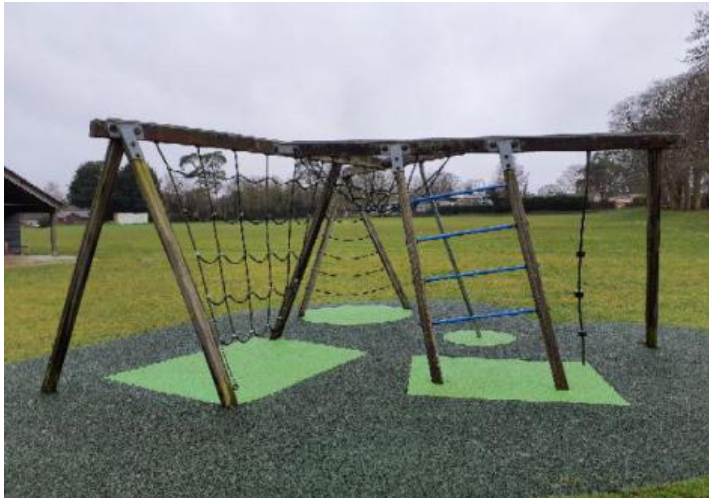
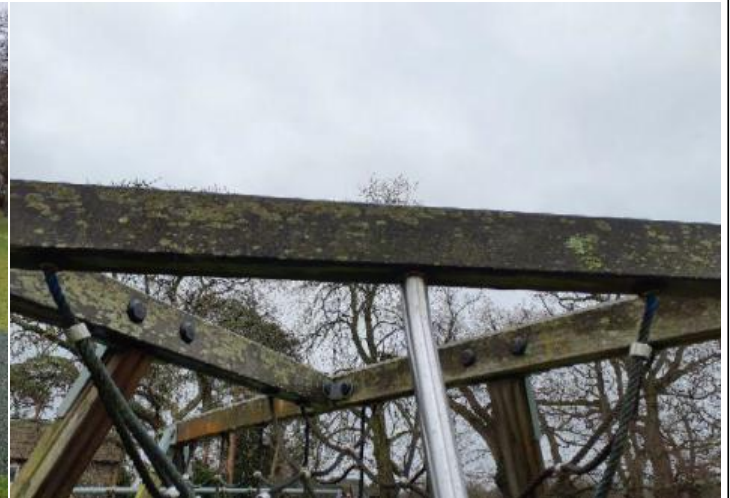
Finding: There is algae or moss on the surface of the equipment

Action: Clean and treat appropriately

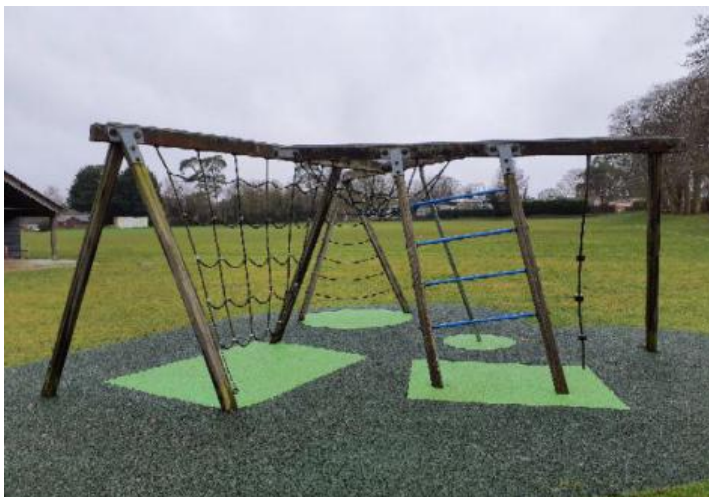
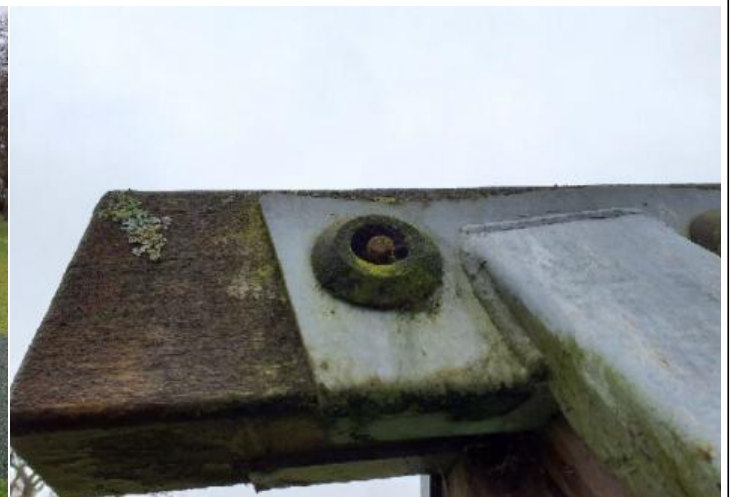
Finding: There is/are bolt cap covers missing or damaged on the item

Action: Replace missing or damaged bolt cap covers

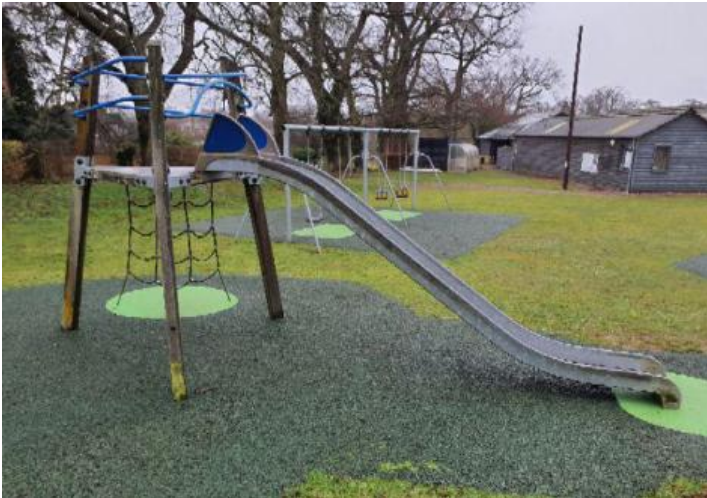
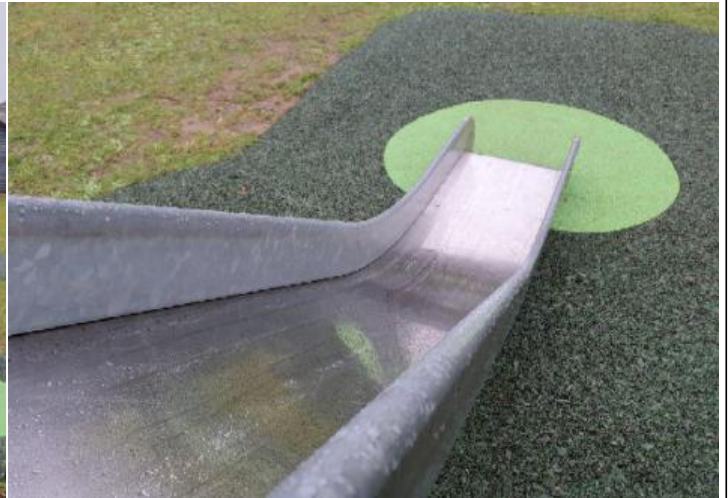
Finding: There are a number of dents in the slide surface

Action: Monitor for any further deterioration and repair as required

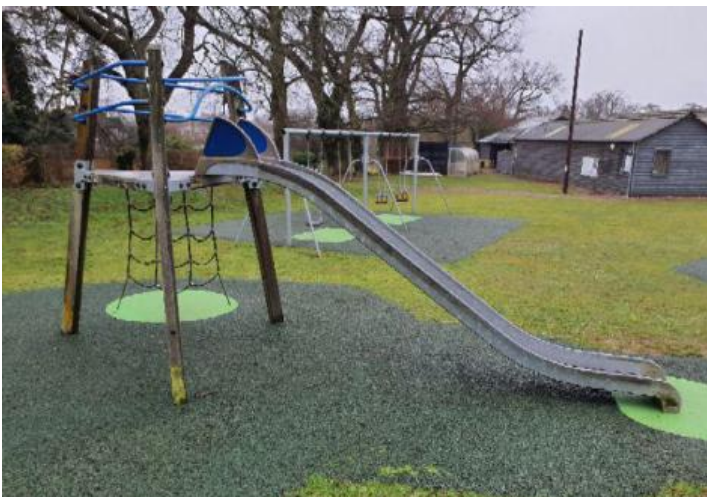
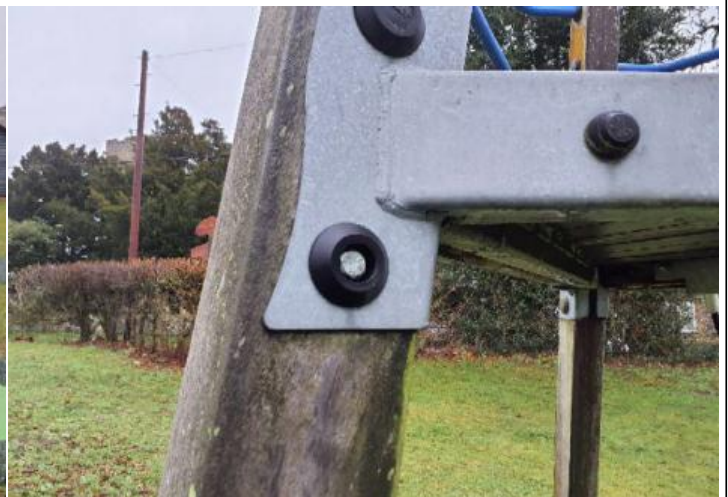
Finding: There is/are bolt cap covers missing or damaged on the item

Action: Replace missing or damaged bolt cap covers

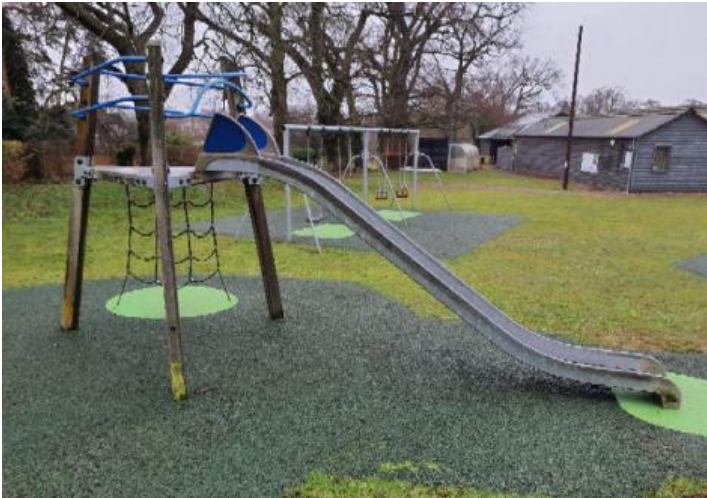
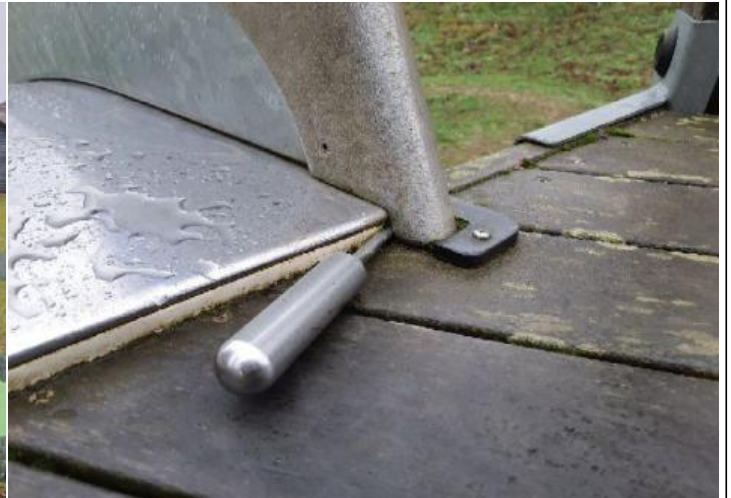
Finding: There is/are finger entrapment/s in the slide starting section and the item fails to meet the requirements of BS EN 1176 Part 1 4.2.7.6 Entrapment of fingers

Action: Monitor - No remedial work recommended

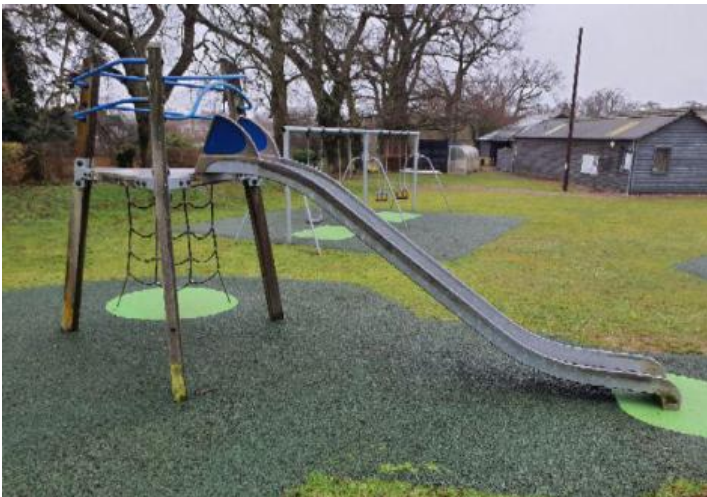
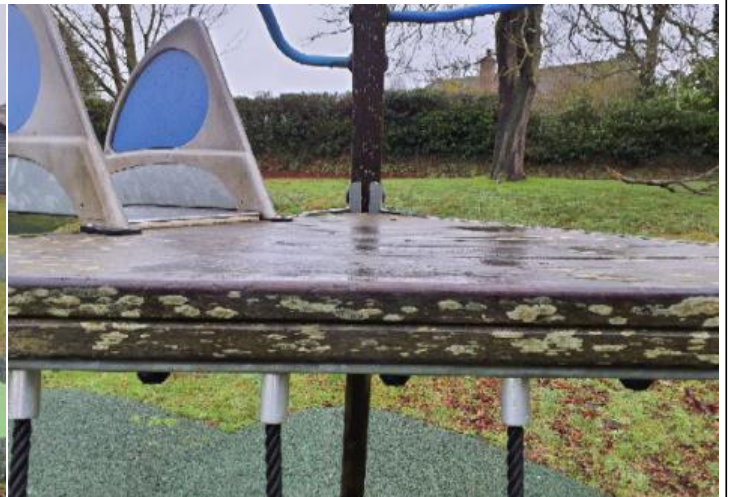
Finding: There is algae or moss on the surface of the equipment

Action: Clean and treat appropriately

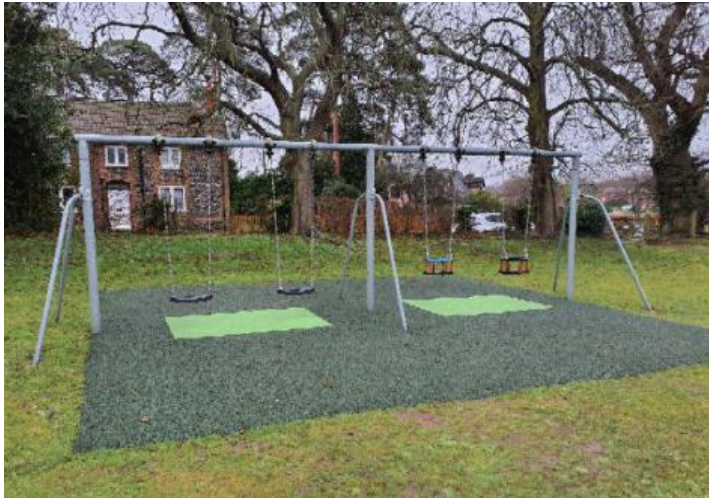
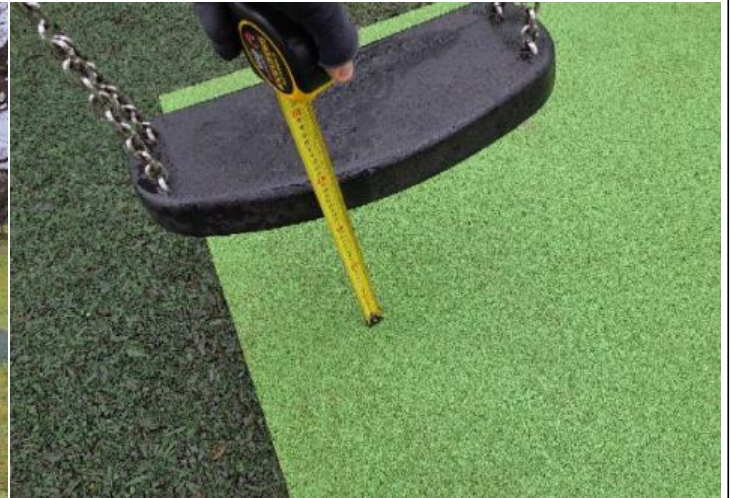
Finding: The seat clearance from finished surface level to the underside of the seat is too low and does not meet the requirements of BS EN 1176 Part 2 (350mm minimum clearance required)

Action: Adjust seat height/s (400mm-500mm is recommended)

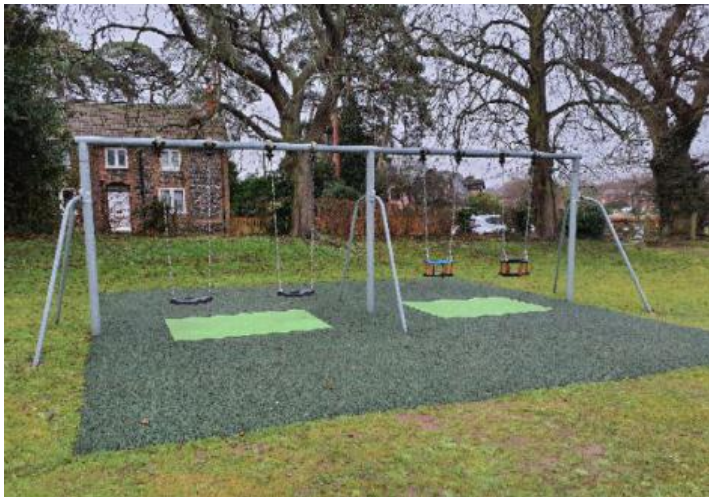
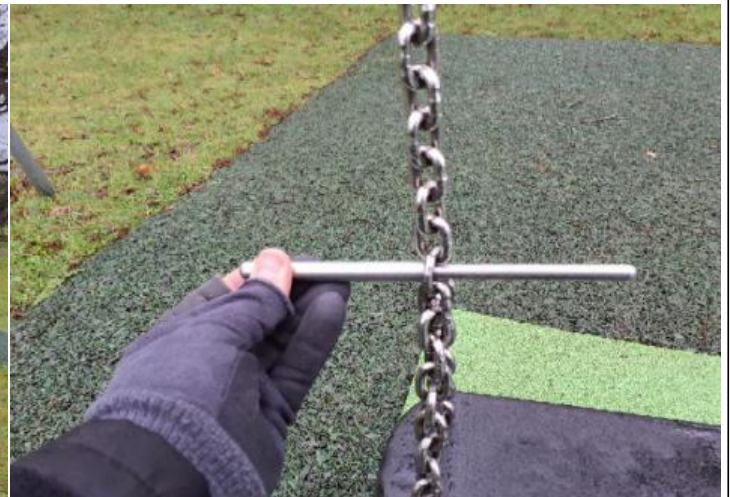
Finding: The connecting links are in excess of 8.6mm and less than 12mm and fail the requirements of BS EN 1176 Part 1; clause 4.2.13, Chains

Action: Monitor use and replace with compliant links at the next maintenance cycle

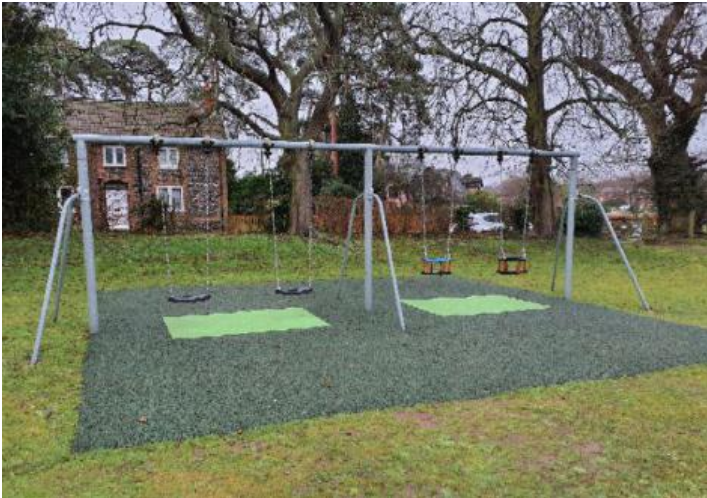
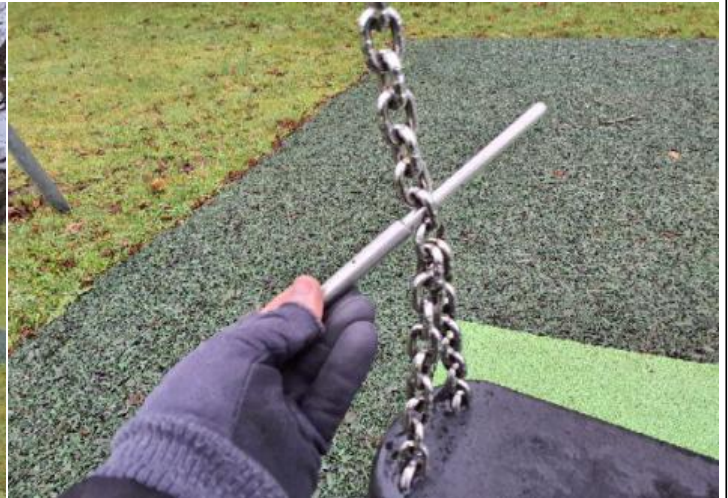
Finding: The chain openings are in excess of 8.6mm and do not meet the recommendations of BS EN 1176 Part 1

Action: Monitor - No remedial work recommended

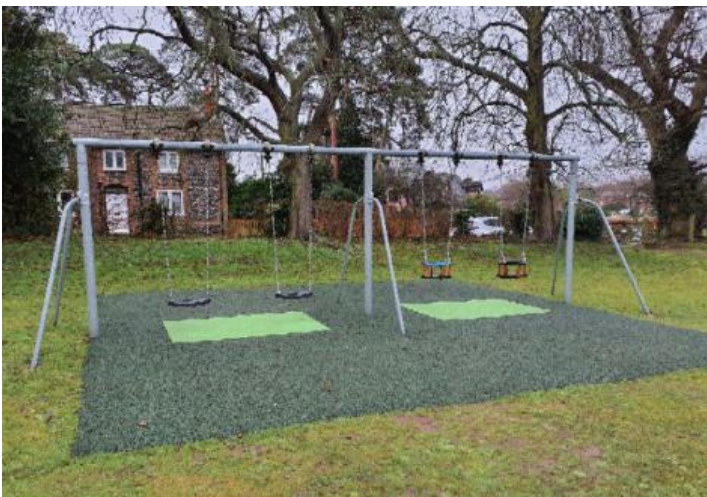
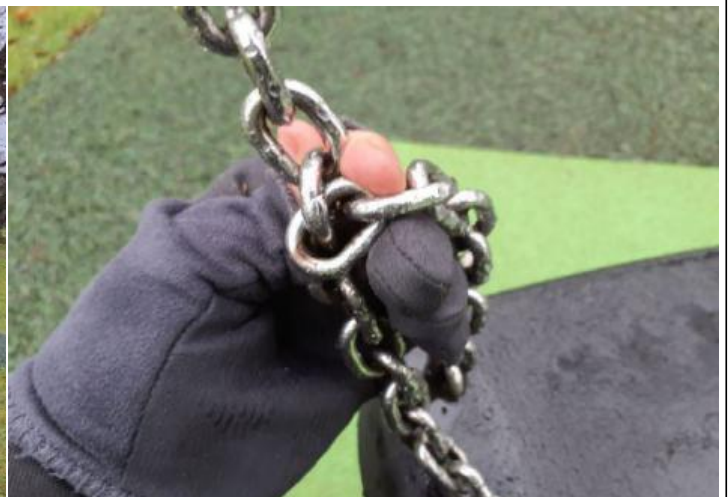
Finding: There is some notable evidence of chain wear

Action: Monitor for any further deterioration and replace when 40% worn
