Operational Inspection

Thurston Parish Council

New Green Centre
New Green Ave, Thurston, IP31 3TG

Operational Inspection - 2-September-2024 - 11:53 Inspector Dan Carr

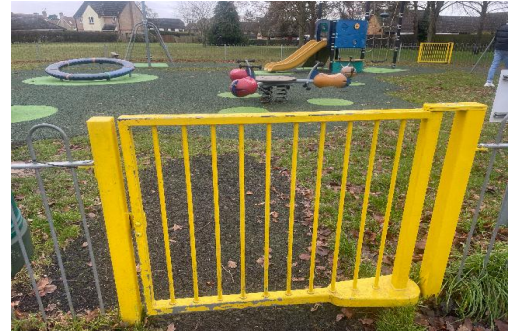
Item: Gate - Self Closing
Manufacturer: I.A.E. Fencing
Surface Type: Bonded Rubber Mulch
Item Quantity: 1
Equipment Compliance: N/A
Surface Area Compliance: N/A

The gate is closing too quickly (less than 4 seconds) - Take corrective action to ensure that the gate closes in 4-8 seconds

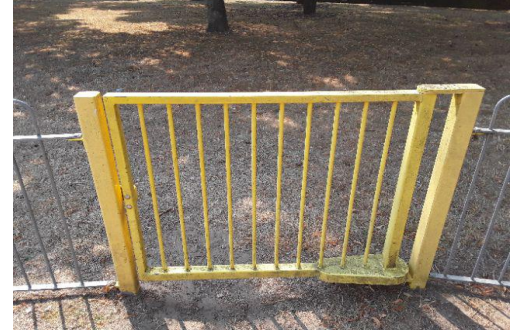
Item: Gate - Self Closing
Manufacturer: I.A.E. Fencing
Surface Type: Grass
Item Quantity: 1
Equipment Compliance: N/A
Surface Area Compliance: N/A

The area around the item has eroded and may become slippery - Reinststate eroded area

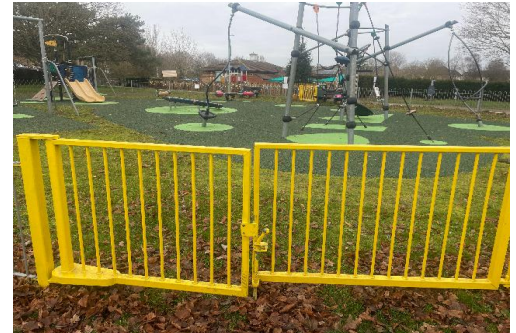
Item: Gate - Combination
Manufacturer: I.A.E. Fencing
Surface Type: Grass
Item Quantity: 1
Equipment Compliance: N/A
Surface Area Compliance: N/A

The paintwork on this item has been damaged or worn exposing the metal underneath which is rusting - Treat any rusting components and repaint

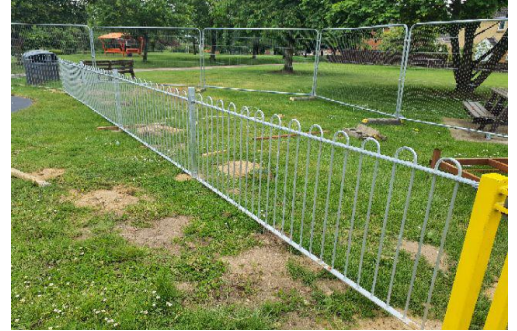
Item: Fence - Bow Top
Manufacturer: I.A.E. Fencing
Surface Type: Grass
Item Quantity: 1
Equipment Compliance: N/A
Surface Area Compliance: N/A

The paintwork on this item has been damaged or worn exposing the metal underneath which is rusting - Treat any rusting components and repaint

There is or are fixings missing on the item - Replace 2 missing fixings

There are 2 loose posts around the fence - Monitor for any further deterioration and reset as required

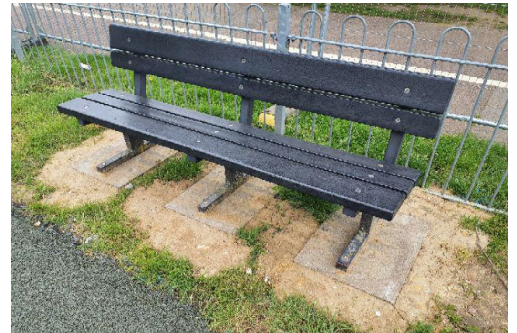
Item: Bench
Manufacturer: Not Identified
Surface Type: Mixed Surface
Item Quantity: 1
Equipment Compliance: N/A
Surface Area Compliance: N/A

The paintwork on this item has been damaged or worn exposing the metal underneath which is rusting - Treat any rusting components and repaint

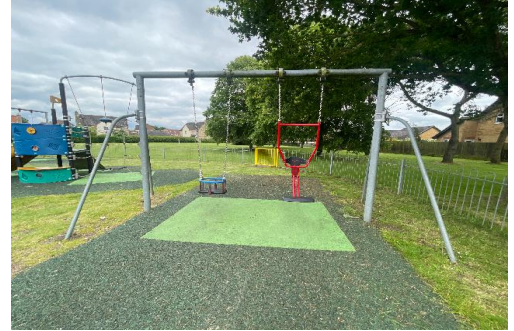
Item: 1 Bay 2 Seat (Cradle)
Manufacturer: Kompan Ltd
Surface Type: Grass Matrix Tiles
Item Quantity: 1
Equipment Compliance: No
Surface Area Compliance: Yes

There is algae or moss on the surface of the equipment - Clean and treat appropriately

There is some tree debris on the surfacing - Remove and maintain

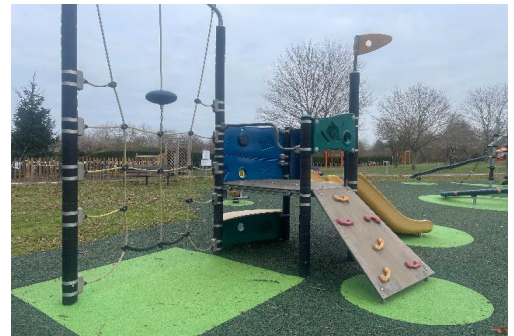
Item: Multi Play (Senior)
Manufacturer: Kompan Ltd
Surface Type: Grass Matrix Tiles
Item Quantity: 1
Equipment Compliance: N/A
Surface Area Compliance: N/A

The item is slightly loose in its foundations - Monitor for any further deterioration and repair as required

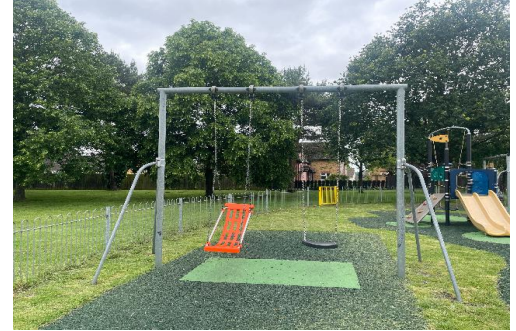
Item: 1 Bay 2 Seat (Flat)
Manufacturer: Kompan Ltd
Surface Type: Bonded Rubber Mulch
Item Quantity: 1
Equipment Compliance: No
Surface Area Compliance: Yes

There is some notable evidence of chain wear - Monitor for any further deterioration and replace when 40% worn

There is algae or moss on the surface of the equipment - Clean and treat appropriately

There is/are bolt cap covers missing or damaged on the item - Replace missing or damaged bolt cap covers

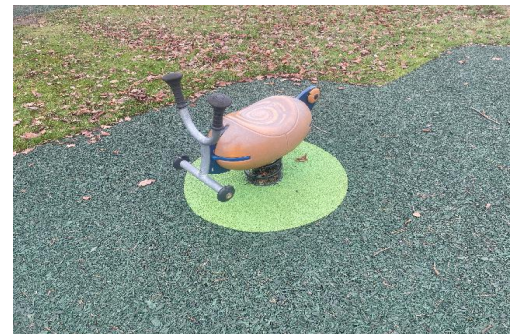
Item: Misc Springer
Manufacturer: Kompan Ltd
Surface Type: Grass Matrix Tiles
Item Quantity: 1
Equipment Compliance: N/A
Surface Area Compliance: N/A

The paintwork on the spring has been damaged or worn exposing the metal underneath which is rusting - Treat any rusting components and repaint

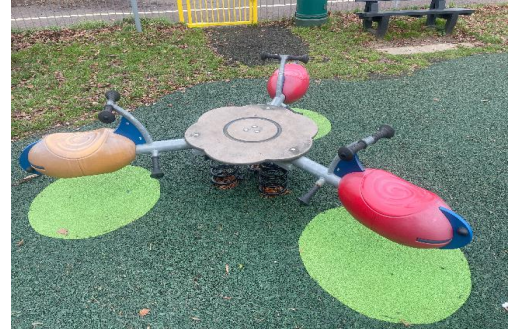
Item: Three Way Springer
Manufacturer: Kompan Ltd
Surface Type: Grass Matrix Tiles
Item Quantity: 1
Equipment Compliance: N/A
Surface Area Compliance: N/A

There is or are fixings missing on the item - Replace all missing fixings

The paintwork on the spring has been damaged or worn exposing the metal underneath which is rusting - Treat any rusting components and repaint

There is some evidence of fire damage to the item - Monitor for any further deterioration and repair as required

A number of Inaccessible fixing(s) have worked loose - Secure all loose fixings

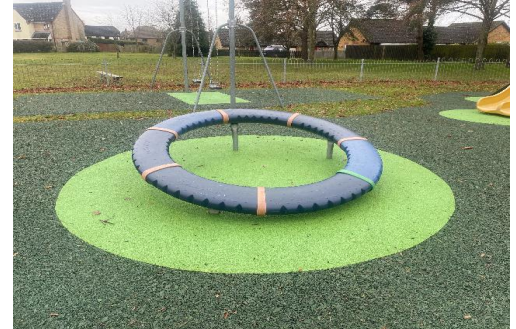
Item: Supernova
Manufacturer: Kompan Ltd
Surface Type: Grass Matrix Tiles
Item Quantity: 1
Equipment Compliance: N/A
Surface Area Compliance: N/A

Some segments have minor damage - Monitor

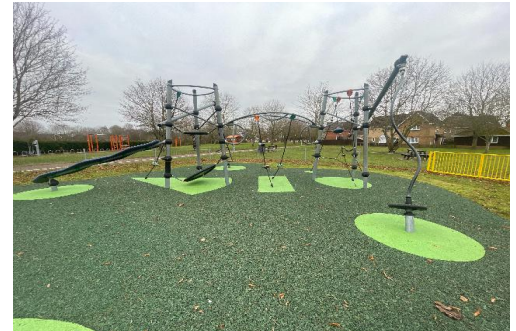
Item: Multi Play (Senior)
Manufacturer: Kompan Ltd
Surface Type: Grass Matrix Tiles
Item Quantity: 1
Equipment Compliance: N/A
Surface Area Compliance: N/A

There is/are bolt cap covers missing or damaged on the item - Replace missing or damaged bolt cap covers

The ropes/nets are worn/damaged in places - Monitor for any further deterioration and repair or replace as required

The item has been damaged - Monitor for any further deterioration and replace as required

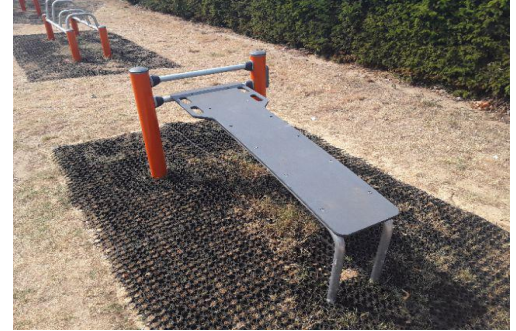
Item: Sit Up Station
Manufacturer: Kompan Ltd
Surface Type: Grass Matrix Tiles
Item Quantity: 1
Equipment Compliance: N/A
Surface Area Compliance: N/A

There is a significant amount of broken glass on site - Remove the glass and maintain the area

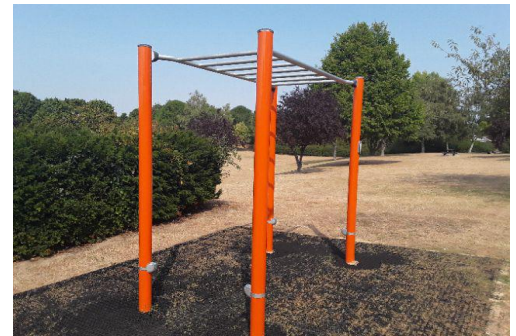
Item: Overhead Bars
Manufacturer: Kompan Ltd
Surface Type: Grass Matrix Tiles
Item Quantity: 1
Equipment Compliance: N/A
Surface Area Compliance: N/A

The surfacing around the item is damaged - Repair the damaged areas of surfacing

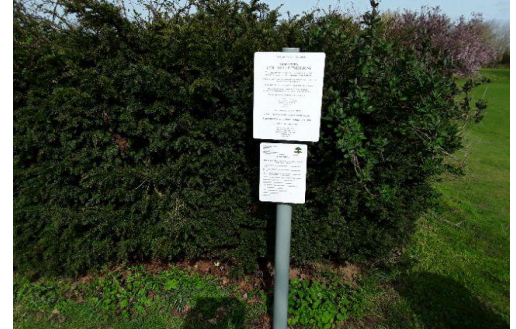
Item: Sign
Manufacturer: Unknown
Surface Type: Grass
Item Quantity: 1
Equipment Compliance: N/A
Surface Area Compliance: N/A

The item has been damaged - Monitor for any further deterioration and replace as required

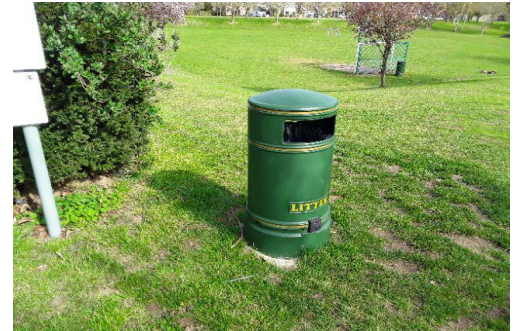
Item: Litter Bin
Manufacturer: Glasdon
Surface Type: Grass
Item Quantity: 1
Equipment Compliance: N/A
Surface Area Compliance: N/A

The item is loose in its foundations - Reinstall item to secure

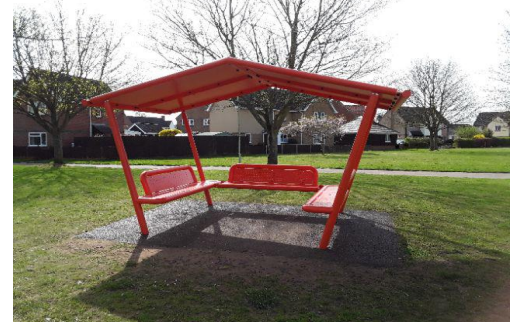
Item: Shelter
Manufacturer: Caloo
Surface Type: Wet Pour
Item Quantity: 1
Equipment Compliance: N/A
Surface Area Compliance: N/A

There is/are bolt cap covers missing or damaged on the item - Replace 9 missing or damaged bolt cap covers

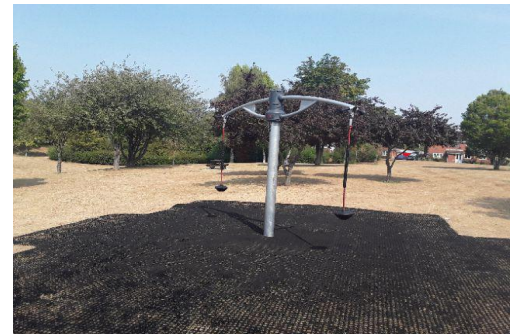
Item: Overhead Rotator
Manufacturer: Kompan Ltd
Surface Type: Grass Matrix Tiles
Item Quantity: 1
Equipment Compliance: N/A
Surface Area Compliance: N/A

The surfacing around the item is damaged - Repair the damaged areas of surfacing

There is/are bolt cap covers missing or damaged on the item - Replace missing or damaged bolt cap covers

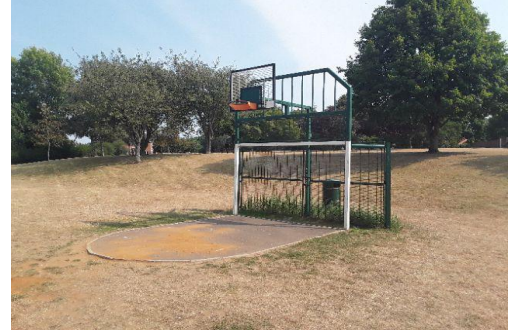
Item: Goal End
Manufacturer: Unknown
Surface Type: Tarmac
Item Quantity: 1
Equipment Compliance: N/A
Surface Area Compliance: N/A

There are trip hazards at the edges of the surface - Reinstate surrounding surface levels to remove the trip points

There is surface corrosion present on the item - Consider treating and repainting the item

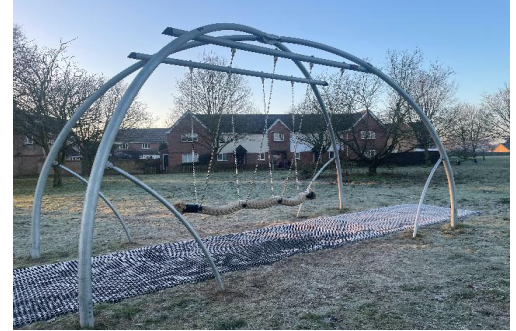
Item: Giant Rope Swing
Manufacturer: Kompan Ltd
Surface Type: Grass Matrix Tiles
Item Quantity: 1
Equipment Compliance: N/A
Surface Area Compliance: N/A

The surfacing around the item is damaged - Repair the damaged areas of surfacing

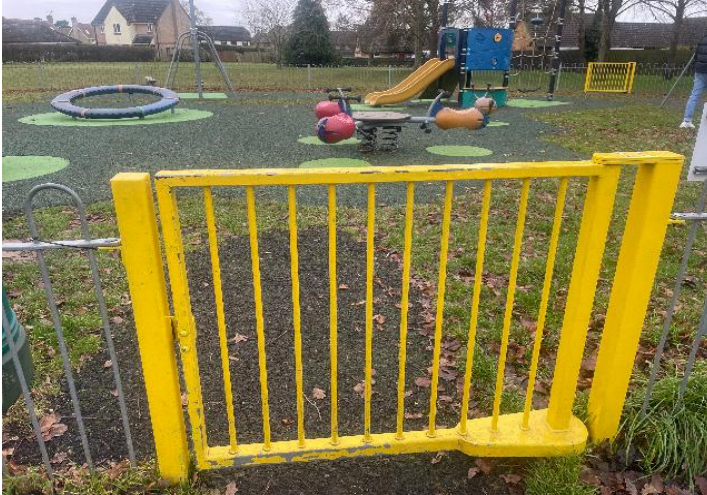
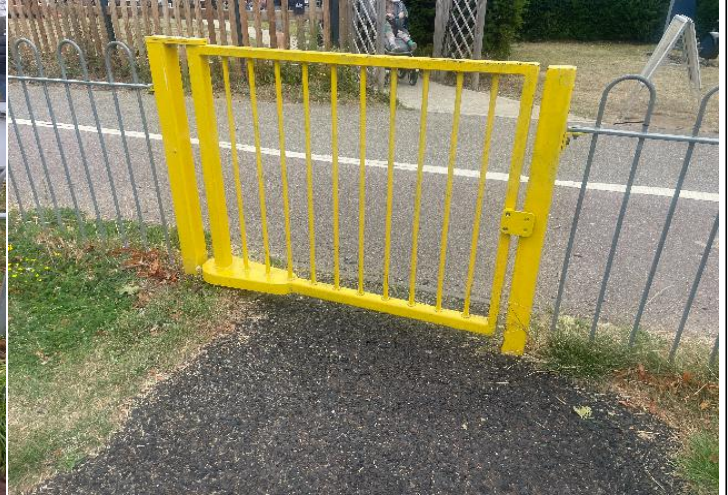
Item: Gates - Gate - Self Closing
Manufacturer: I.A.E. Fencing

Finding: The gate is closing too quickly (less than 4 seconds)

Action: Take corrective action to ensure that the gate closes in 4-8 seconds

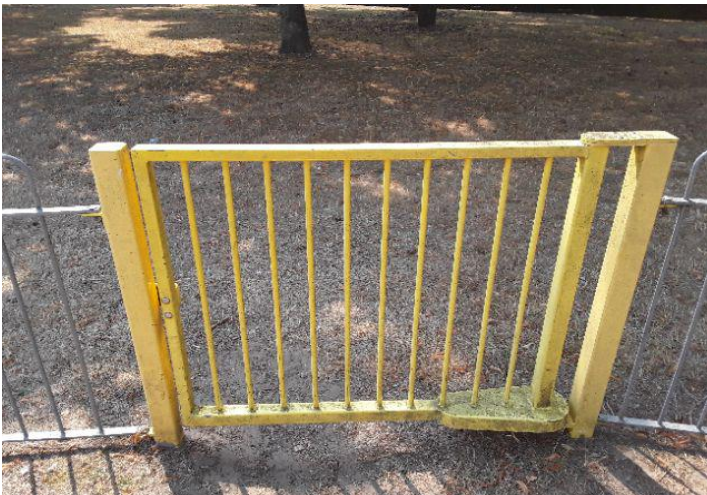
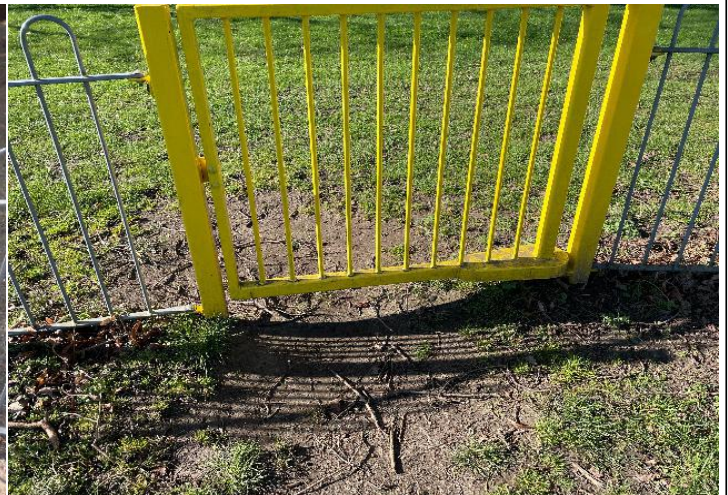
Item: Gates - Gate - Self Closing
Manufacturer: I.A.E. Fencing

Finding: The area around the item has eroded and may become slippery

Action: Reinstate eroded area

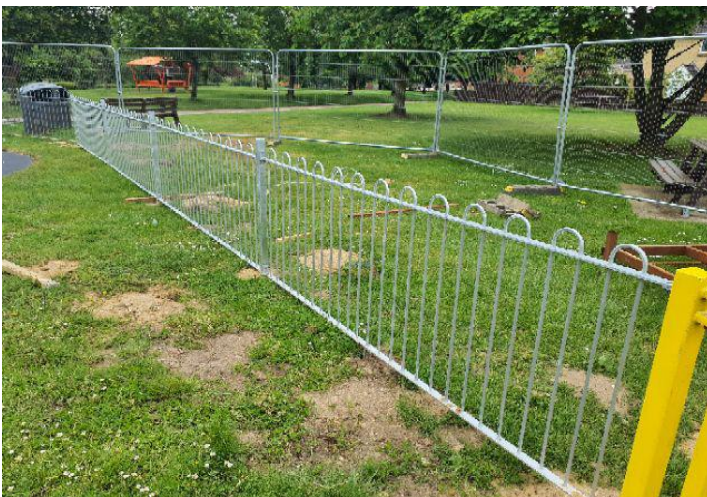
Item: Fences - Fence - Bow Top
Manufacturer: I.A.E. Fencing

Finding: The paintwork on this item has been damaged or worn exposing the metal underneath which is rusting

Action: Treat any rusting components and repaint

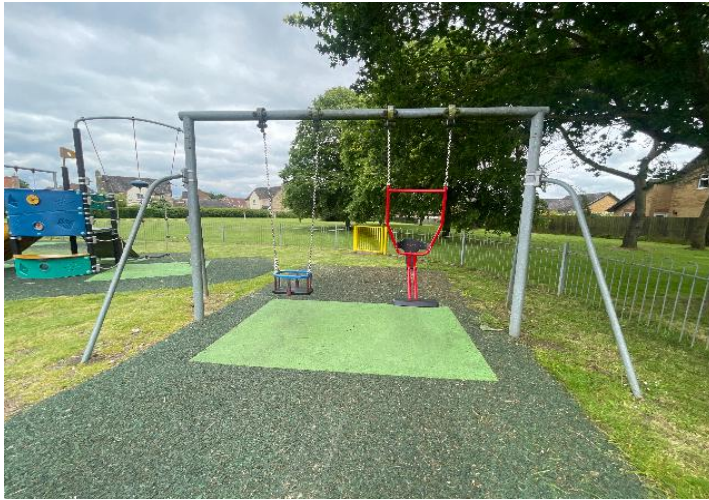
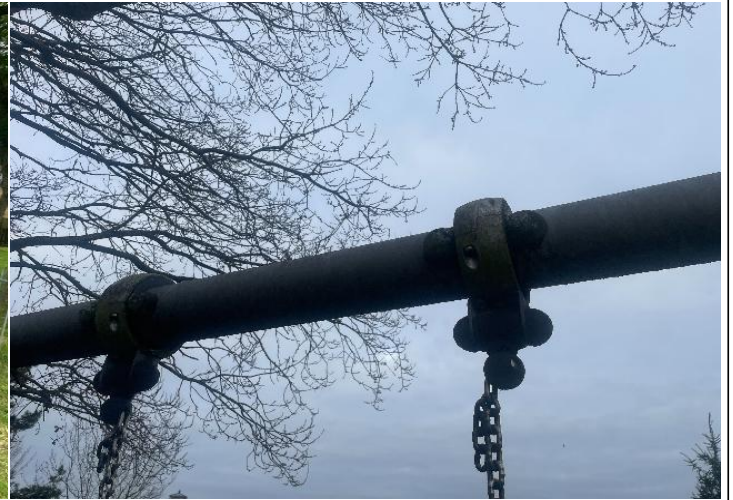
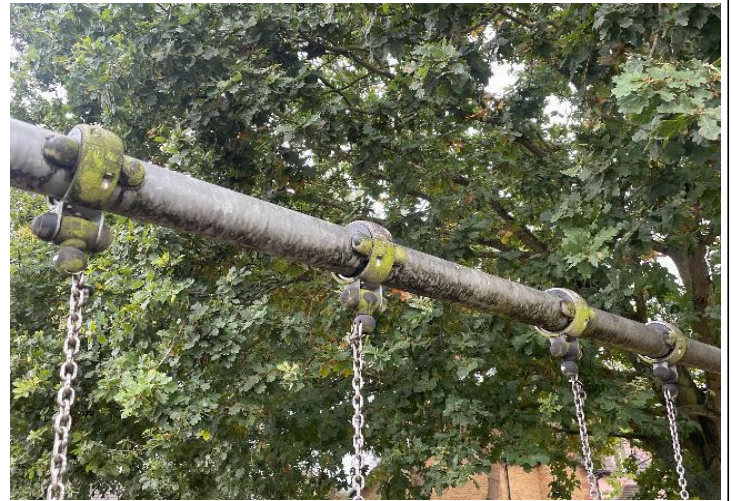
Item: Swings - 1 Bay 2 Seat (Cradle)
Manufacturer: Kompan Ltd

Finding: There is algae or moss on the surface of the equipment

Action: Clean and treat appropriately

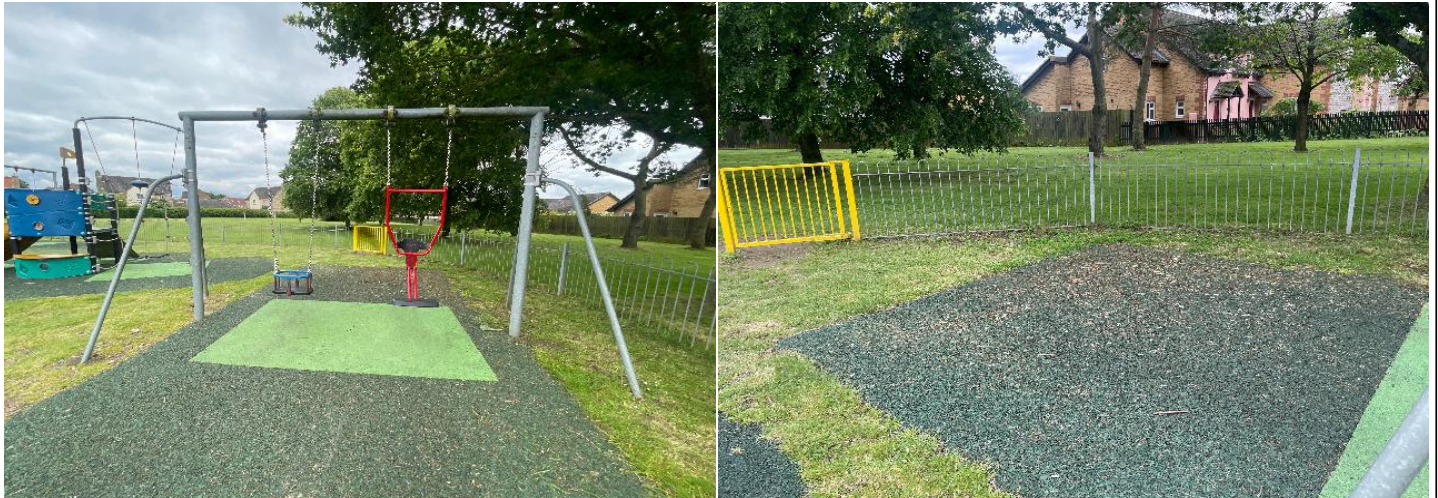
Item: Swings - 1 Bay 2 Seat (Cradle)
Manufacturer: Kompan Ltd

Finding: There is some tree debris on the surfacing

Action: Remove and maintain

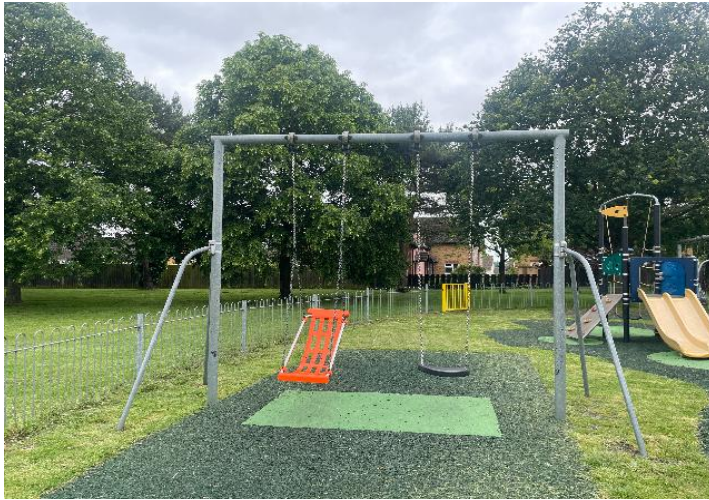
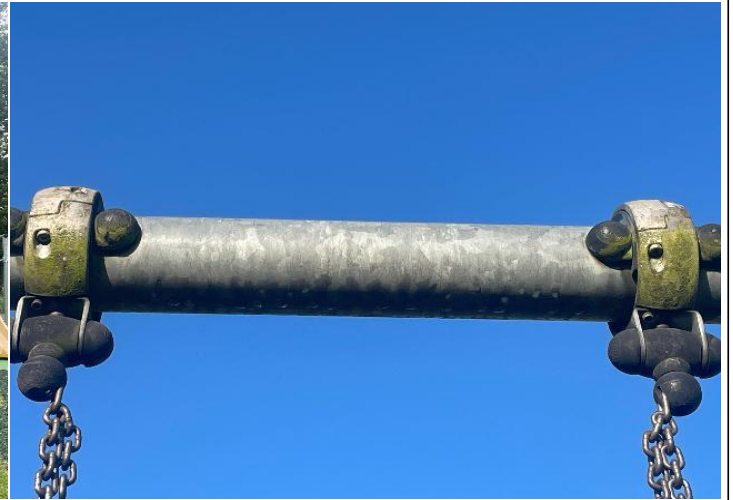
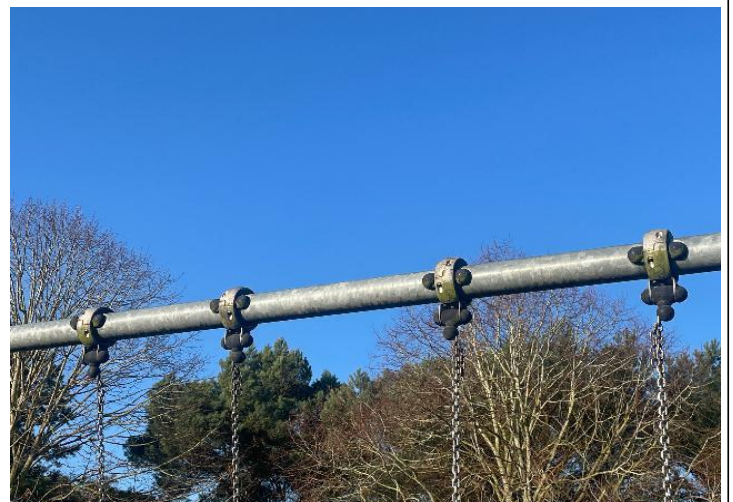
Item: Swings - 1 Bay 2 Seat (Flat)
Manufacturer: Kompan Ltd

Finding: There is algae or moss on the surface of the equipment

Action: Clean and treat appropriately

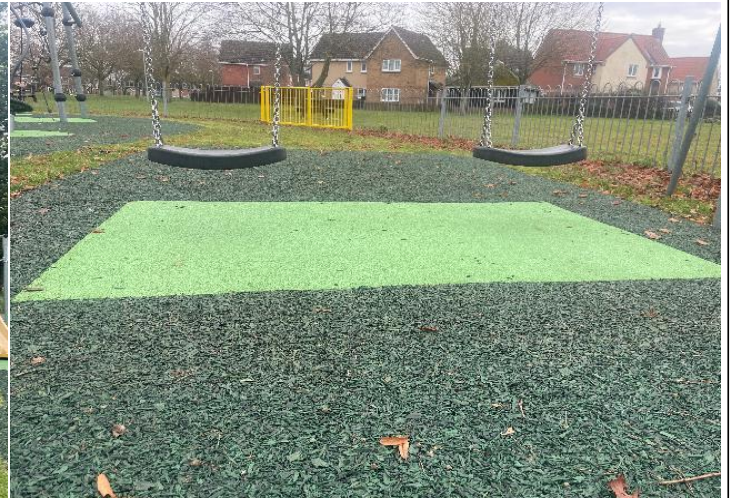
Item: Swings - 1 Bay 2 Seat (Flat)
Manufacturer: Kompan Ltd

Finding: Seat is low

Action: Adjust

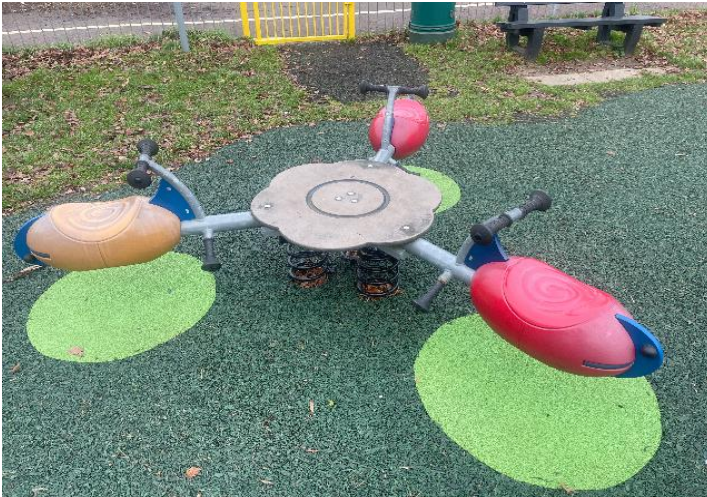
Item: Rocking Equipment - Three Way Springer
Manufacturer: Kompan Ltd

Finding: The paintwork on the spring has been damaged or worn exposing the metal underneath which is rusting

Action: Treat any rusting components and repaint

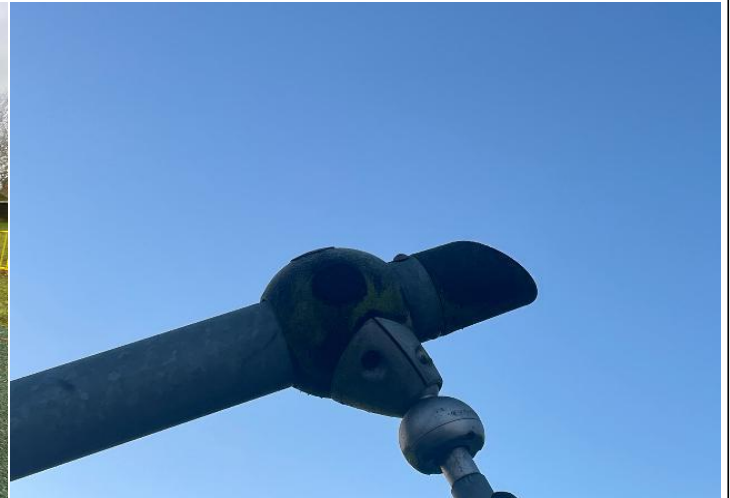
Item: Activity Equipment - Multi Play (Senior)
Manufacturer: Kompan Ltd

Finding: There is algae or moss on the surface of the equipment

Action: Clean and treat appropriately

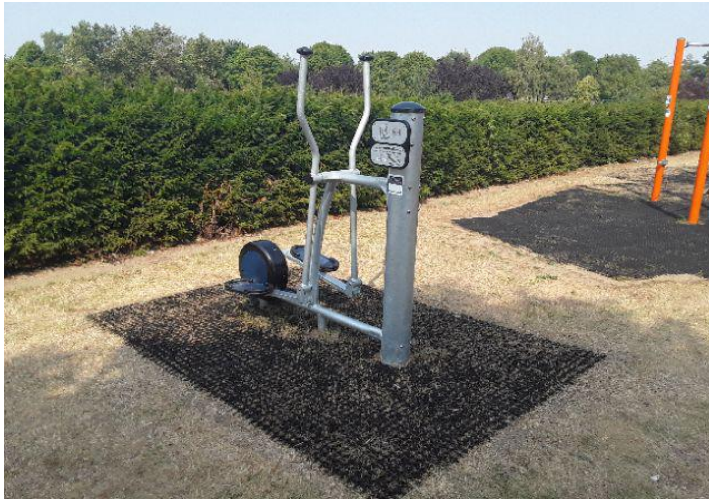
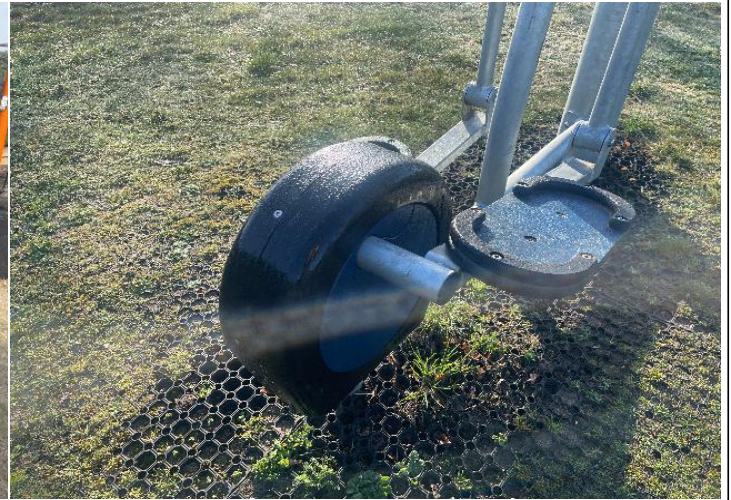
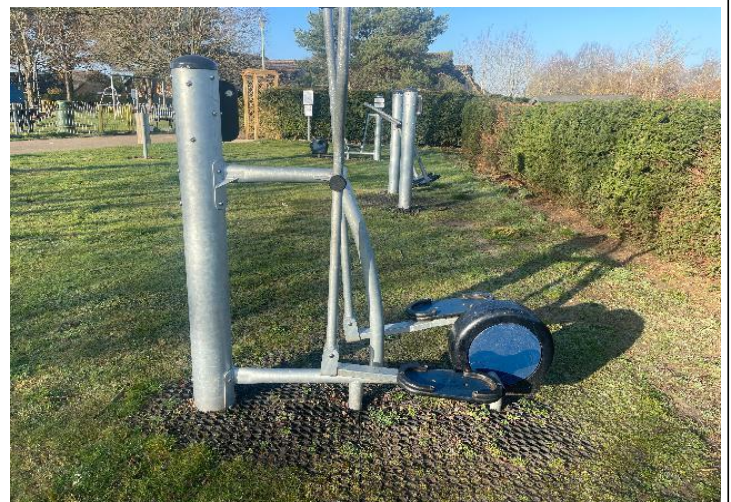
Item: Outdoor Fitness Equipment - Cross Trainer **Risk Level:** V - Very Low Risk
Manufacturer: Kompan Ltd **Surface:** Grass Matrix Tiles

Finding: Slight rubbing on plastic cover

Action: Monitor

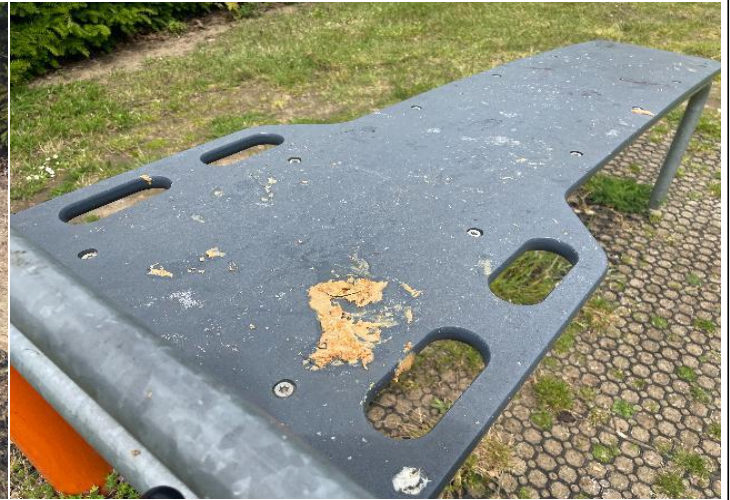
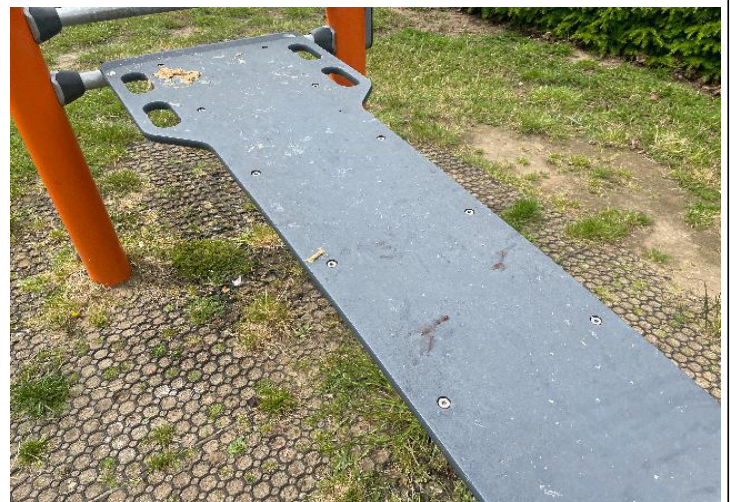
Item: Outdoor Fitness Equipment - Sit Up Station **Risk Level:** L - Low Risk
Manufacturer: Kompan Ltd **Surface:** Grass Matrix Tiles

Finding: Food wast on equipment

Action: Remove and clean

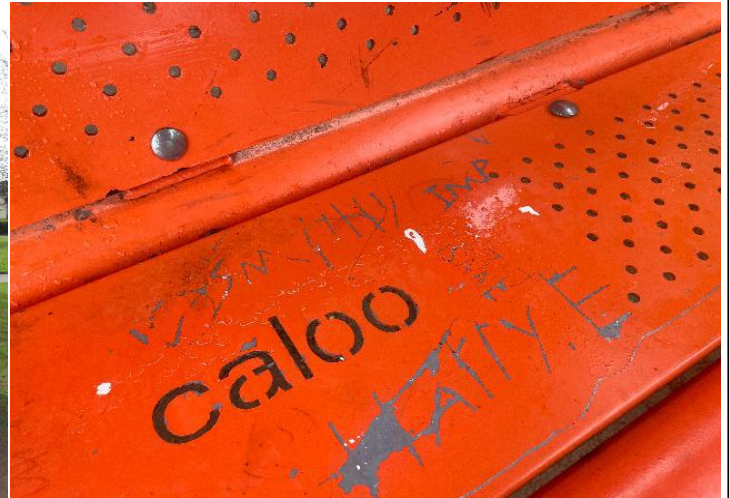
Item: Ancillary Items - Shelter
Manufacturer: Caloo

Finding: There is some graffiti present

Action: Remove the graffiti

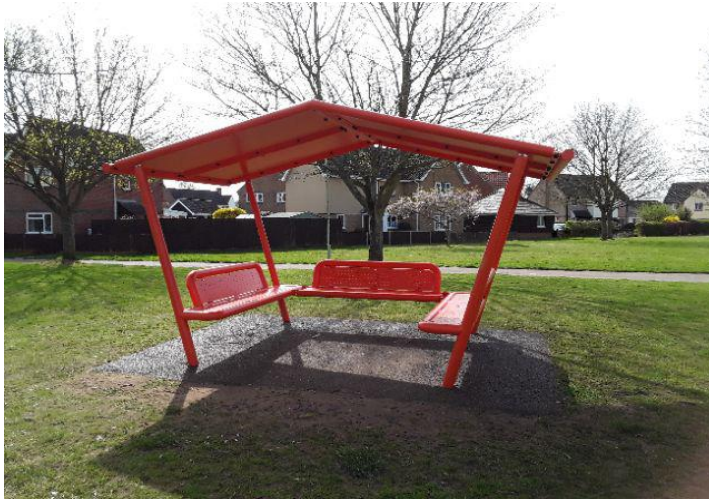
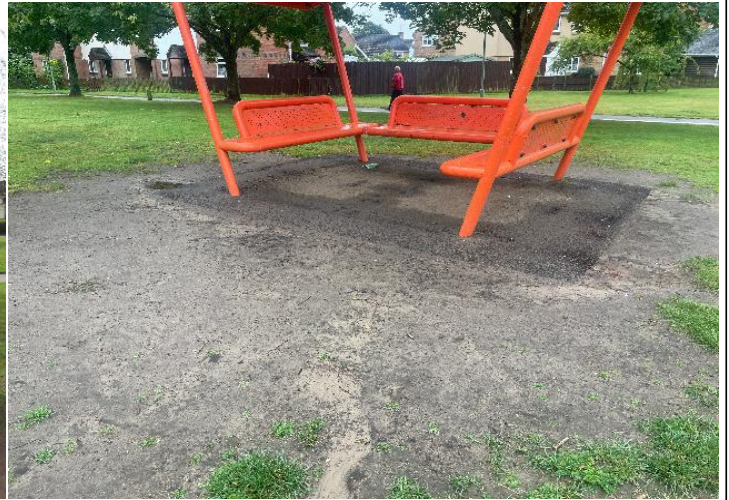
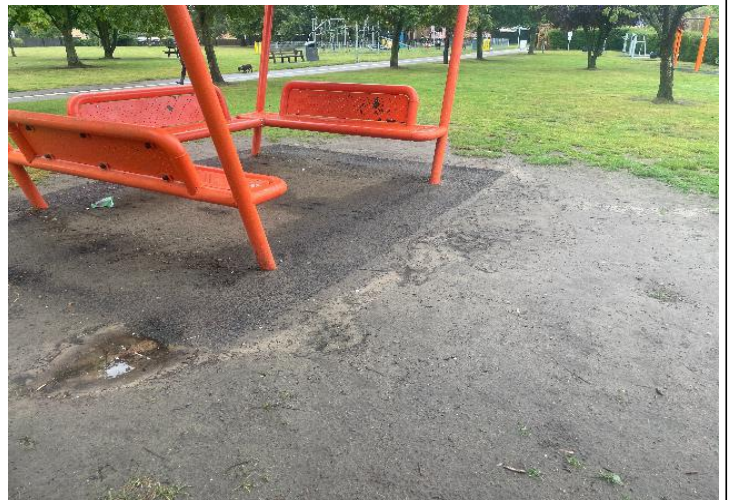
Item: Ancillary Items - Shelter
Manufacturer: Caloo

Finding: The surface has eroded in some areas

Action: Reinststate the surface

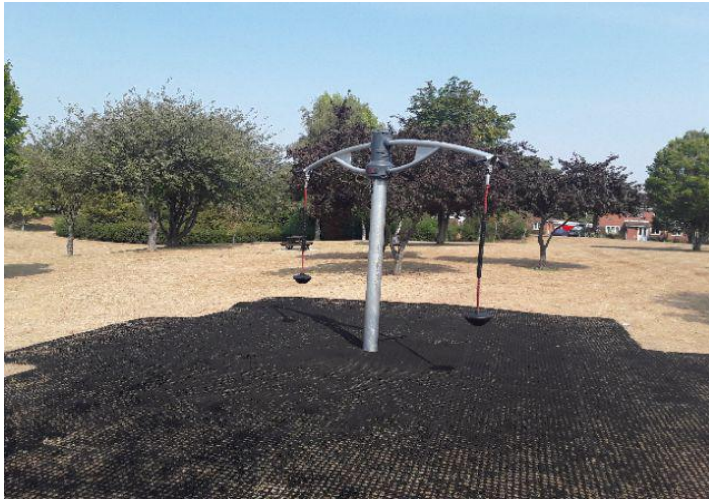
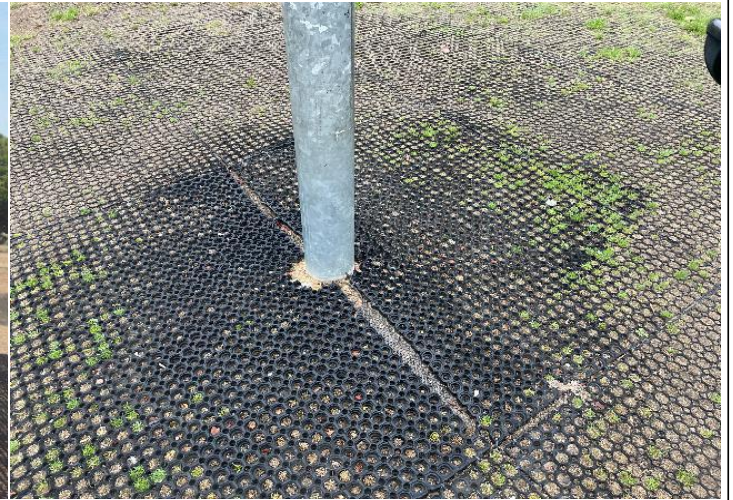
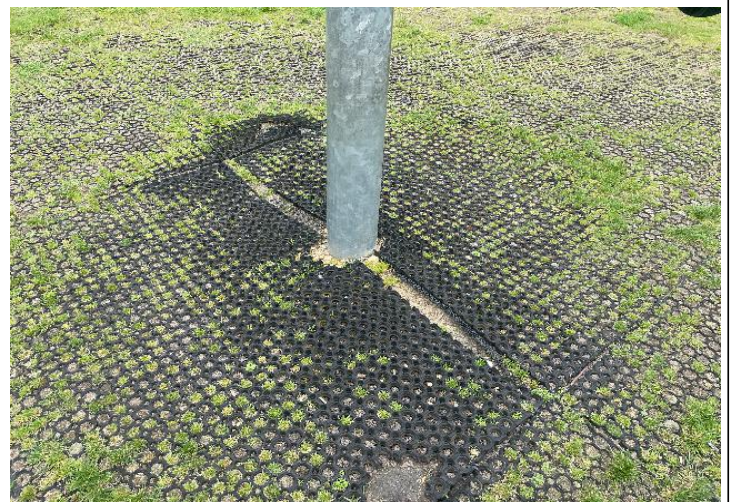
Item: Activity Equipment - Overhead Rotator
Manufacturer: Kompan Ltd

Finding: There are gaps opening between the grass mat tiles

Action: Reinststate surface

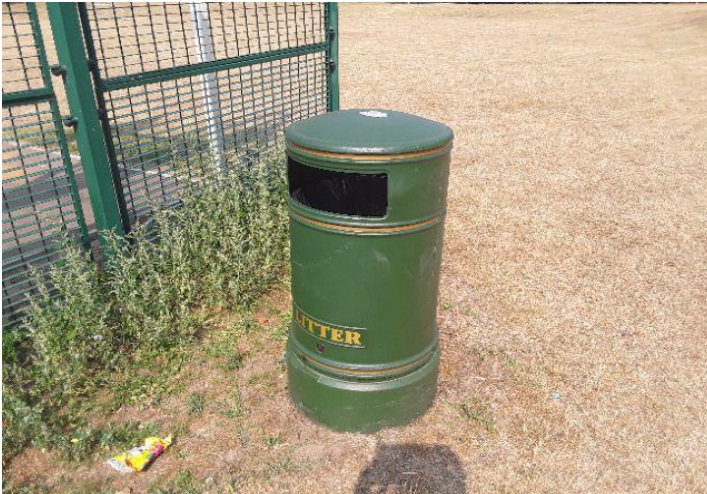
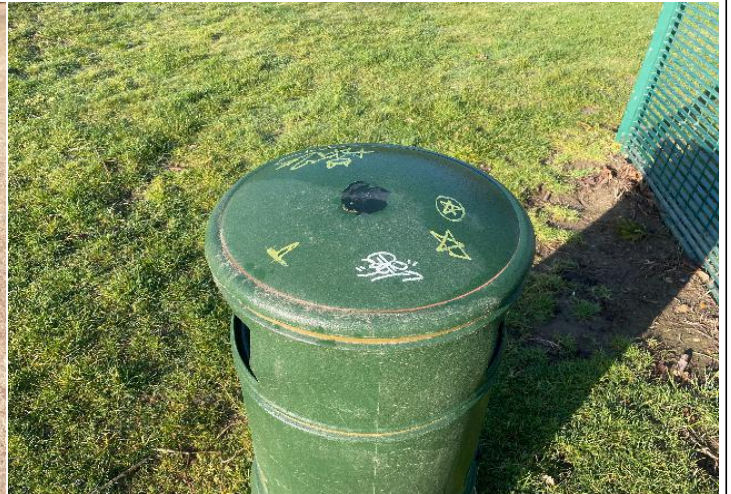
Item: Ancillary Items - Litter Bin
Manufacturer: Unknown

Finding: There is some graffiti present

Action: Remove the graffiti
