Operational Inspection

Thurston Parish Council

New Green Centre
New Green Ave, Thurston, IP31 3TG

Operational Inspection - 6-December-2024 - 08:59 Inspector Dan Carr

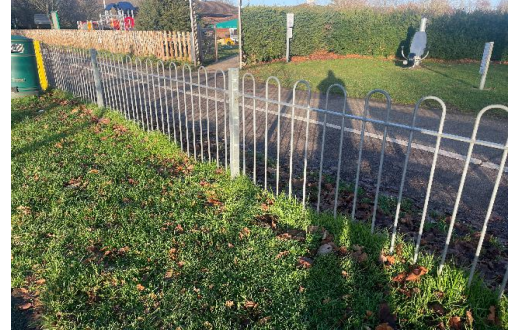
The paintwork on this item has been damaged or worn exposing the metal underneath which is rusting - Treat any rusting components and repaint

There are 2 loose posts around the fence - Monitor for any further deterioration and reset as required

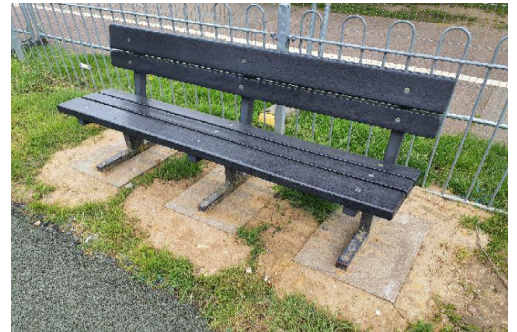
The paintwork on this item has been damaged or worn exposing the metal underneath which is rusting - Treat any rusting components and repaint

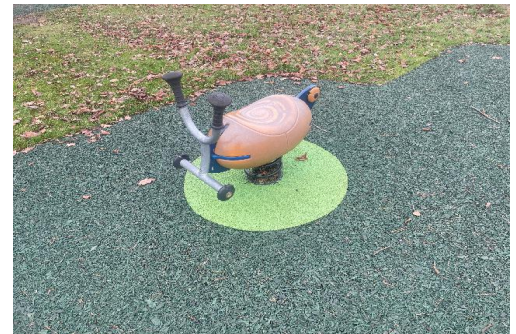
The paintwork on the spring has been damaged or worn exposing the metal underneath which is rusting - Treat any rusting components and repaint

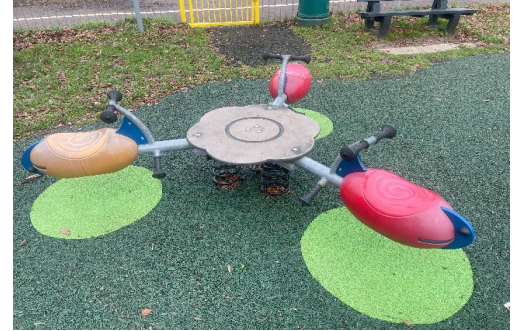
The paintwork on the spring has been damaged or worn exposing the metal underneath which is rusting - Treat any rusting components and repaint

There is some evidence of fire damage to the item - Monitor for any further deterioration and repair as required

A number of Inaccessiblefixing(s) have worked loose - Secure all loose fixings

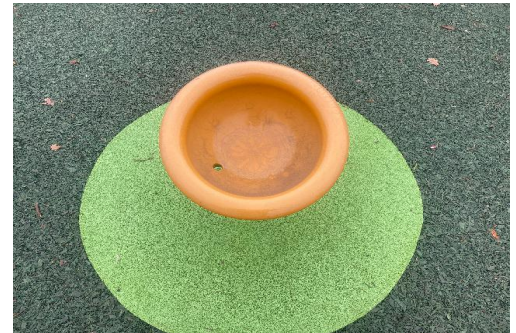
The item has been damaged - Monitor for any further deterioration and replace as required

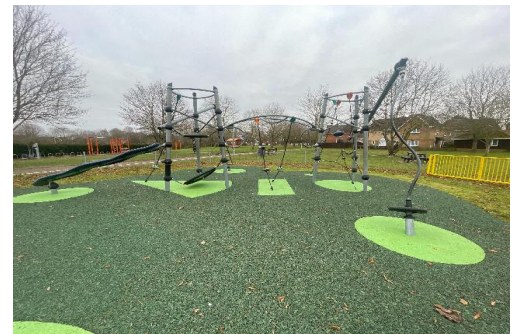
There is/are bolt cap covers missing or damaged on the item - Replace missing or damaged bolt cap covers

There is algae or moss on the surface of the equipment - Clean and treat appropriately

The ropes/nets are worn/damaged in places - Monitor for any further deterioration and repair or replace as required

The item has been damaged - Monitor for any further deterioration and replace as required

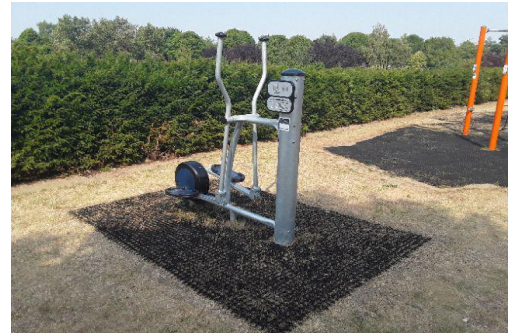
Slight rubbing on plastic cover - Monitor

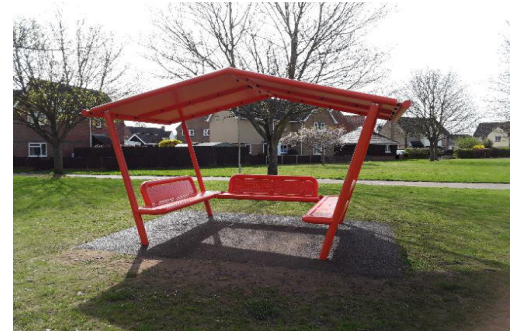
There is/are bolt cap covers missing or damaged on the item - Replace 9 missing or damaged bolt cap covers

There is some graffiti present - Remove the graffiti

The surface has eroded in some areas - Reinstate the surface

The paint is flaking off the metalwork - Rub down and re-paint

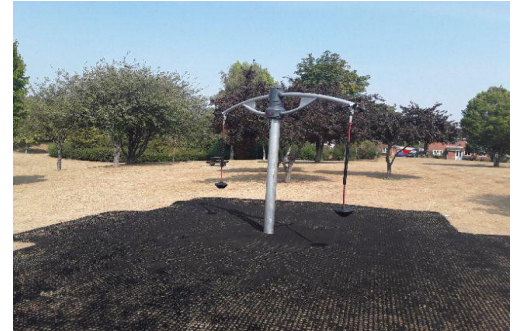
There are gaps opening between the grass mat tiles -
Reinstate surface

There is/are bolt cap covers missing or damaged on the
item - Replace missing or damaged bolt cap covers

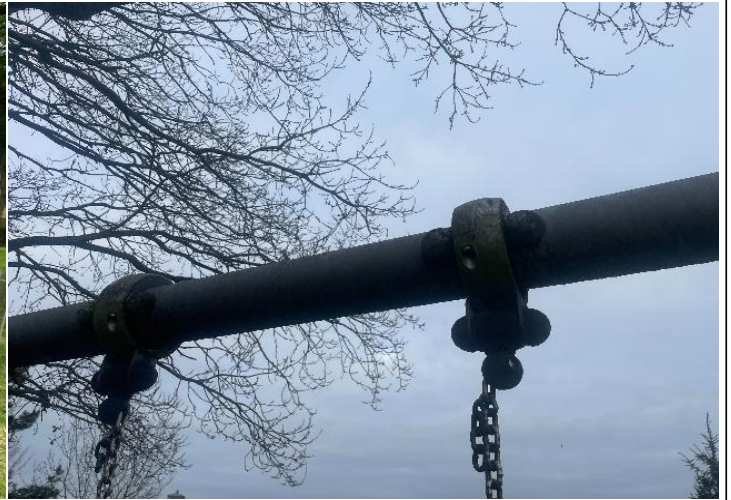
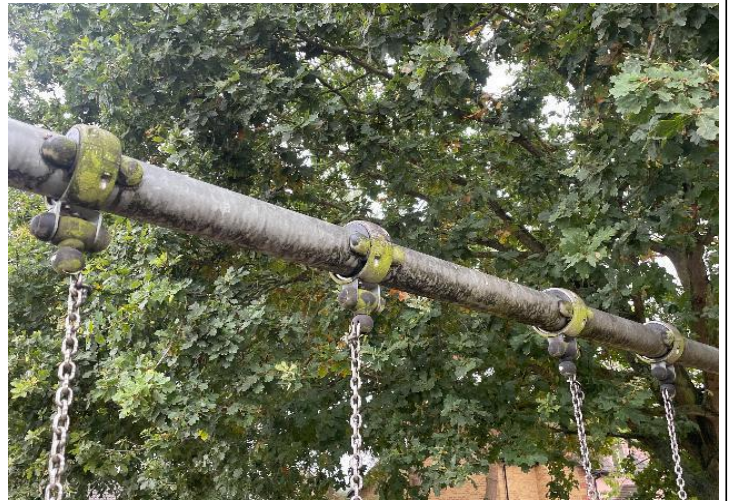
Item: Swings - 1 Bay 2 Seat (Cradle)
Manufacturer: Kompan Ltd

Finding: There is algae or moss on the surface of the equipment

Action: Clean and treat appropriately

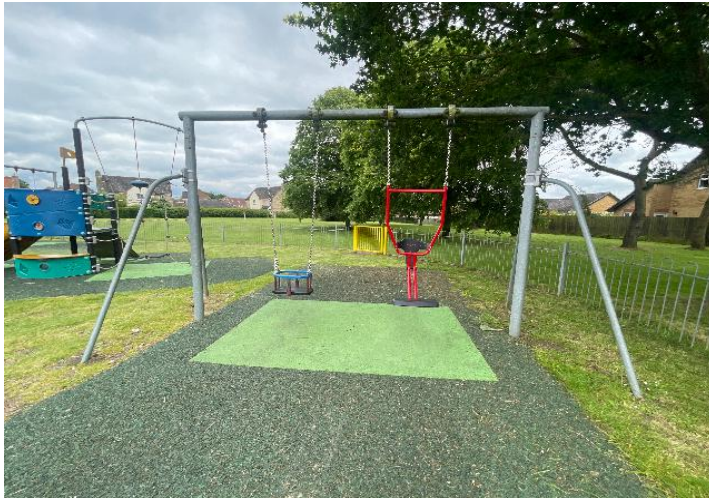
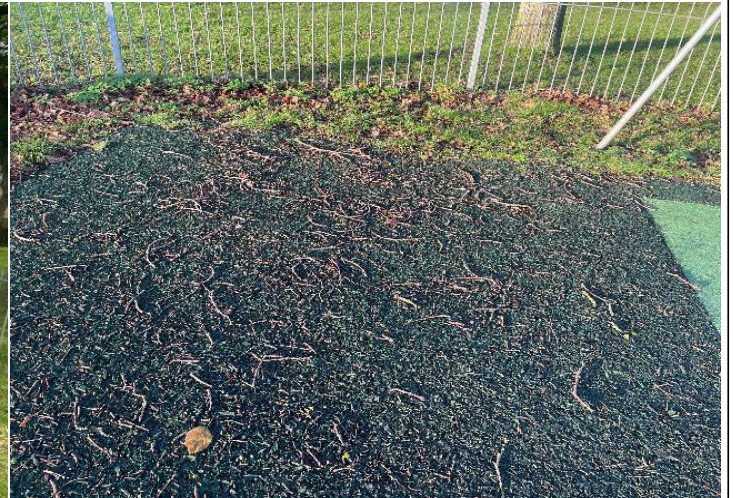
Item: Swings - 1 Bay 2 Seat (Cradle)
Manufacturer: Kompan Ltd

Finding: There is some tree debris on the surfacing

Action: Remove and maintain

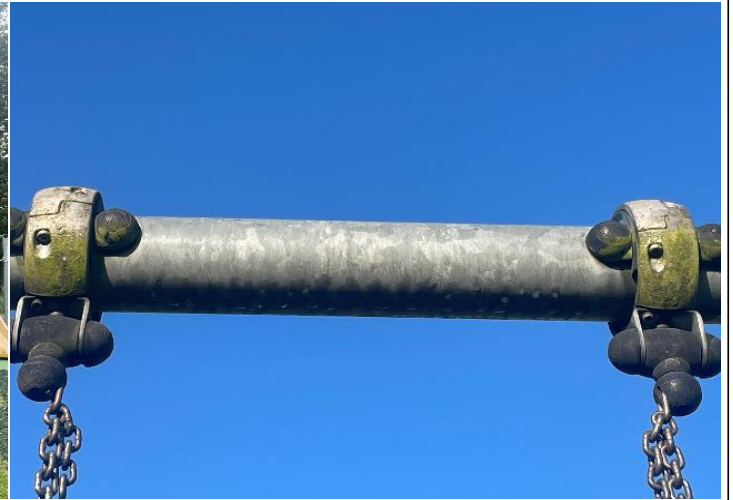
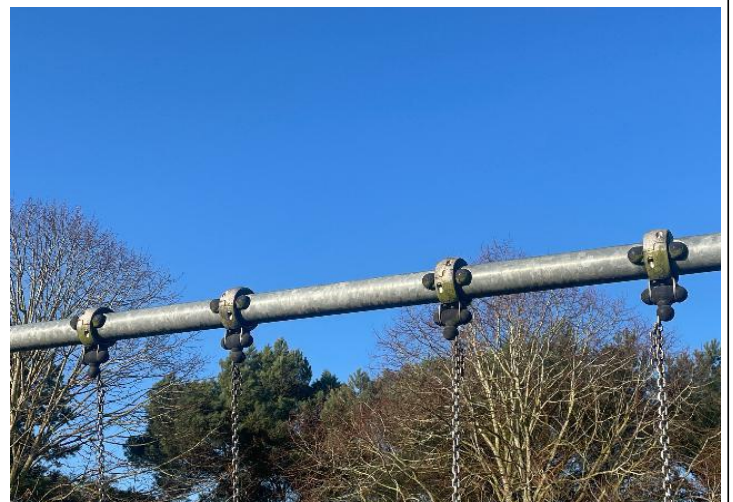
Item: Swings - 1 Bay 2 Seat (Flat)
Manufacturer: Kompan Ltd

Finding: There is algae or moss on the surface of the equipment

Action: Clean and treat appropriately

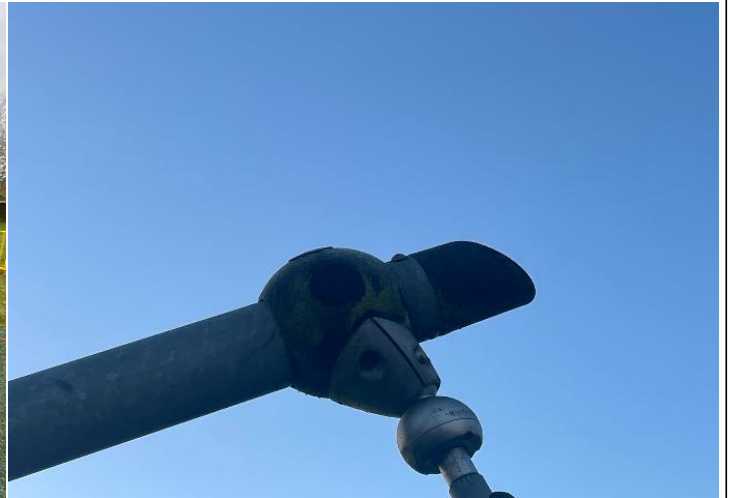
Item: Activity Equipment - Multi Play (Senior)
Manufacturer: Kompan Ltd

Finding: There is algae or moss on the surface of the equipment

Action: Clean and treat appropriately

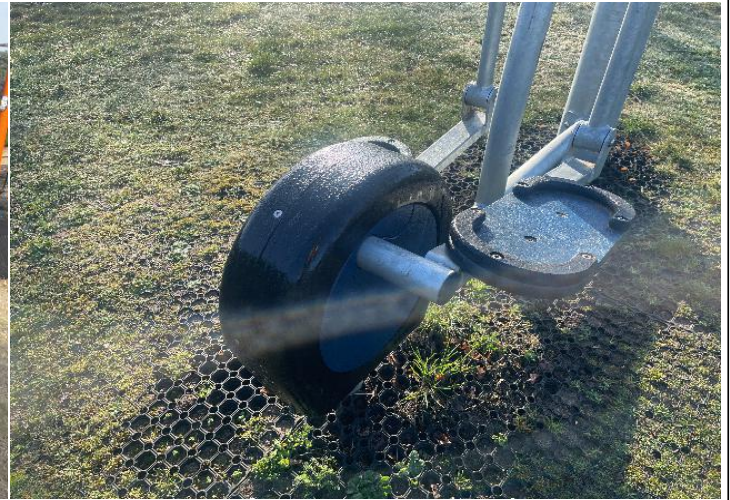
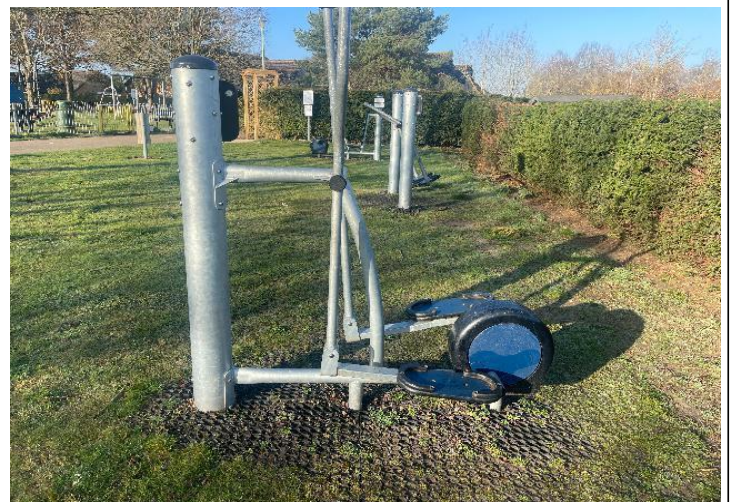
Item: Outdoor Fitness Equipment - Cross Trainer **Risk Level:** V - Very Low Risk
Manufacturer: Kompan Ltd **Surface:** Grass Matrix Tiles

Finding: Slight rubbing on plastic cover

Action: Monitor

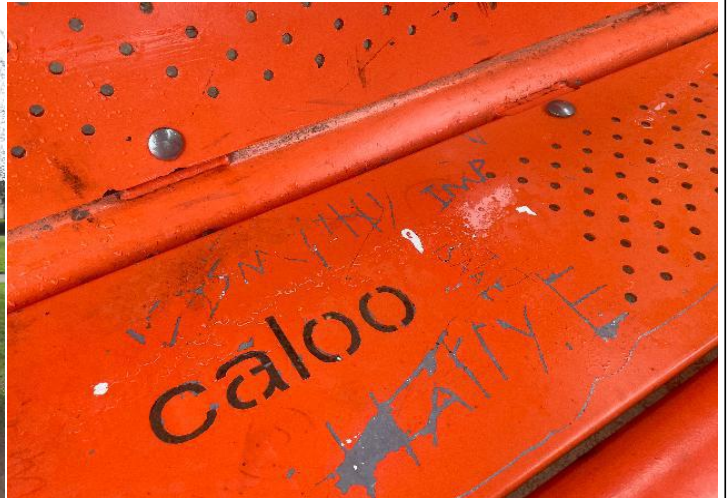
Item: Ancillary Items - Shelter
Manufacturer: Caloo

Finding: There is some graffiti present

Action: Remove the graffiti

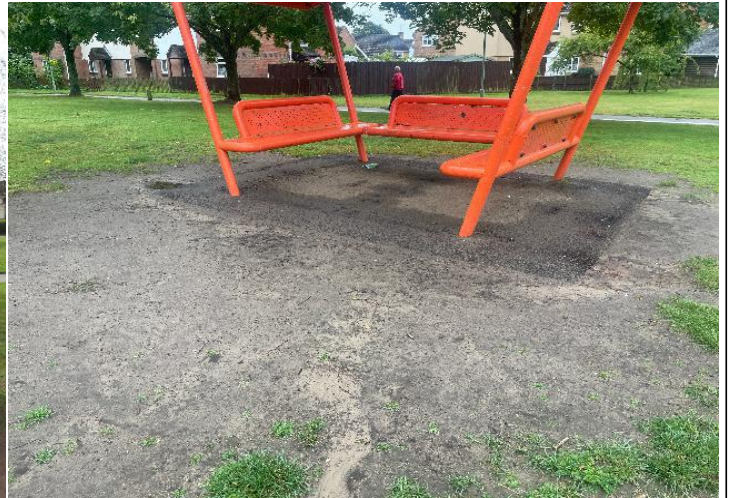
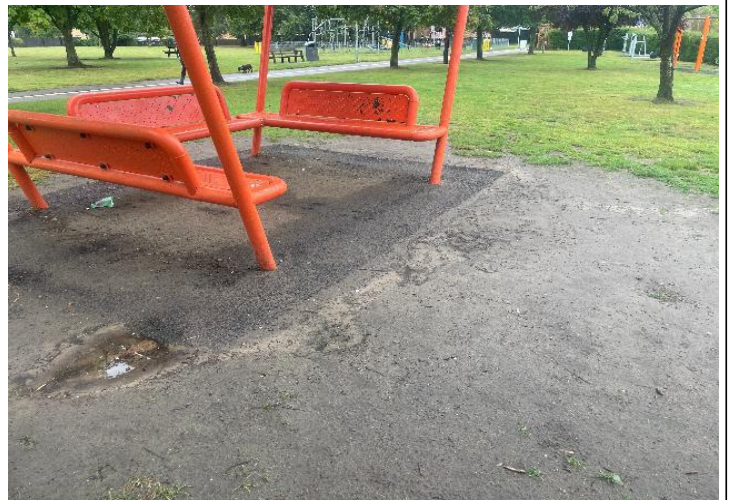
Item: Ancillary Items - Shelter
Manufacturer: Caloo

Finding: The surface has eroded in some areas

Action: Reinststate the surface

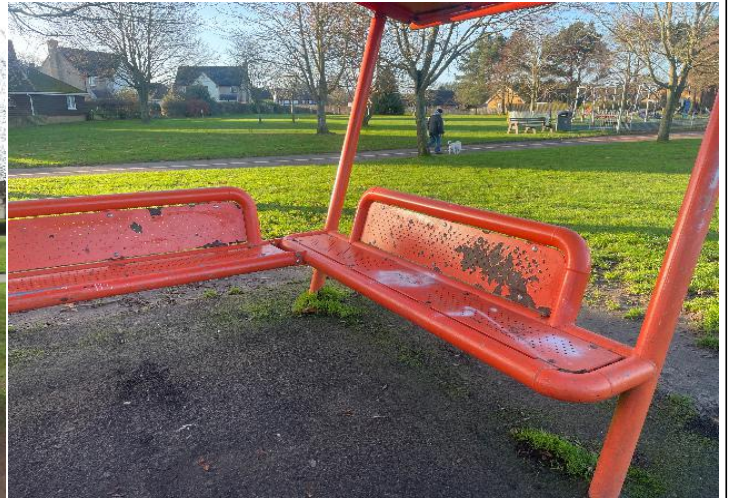
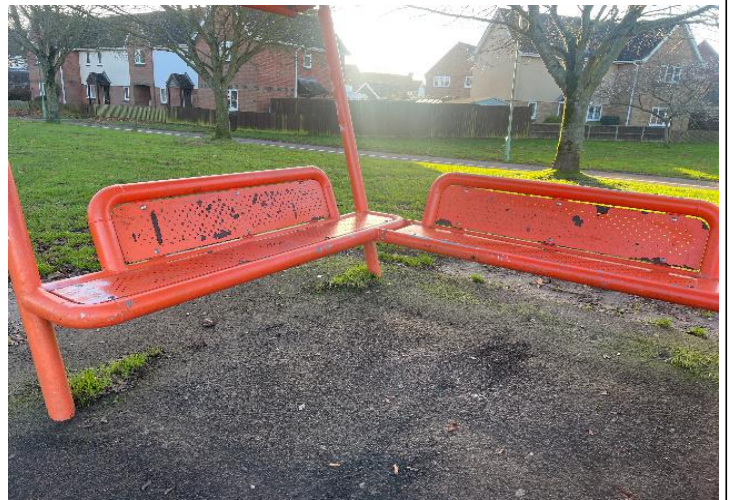
Item: Ancillary Items - Shelter
Manufacturer: Caloo

Finding: The paint is flaking off the metalwork

Action: Rub down and re-paint

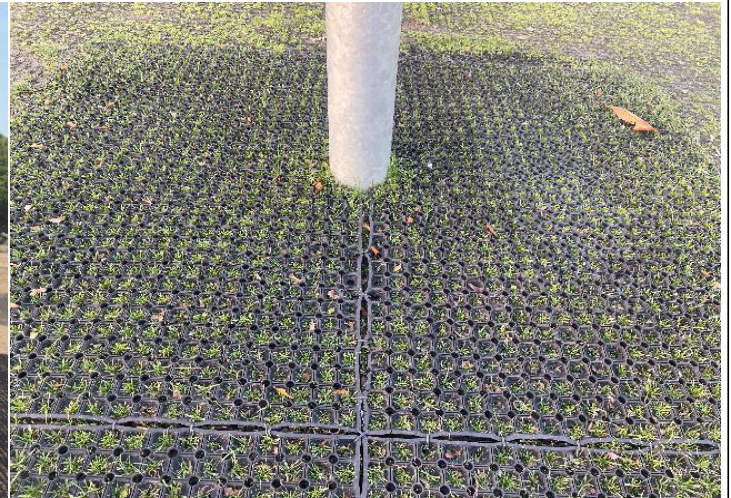
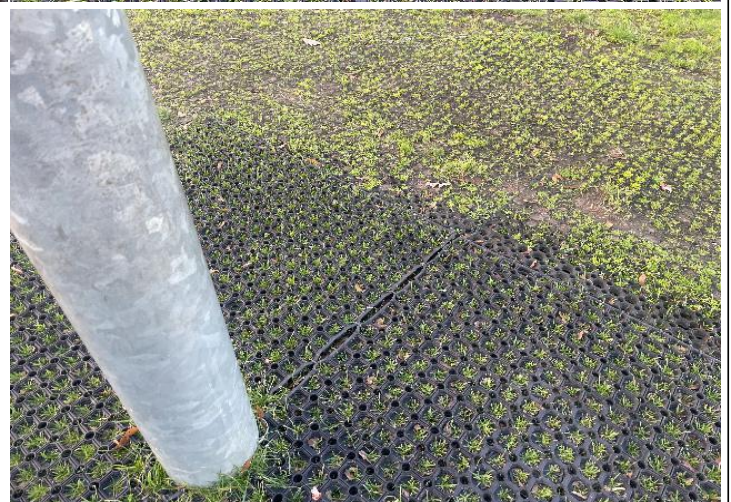
Item: Activity Equipment - Overhead Rotator
Manufacturer: Kompan Ltd

Finding: There are gaps opening between the grass mat tiles

Action: Reinststate surface

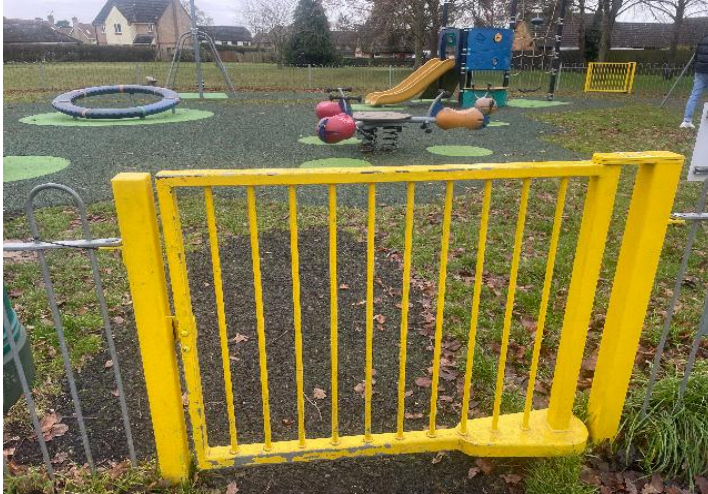
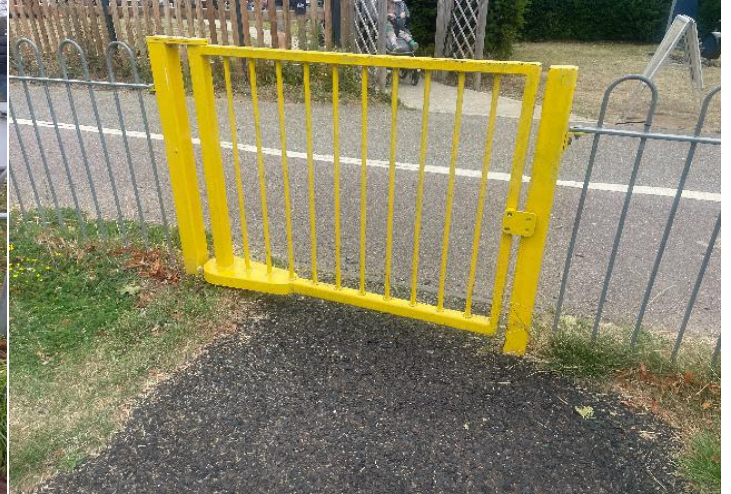
Item: Gates - Gate - Self Closing
Manufacturer: I.A.E. Fencing

Finding: The gate is closing too quickly (less than 4 seconds)

Action: Take corrective action to ensure that the gate closes in 4-8 seconds

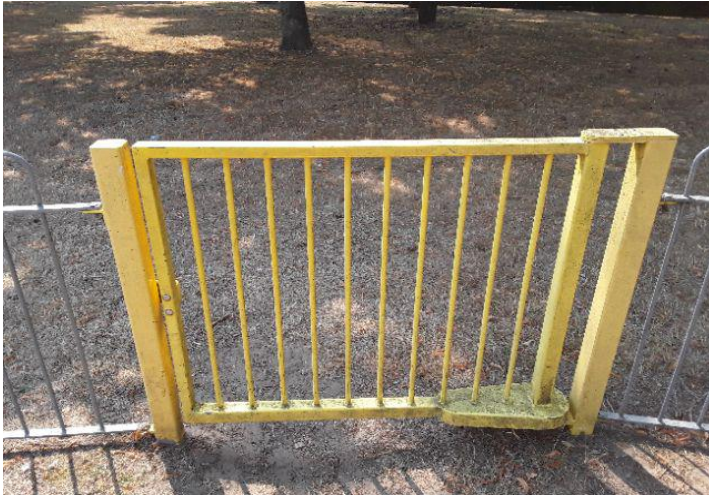
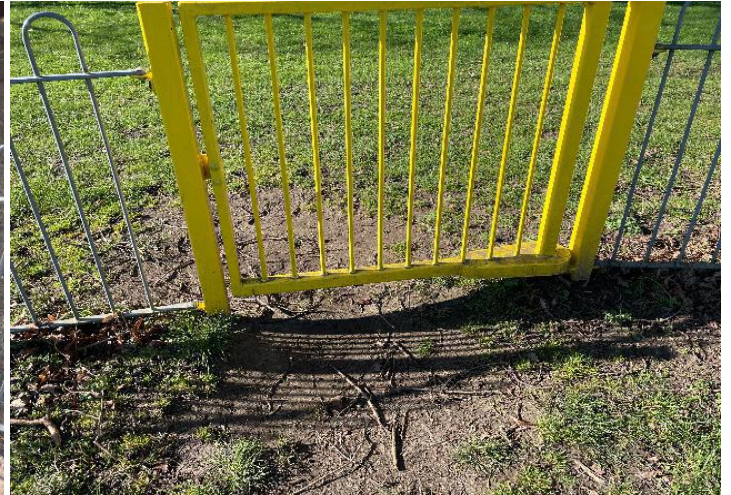
Item: Gates - Gate - Self Closing
Manufacturer: I.A.E. Fencing

Finding: The area around the item has eroded and may become slippery

Action: Reinststate eroded area

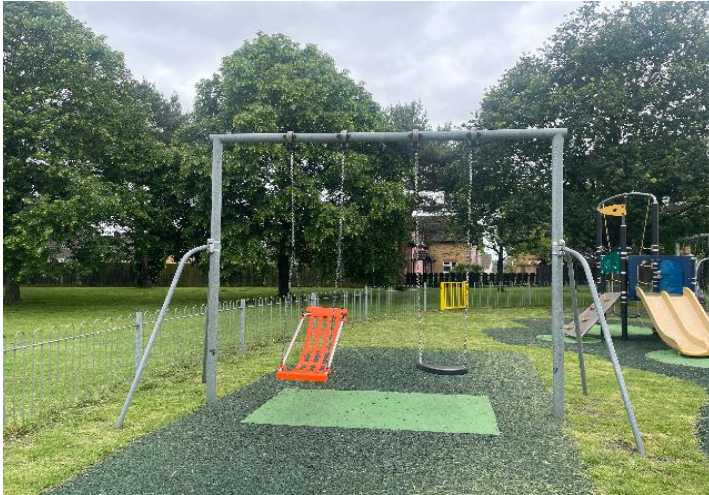
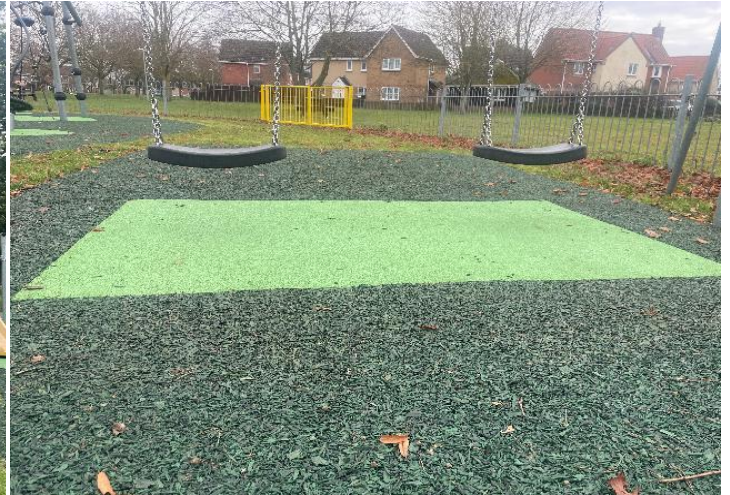
Item: Swings - 1 Bay 2 Seat (Flat)
Manufacturer: Kompan Ltd

Finding: Seat is low

Action: Adjust

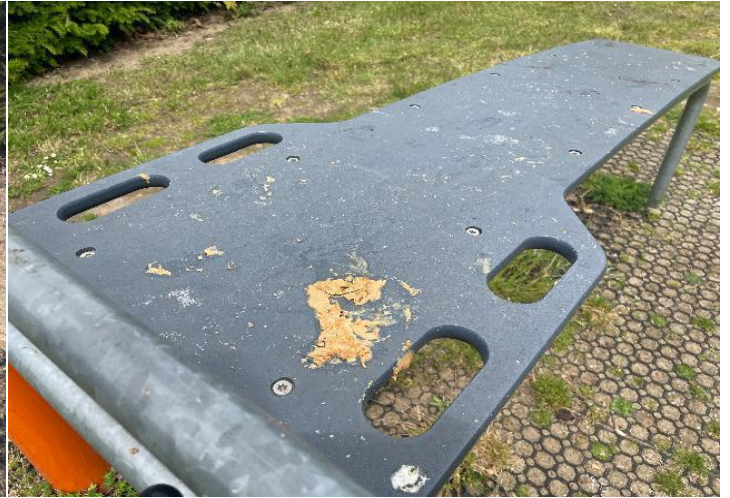
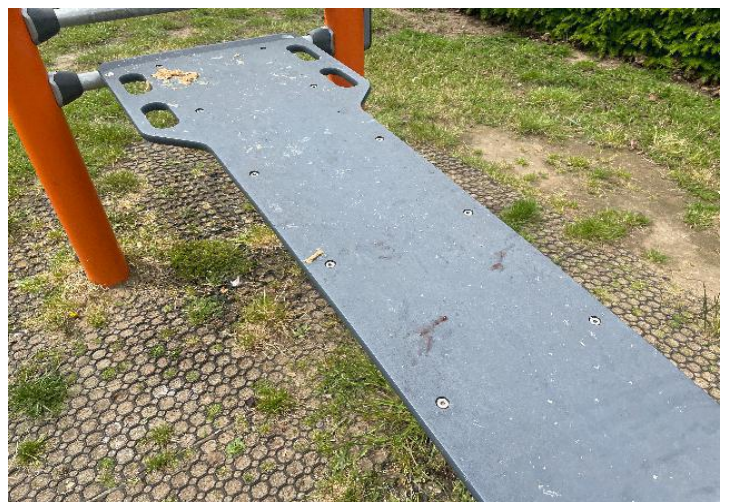
Item: Outdoor Fitness Equipment - Sit Up Station **Risk Level:** L - Low Risk
Manufacturer: Kompan Ltd **Surface:** Grass Matrix Tiles

Finding: Food waste on equipment

Action: Remove and clean

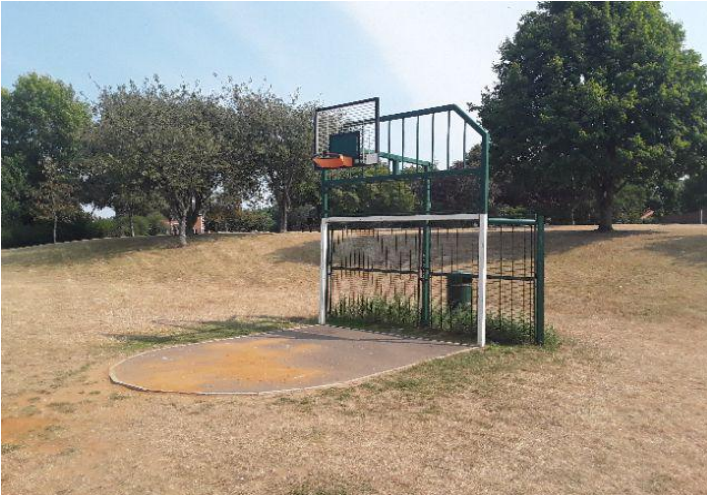
Item: Multi Use Games Area - Goal End
Manufacturer: Unknown

Finding: There is surface corrosion present on the item

Action: Consider treating and repainting the item

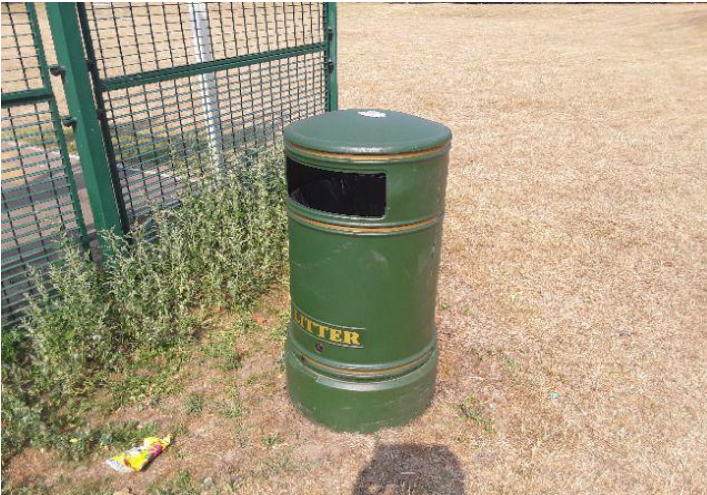
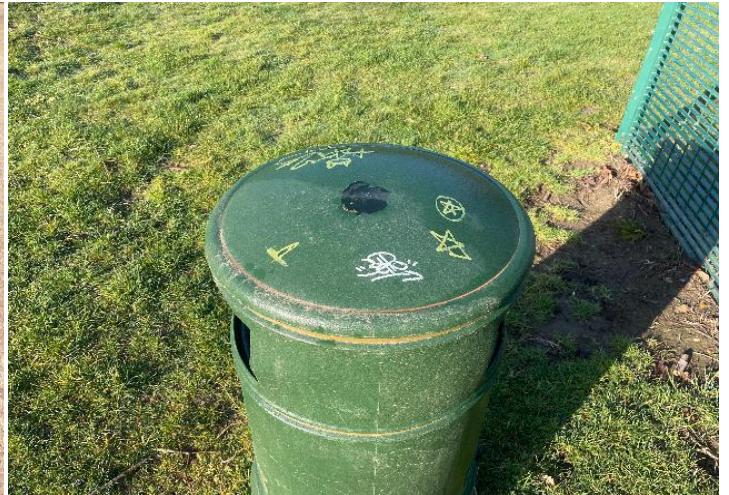
Item: Ancillary Items - Litter Bin
Manufacturer: Unknown

Finding: There is some graffiti present

Action: Remove the graffiti

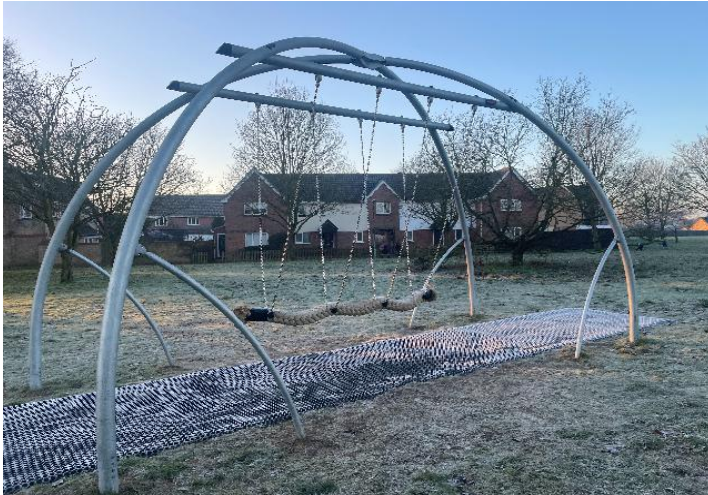
Item: Swings - Giant Rope Swing
Manufacturer: Kompan Ltd

Finding: The surfacing around the item is damaged

Action: Repair the damaged areas of surfacing
