## Operational Inspection

Thurston Parish Council

New Green Centre  
New Green Ave, Thurston, IP31 3TG

Operational Inspection - 3-June-2024 - 12:53 Inspector Dan Carr

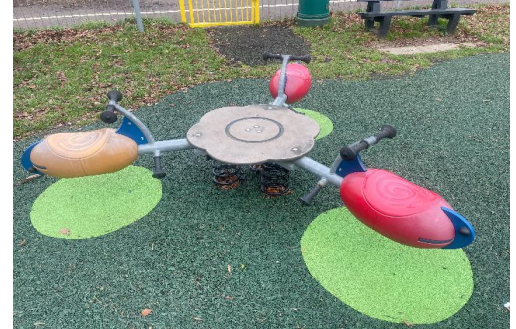
There is or are fixings missing on the item - Replace all missing fixings

The paintwork on the spring has been damaged or worn exposing the metal underneath which is rusting - Treat any rusting components and repaint

There is some evidence of fire damage to the item - Monitor for any further deterioration and repair as required

A number of Inaccessible fixing(s) have worked loose - Secure all loose fixings

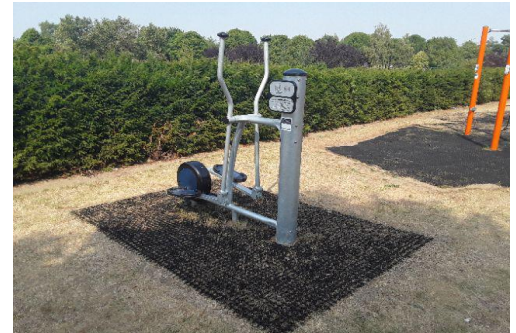
Slight rubbing on plastic cover - Monitor

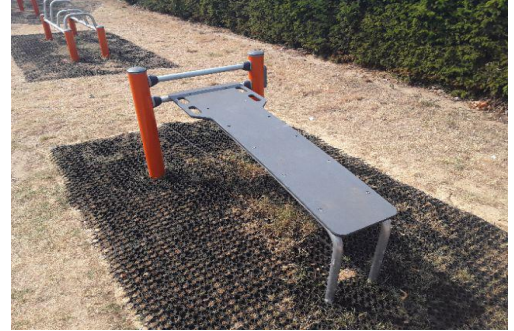
There is a significant amount of broken glass on site - Remove the glass and maintain the area

Food wast on equipment - Remove and clean

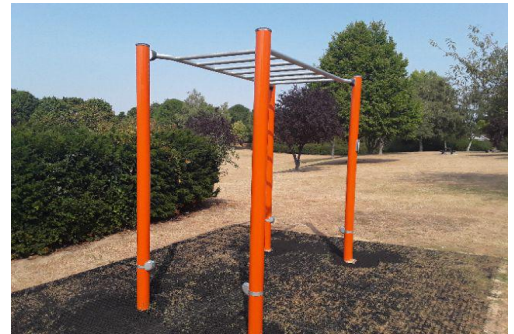
The surfacing around the item is damaged - Repair the damaged areas of surfacing

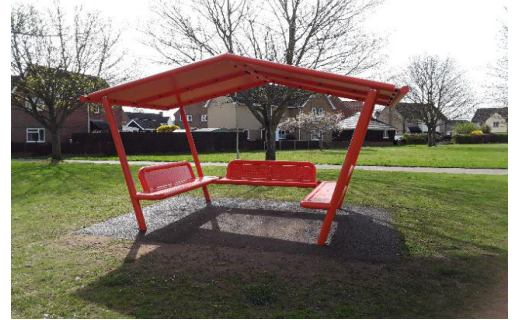
There is/are bolt cap covers missing or damaged on the item - Replace 9 missing or damaged bolt cap covers

There is some graffiti present - Remove the graffiti

The surface has eroded in some areas - Reinststate the surface

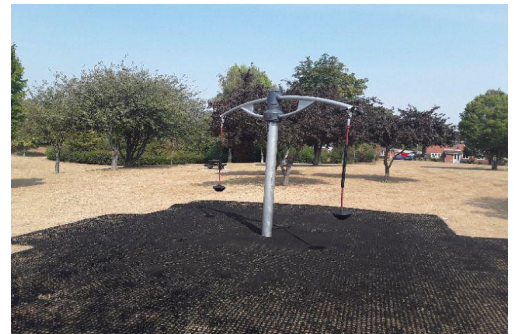
The surfacing around the item is damaged - Repair the damaged areas of surfacing

There are gaps opening between the grass mat tiles - Reinststate surface

There is/are bolt cap covers missing or damaged on the item - Replace missing or damaged bolt cap covers

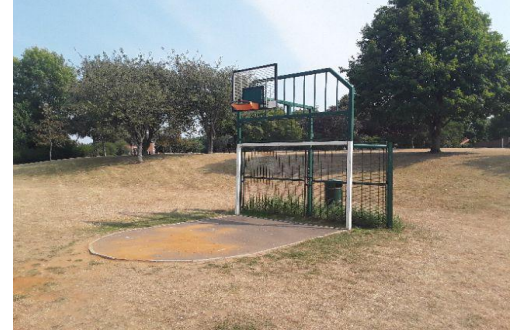
There are trip hazards at the edges of the surface - Reinstate surrounding surface levels to remove the trip points

There is surface corrosion present on the item - Consider treating and repainting the item

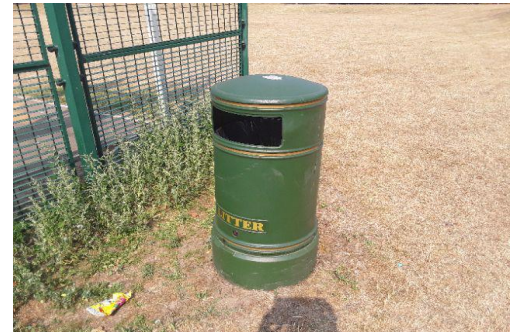
There is some graffiti present - Remove the graffiti

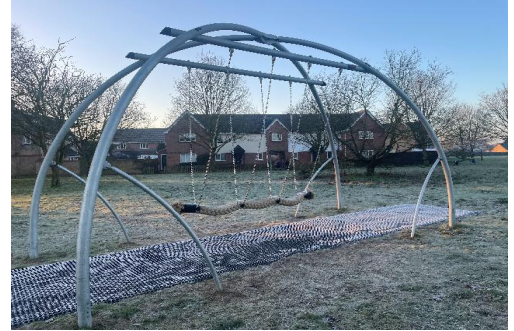
The surfacing around the item is damaged - Repair the damaged areas of surfacing

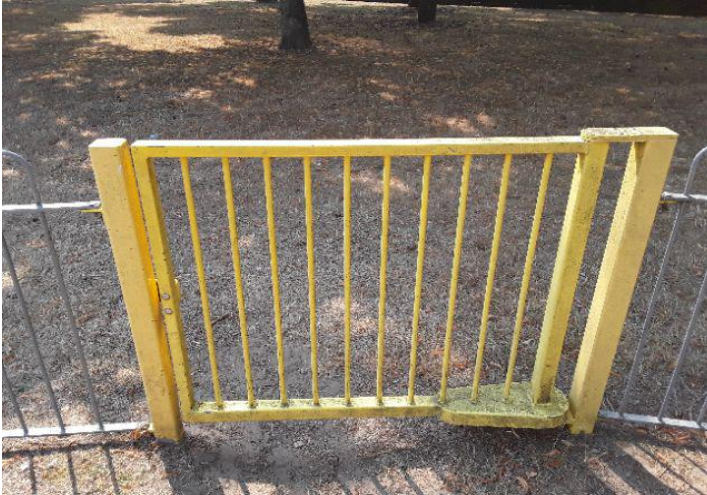
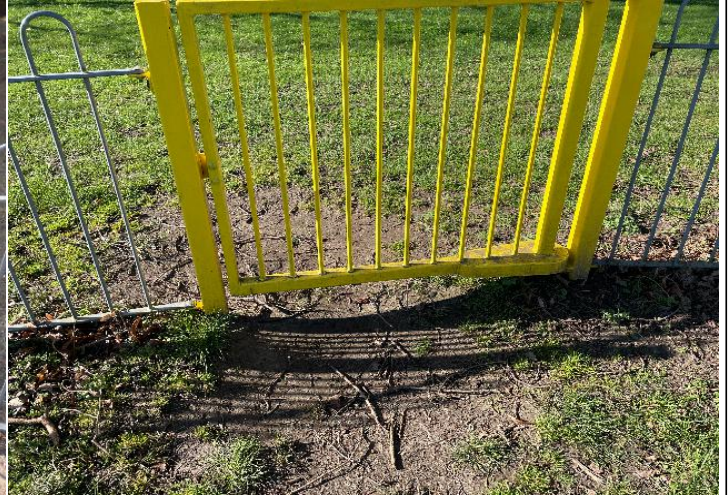
### 8 - Low Risk (Finding 1)

**Finding:** The area around the item has eroded and may become slippery

**Action:** Reinststate eroded area

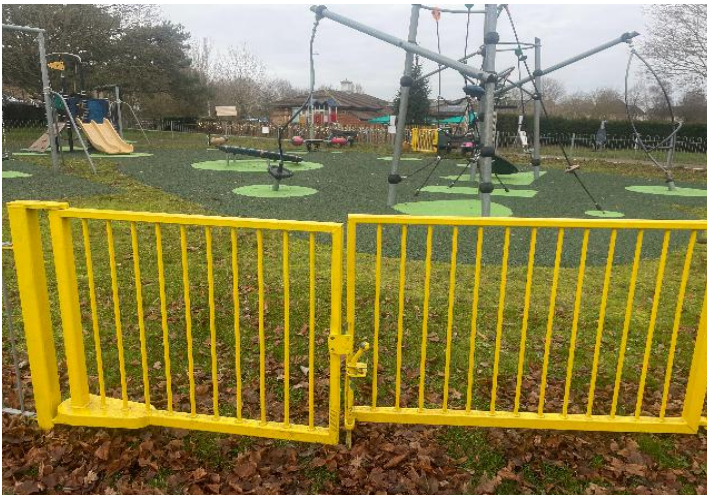
### 6 - Low Risk (Finding 1)

**Finding:** The paintwork on this item has been damaged or worn exposing the metal underneath which is rusting

**Action:** Treat any rusting components and repaint

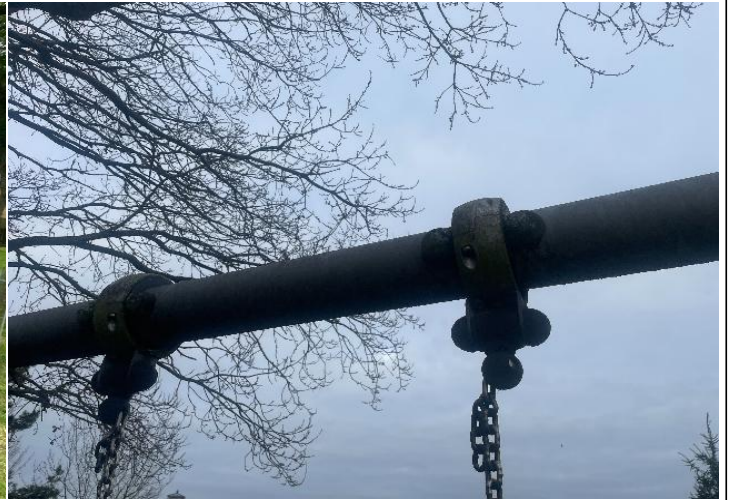
**Item:** Swings - 1 Bay 2 Seat (Cradle)  
**Manufacturer:** Kompan Ltd

**Finding:** There is algae or moss on the surface of the equipment

**Action:** Clean and treat appropriately

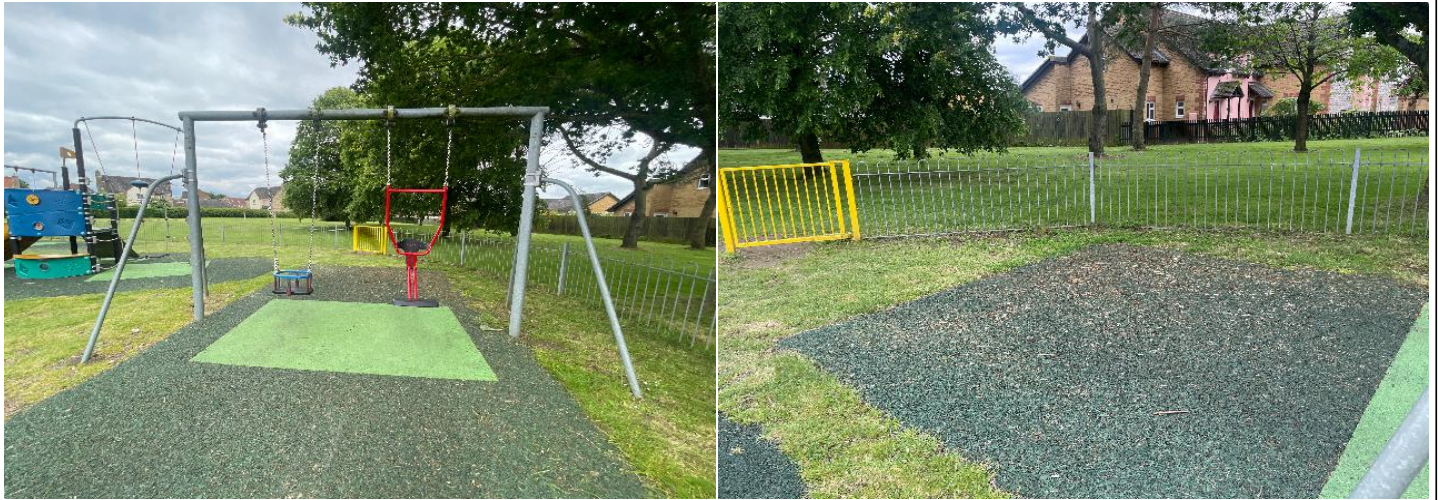
**Item:** Swings - 1 Bay 2 Seat (Cradle)  
**Manufacturer:** Kompan Ltd

**Finding:** There is some tree debris on the surfacing

**Action:** Remove and maintain

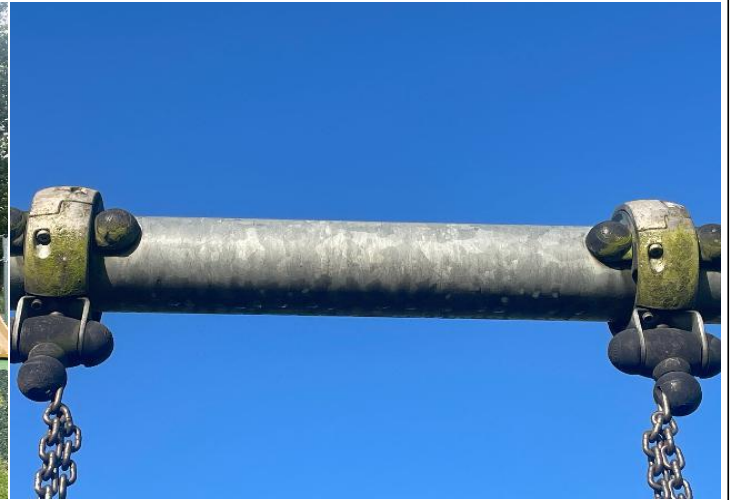
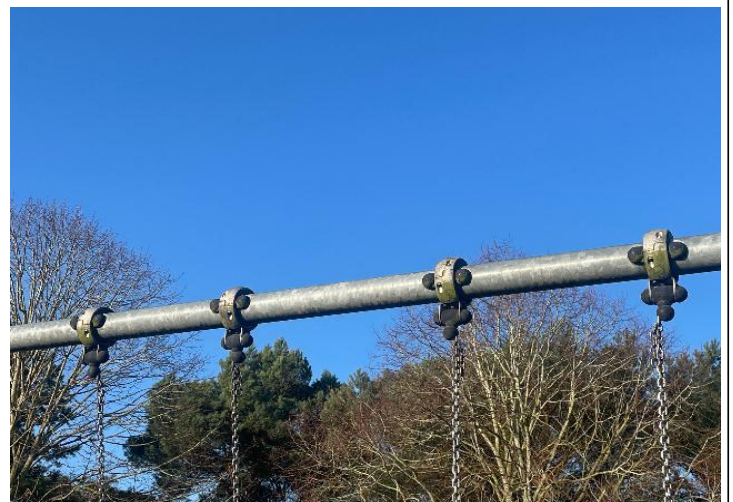
**Item:** Swings - 1 Bay 2 Seat (Flat)  
**Manufacturer:** Kompan Ltd

**Finding:** There is algae or moss on the surface of the equipment

**Action:** Clean and treat appropriately

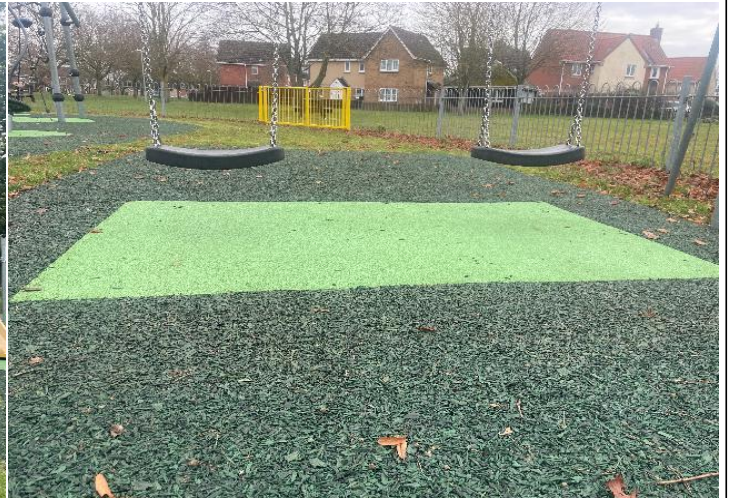
**Item:** Swings - 1 Bay 2 Seat (Flat)  
**Manufacturer:** Kompan Ltd

**Finding:** Seat is low

**Action:** Adjust

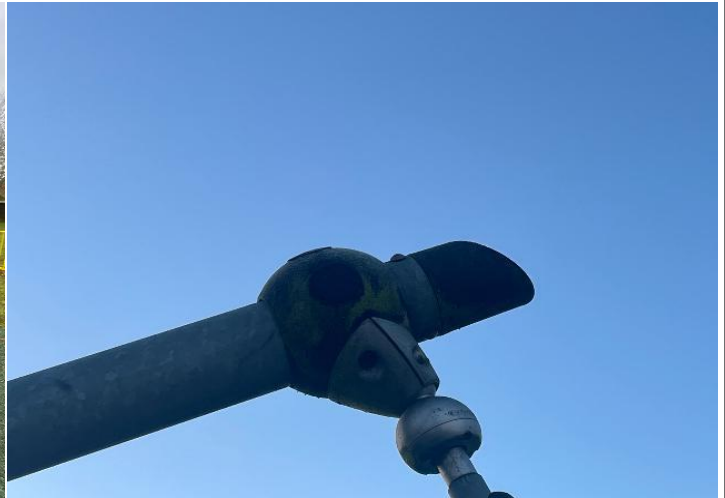
**Item:** Activity Equipment - Multi Play (Senior)  
**Manufacturer:** Kompan Ltd

**Finding:** There is algae or moss on the surface of the equipment

**Action:** Clean and treat appropriately

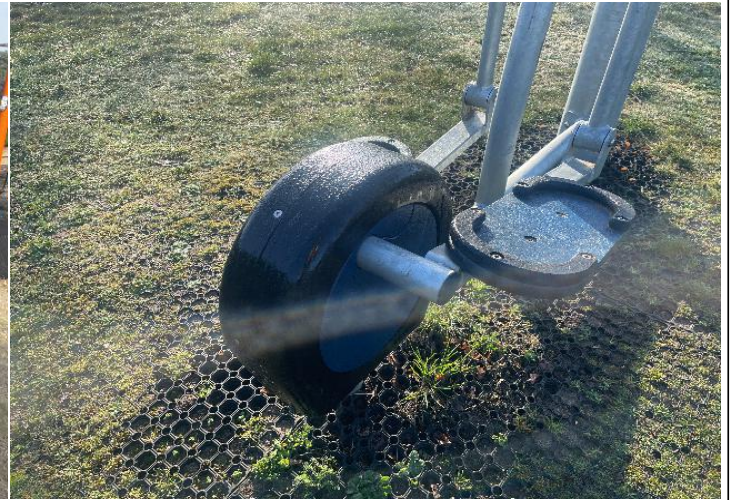
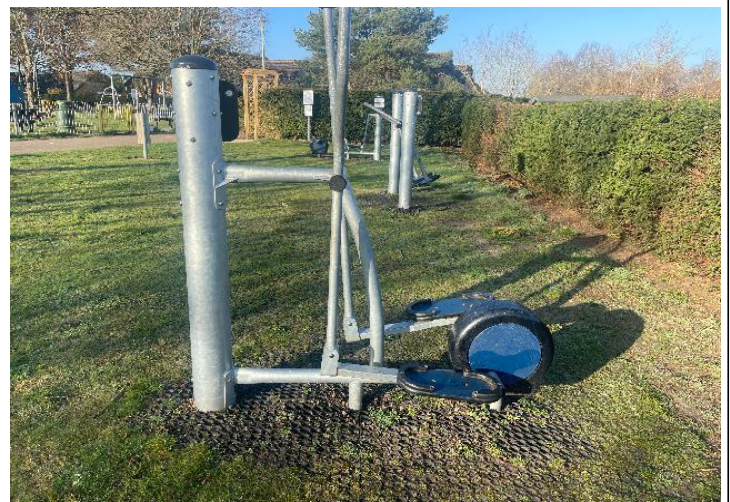
**Item:** Outdoor Fitness Equipment - Cross Trainer **Risk Level:** V - Very Low Risk  
**Manufacturer:** Kompan Ltd **Surface:** Grass Matrix Tiles

**Finding:** Slight rubbing on plastic cover

**Action:** Monitor

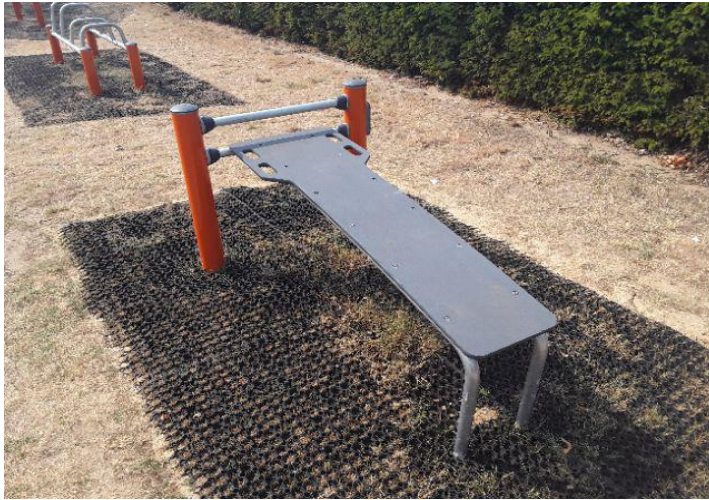
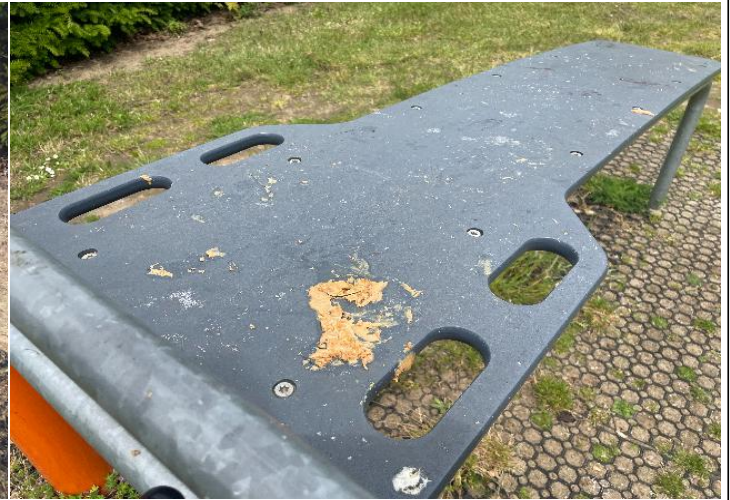
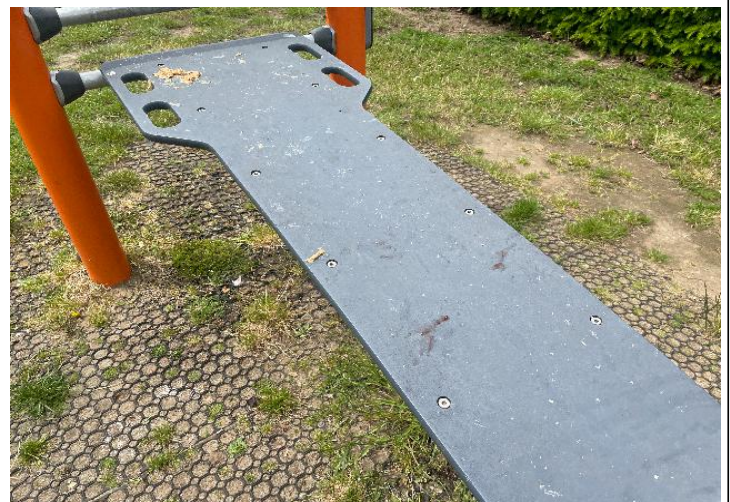
**Item:** Outdoor Fitness Equipment - Sit Up Station **Risk Level:** L - Low Risk  
**Manufacturer:** Kompan Ltd **Surface:** Grass Matrix Tiles

**Finding:** Food wast on equipment

**Action:** Remove and clean

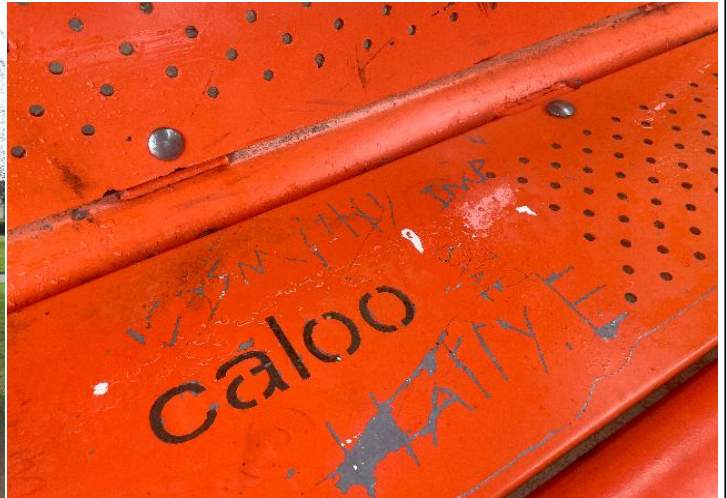
**Item:** Ancillary Items - Shelter  
**Manufacturer:** Caloo

**Finding:** There is some graffiti present

**Action:** Remove the graffiti

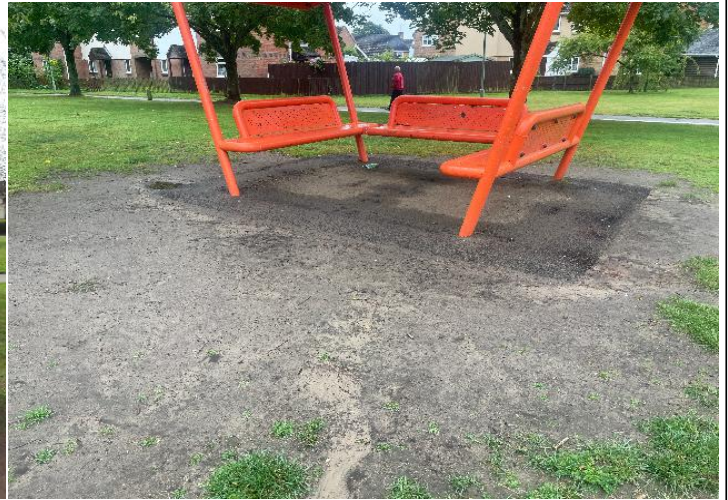
**Item:** Ancillary Items - Shelter  
**Manufacturer:** Caloo

**Finding:** The surface has eroded in some areas

**Action:** Reinststate the surface

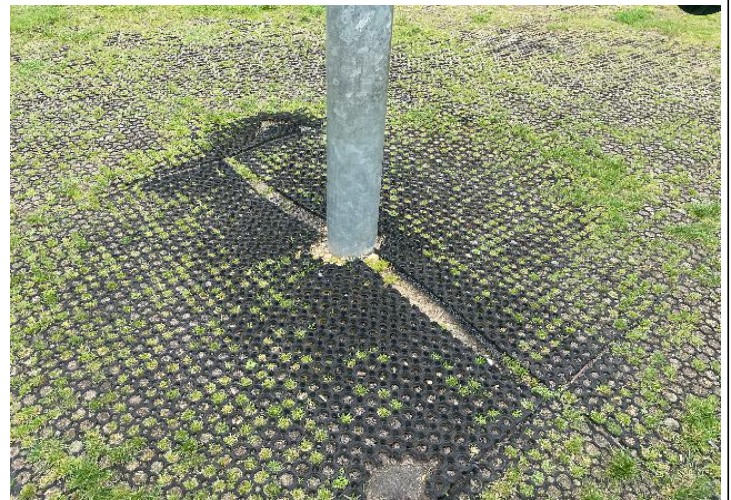
**Item:** Activity Equipment - Overhead Rotator  
**Manufacturer:** Kompan Ltd

**Finding:** There are gaps opening between the grass mat tiles

**Action:** Reinststate surface

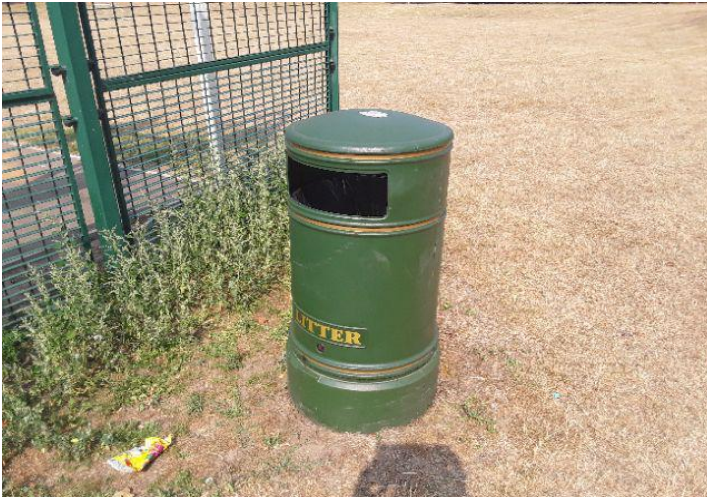
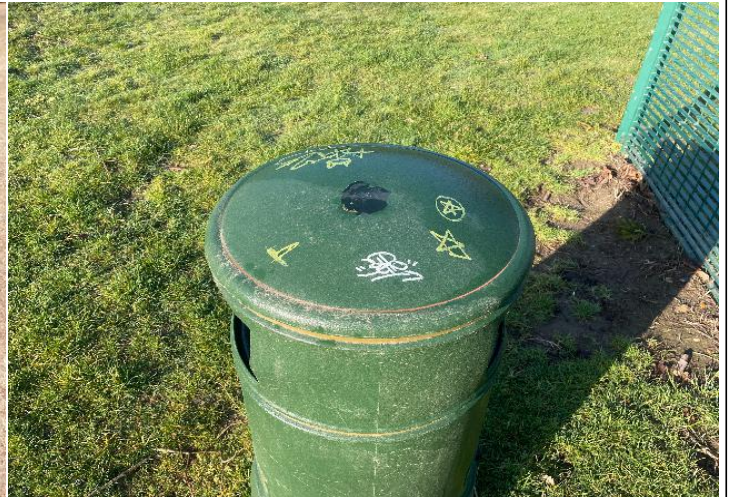
**Item:** Ancillary Items - Litter Bin  
**Manufacturer:** Unknown

**Finding:** There is some graffiti present

**Action:** Remove the graffiti
