## Operational Inspection

Thurston Parish Council

Thurst Coffee Shop Playground  
New Green Centre, New Green Ave, Thurston , IP31  
3TG

Inspection Ref: 2390537

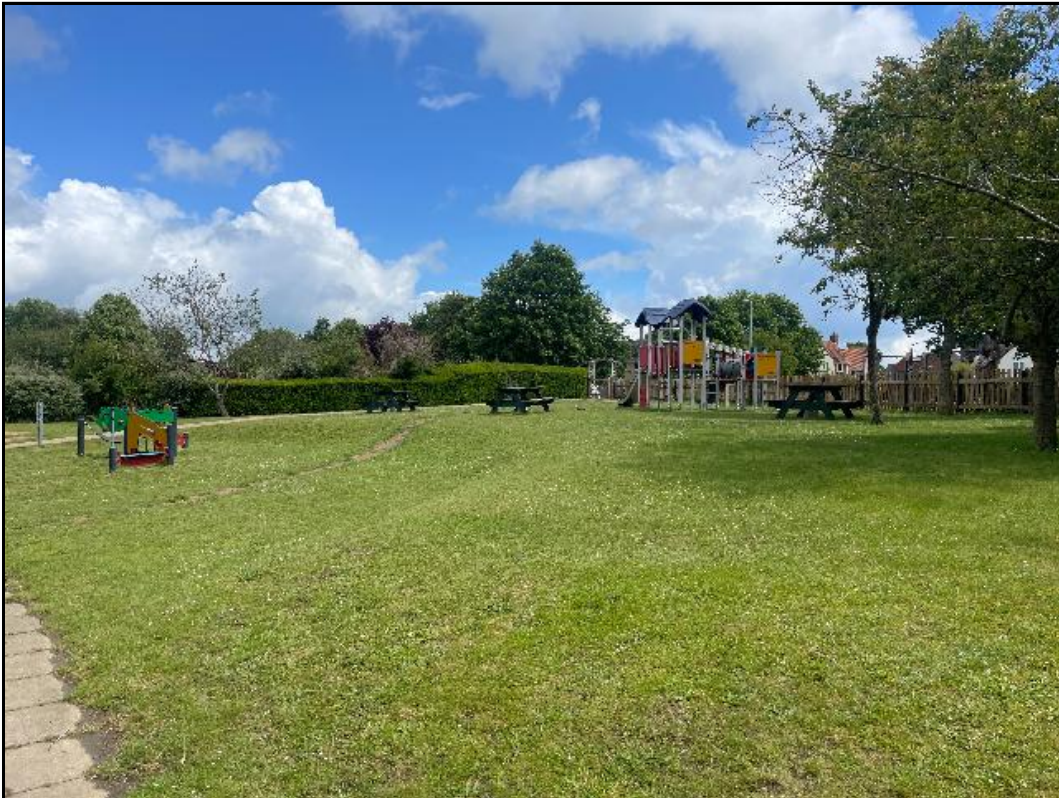
**i** 5 - Very Low Risk

**Item:** Multi Play (Junior)  
**Manufacturer:** Kompan Ltd  
**Surface Type:** Grass Matrix Tiles  
**Item Quantity:** 1  
**Equipment Compliance:** N/A  
**Surface Area Compliance:** N/A

**Finding 1**

This item is satisfactory - no work required -
